BRIDGE INSPECTION REPORT

Br. No. DOC-1

Br. Name STEILACOOM BLDG TRESTLE

DOC - 1 AND DOC - 2
STEILACOOM BUILDING TRESTLE
AND MOORING FLOAT

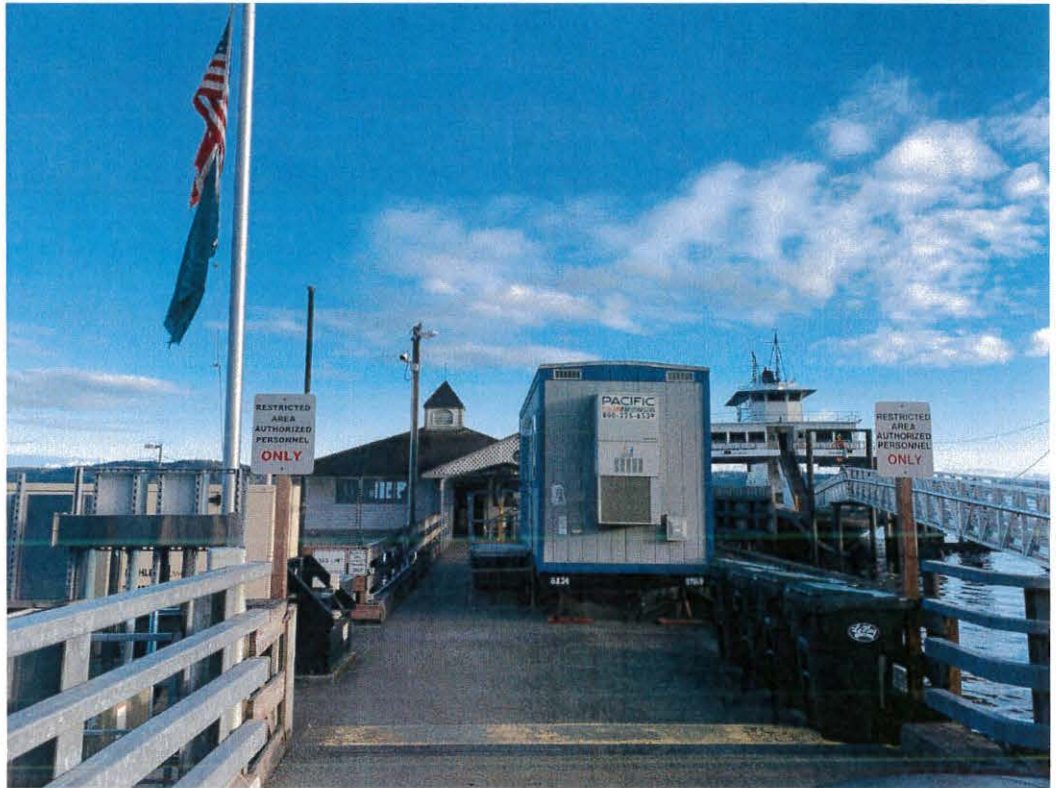
SI-12

0 Orientation
Photo Type: D - Deck
Orientation: Sea
Date: 4/26/2021
Repairs:
Deck looking offshore. Tempoary covid check building on the deck in 2021.

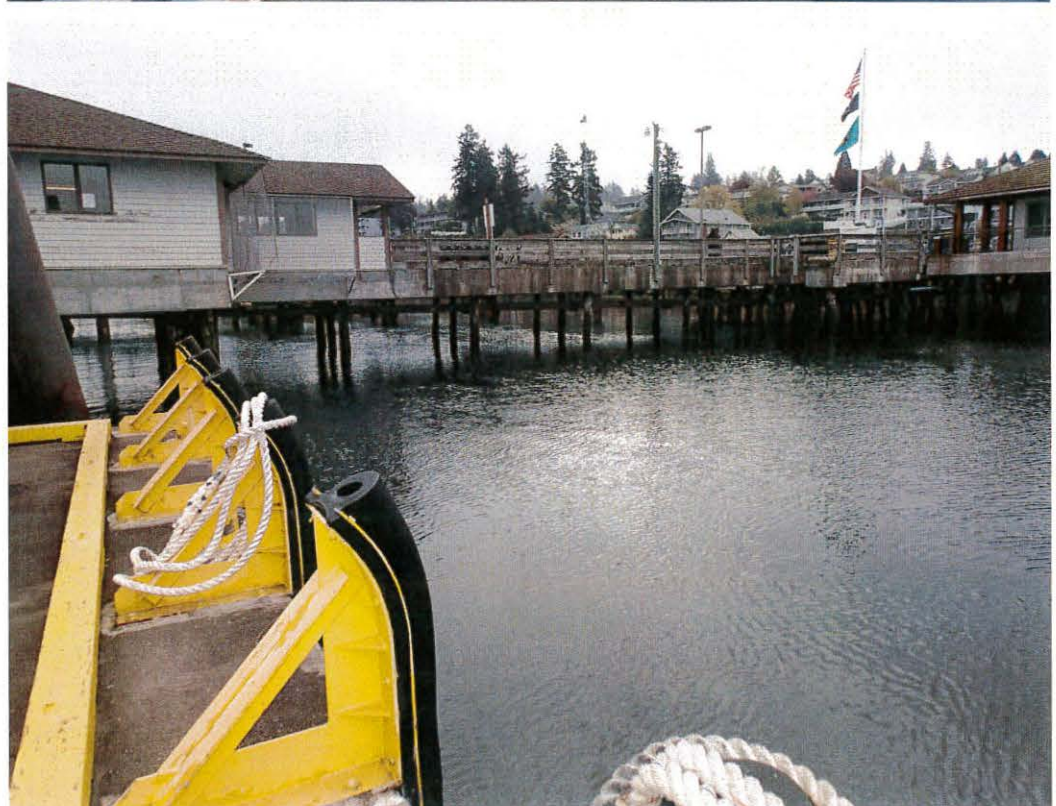
SI-2

0 Orientation
Photo Type: E - Elevation
Orientation: NE
Date: 5/22/2013
Repairs:
Elevation looking right.

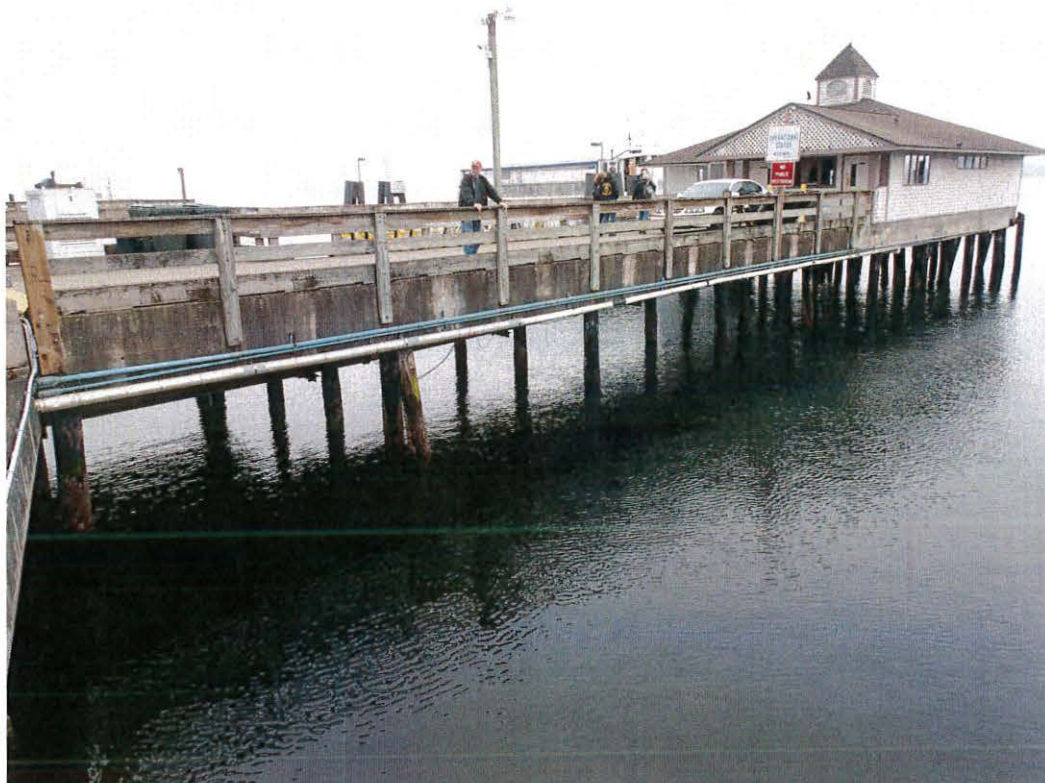
SI-3

0 Orientation
Photo Type: E - Elevation
Orientation: W
Date: 5/22/2013
Repairs:
Elevation looking offshore.

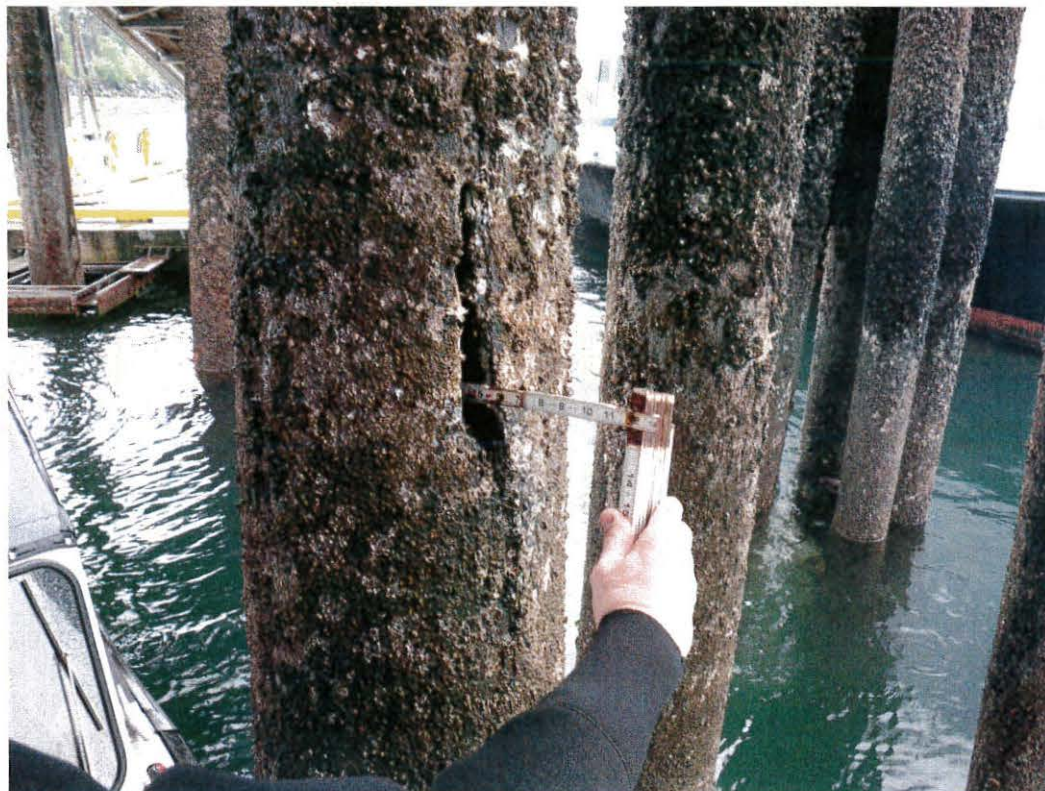
UW-3

8124 TIMBER SUBMERGED PILE:
 There are 49 piles supporting the dock and building. There are also 11 fender piles.
 Timber pile 8.9A has a significant rot pocket that substantially effects the capacity, see attached cross section drawing (photos UW-3, UW-4, #8, and #11). Pile Red Tagged for REPAIR #10002.

8124 Timber Submerged Pile/Column
Photo Type: I - In Depth
Orientation: Left
Date: 5/22/2013
Repairs: 10002
Pile 8.9A: Rot cavity 6"W x 12"H x 6"D
(2013 photo)

8.1	A	100			MDL+12	MBE @ 3:00; 3/4" diam w/ 3" pen.	UW	4/26/2021
						Battered pile.	UW	4/26/2021
8.9	A	50	RT	50"	MDL+20	Battered pile. Two MBEs.		
					MDL+22	Rot cavity from 1:00 - 3:00: 8 x 8 opening to a 12" W x 21" H x 12" deep cavity. Photos #UW-3 and #UW-4.	UW	4/26/2021
9	H	100				Battered pile.	UW	4/26/2021
	A	100					UW	4/26/2021
	B	75			-15.5	MDL		
					MDL+17	Two MBEs @ 4:00 w/ up to 2" pen. Photo #UW-5		
					MDL+19	Two MBEs @ 4:00: 3/4" diam. w/ up to 3" pen.	UW	4/26/2021
					MDL+21	MBE @ 4:00: 3/4" diam. w/ up to 2" pen.		
	C	100				Battered pile has minor striations.	UW	4/26/2021
	D	75			Cap -5	4 holes @ 12:00: 1" W x 2" H x up to 5" deep.	UW	4/26/2021
	E	100				Battered pile.	UW	4/26/2021
	F	75			Cap -5	2 holes @ 12:00: 3/4" diam w/ up to 5" pen.	UW	4/26/2021
	G	100			-15	MDL. Battered pile.	UW	4/26/2021
	H	75			Cap -5	MBE @ 5:00 w/ 3" pen. And MBE @12:00 3/4" diam. w/ 4" pen.	UW	4/26/2021

Repair No	Pr	R	Repair Descriptions	BMS	Noted	Maint	Verified
10000	3	B	Timber curbing has sections of rot. Recommend replacing all timber curbing that is rotten.	8817	5/22/2013		
10001	2	B	Steel sliding plate joint has been sawcut near full length for conduit placement. Spot welds used to reset are now breaking apart. Reweld sawcut with more than the occasional skip weld.	8408	4/8/2019		
10002	1	B	Timber pile 8.9A has a significant rot pocket that substantially effects the capacity. 2019 inspection moved this pile from Yellow to Red Tagged. Evaluate capacity/demand and replace as required.	8124	4/8/2019

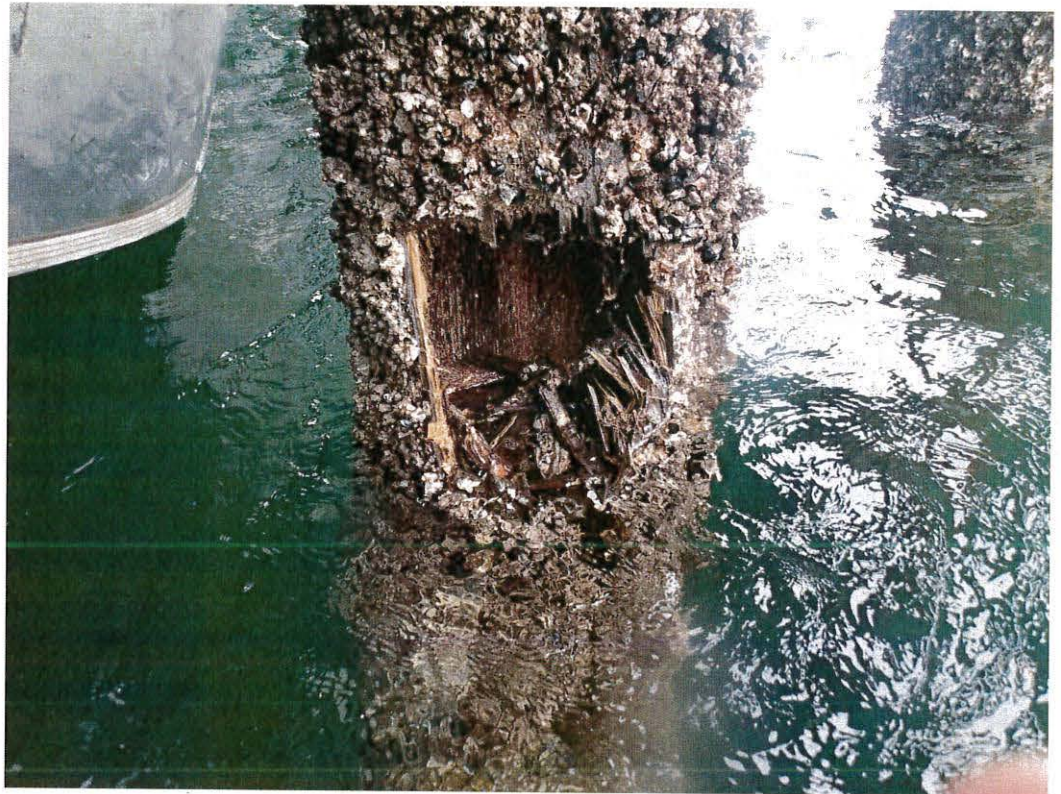
UW-4

8.9A: updated view of rot cavity (2017).

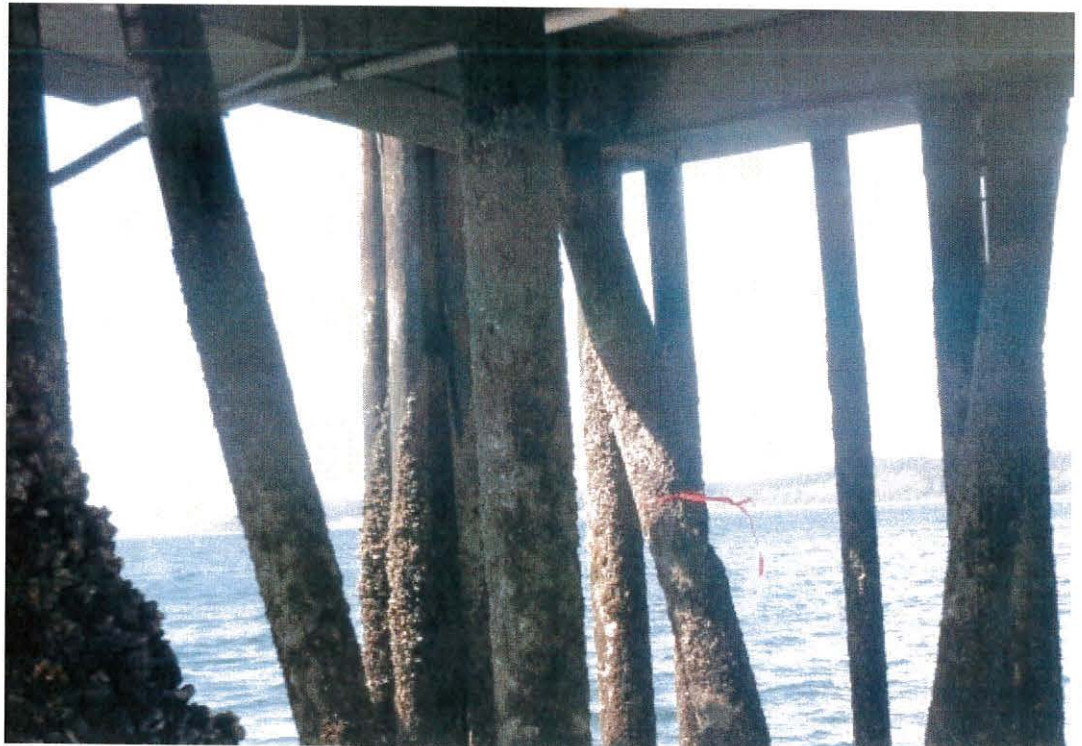
SI-8

Pile 8.9A: Measured 9" W x 16" H x 8" D (2019). Grew to 12"W x 21" H X 12" deep in 2021.

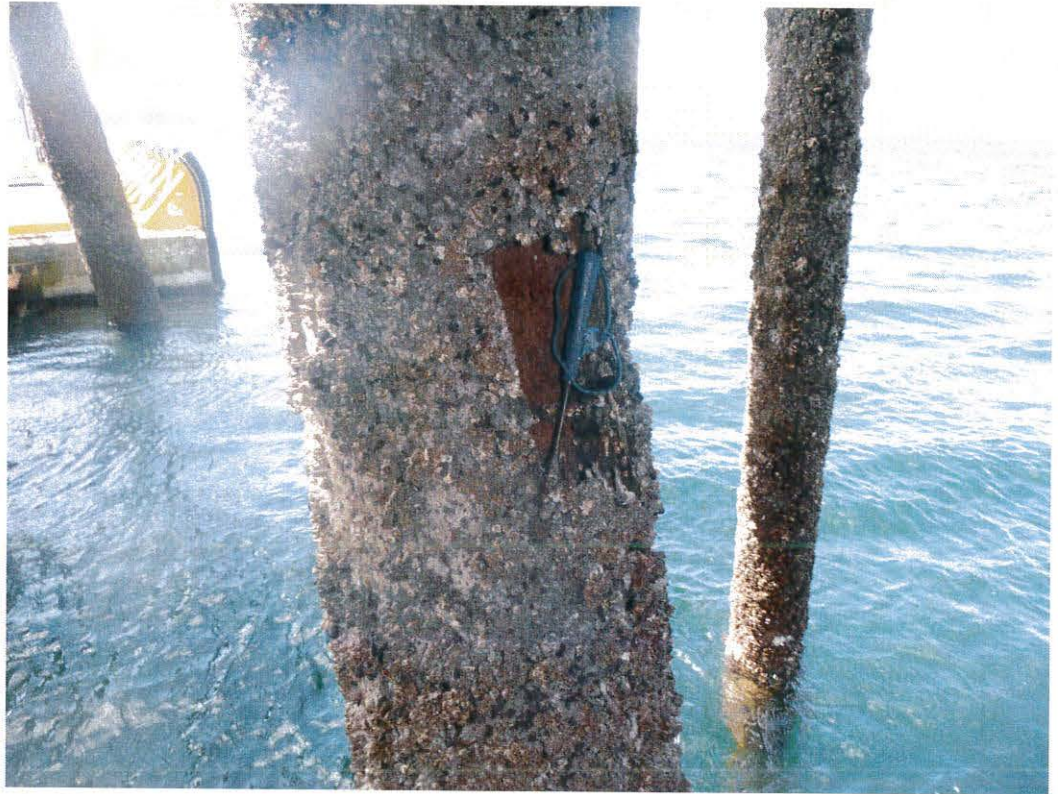
SI-11

Pile 8.9A: Measured 9" W x 16" H x 8" D (2019). Grew to 12"W x 21" H X 12" deep in 2021.

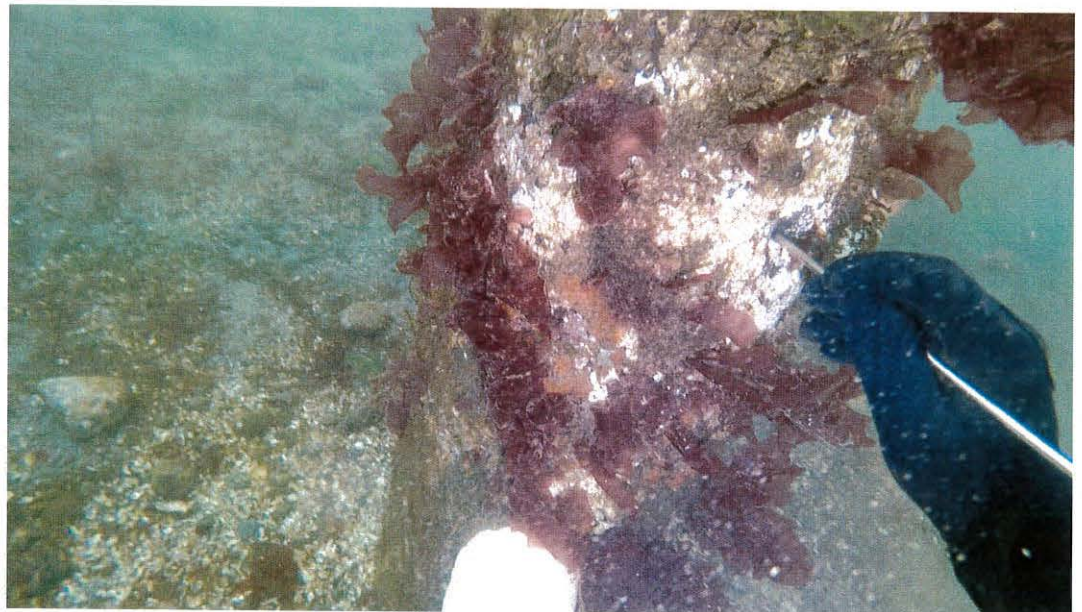
UW-1

Pile 3B: two marine borer entries (MBE's) near mudline.

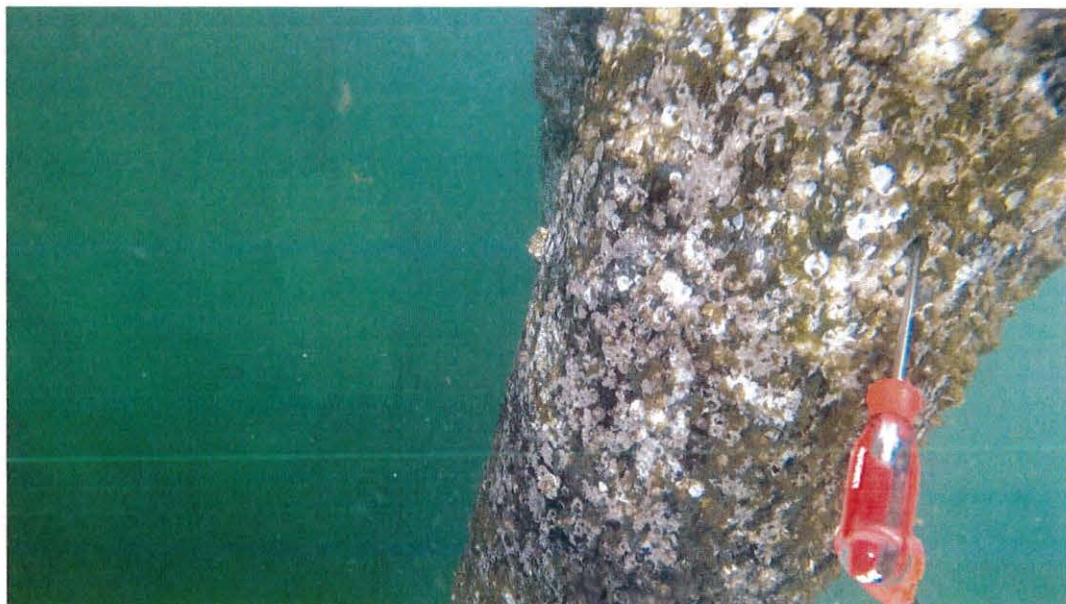
UW-2

Pile 7.1H: MBE with 2.5" penetration. Typical of MBE defects throughout the facility.

7.1	H	100					UW	4/26/2021
	A	100				Battered pile.	UW	4/26/2021
7.9	H	75			MDL+16	Battered pile. MBE; 1/2" diam. w/ 2.5" pen. @ 5:00 (Photo #UW-2)	UW	4/26/2021
	E	100				Battered pile.	UW	4/26/2021
8	A	100			-13.5	MDL	UW	4/26/2021
	B	100			MDL +18 @ 1:00	1/2" opening with 2" pen.	UW	4/26/2021
	C	100			-14.5	MDL		
	D	75			MDL+14	Shake: 1"W x 1/2" D x 2' tall @ 8:00	UW	4/26/2021
	D	75			MDL+15	Two MBEs @ 6:00: 3/4" diam. w/ 2" pen. and 1/2" diam. w/ 1.5" pen.	UW	4/26/2021
	E	75			-13.5	MDL

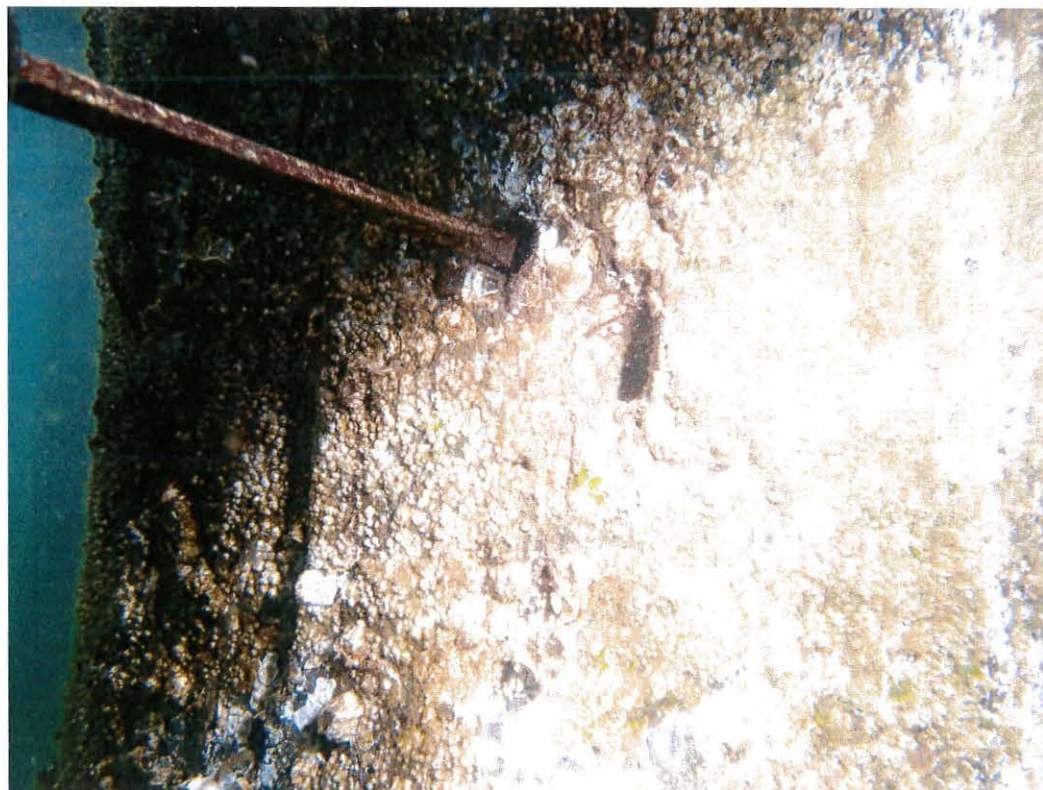
UW-5

Pile 9B: 3 marine borer entry holes. Up to 2" pen. Typical MBE defect.

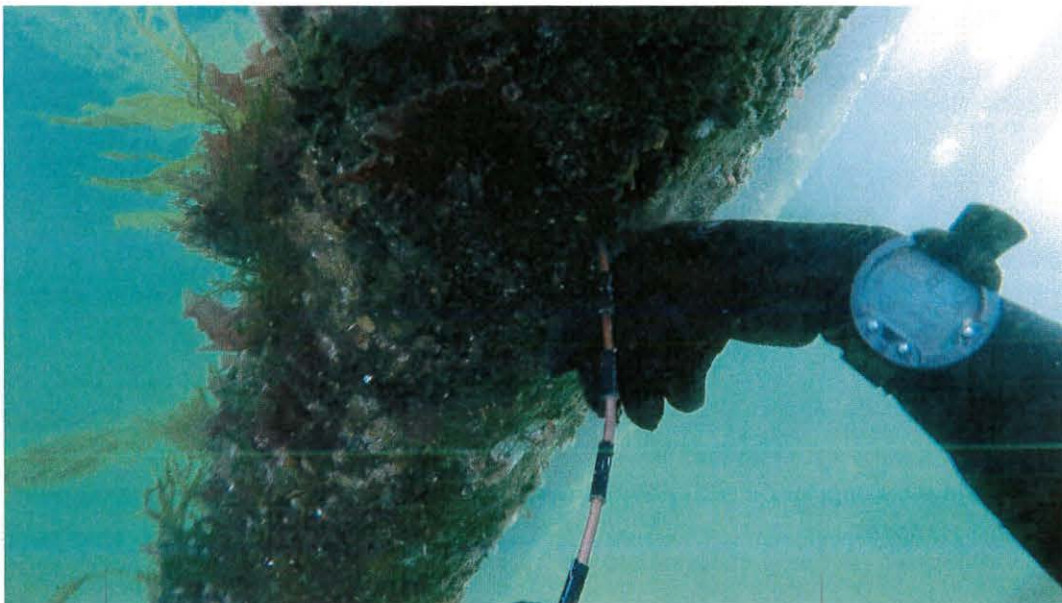
UW-6

Pile F7 has a 3/4" diameter MBE with 3" of penetration at 6:00 MDL +10.

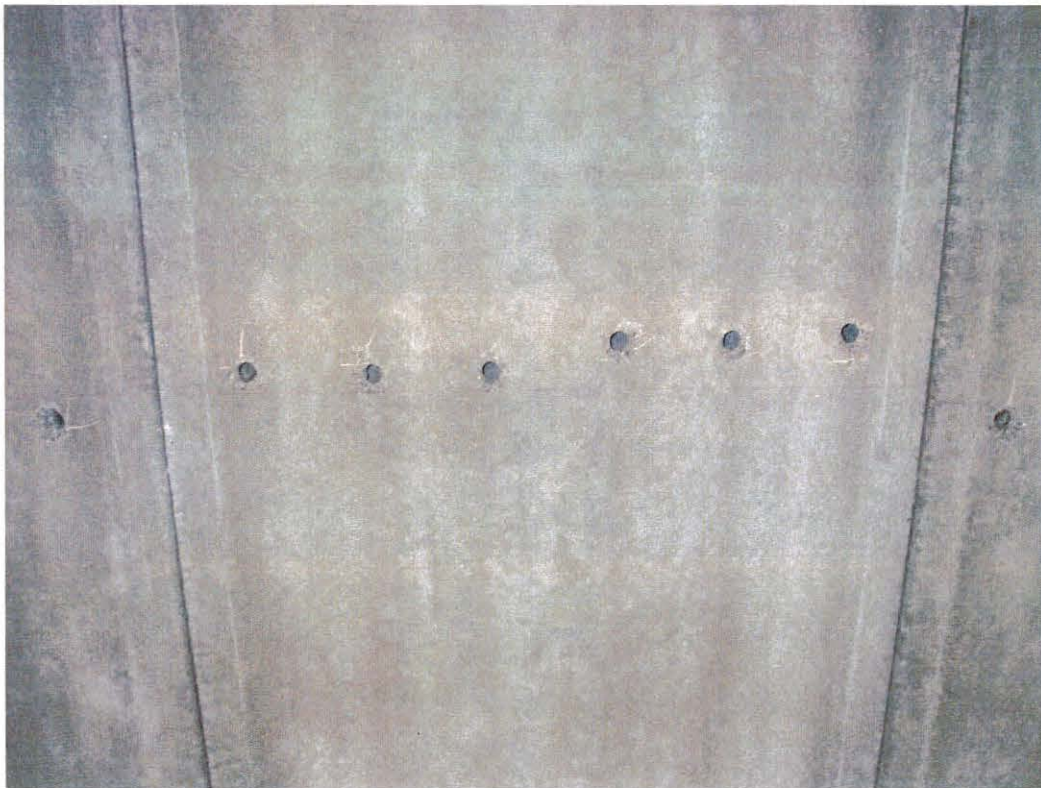
SI-4

8150 PRESTRESSED CONCRETE SLAB W/UNCOATED BARS:
 Each of the precast deck panels have 1" diameter holes drilled in the soffit at midspan, presumably at each of the voids (photo #4). Many of the utility hangers are rusty with some section loss.

Each of the precast deck panels have 1" diameter holes drilled at midspan, presumably at each of the voids.

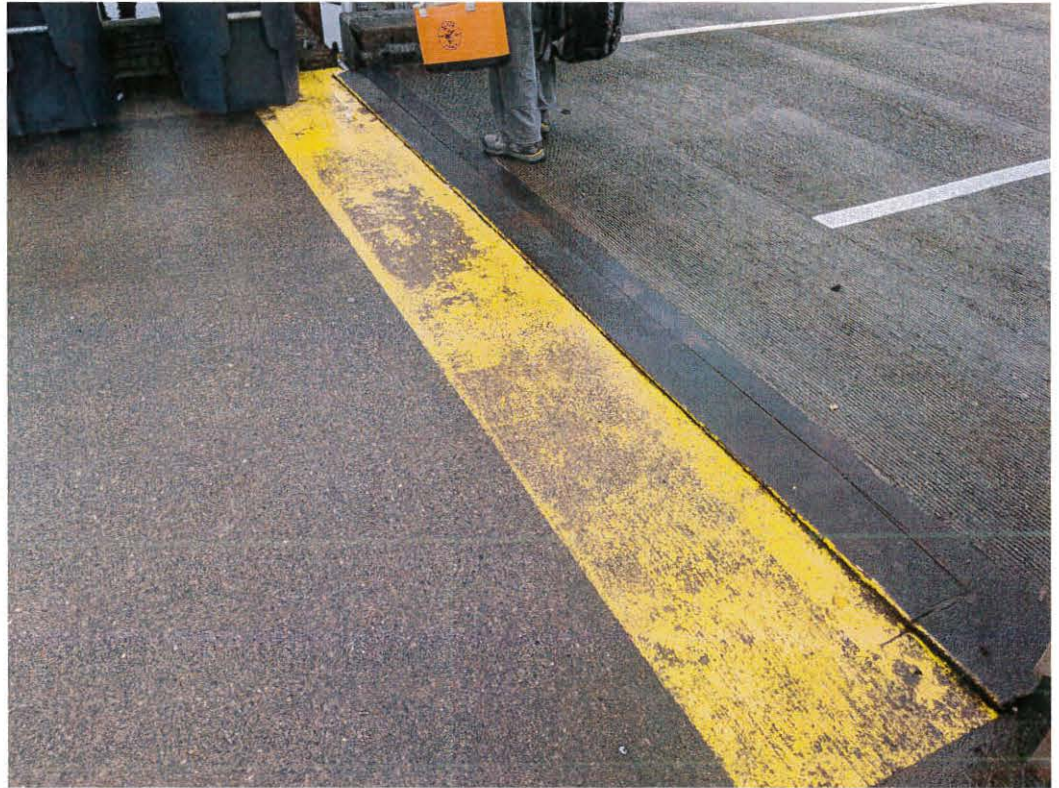
SI-9

8408 STEEL SLIDING PLATE JOINT:
 Joint located at shore side of walkway.
 Steel plate cut near full length for conduit placement (photo #9). Spot welds used to reset are now breaking apart (photo #10). REPAIR #10001.

Steel sliding plate joint between Pierce County Trestle and DOC-1 Trestle. Plate cut near full length for conduit placement

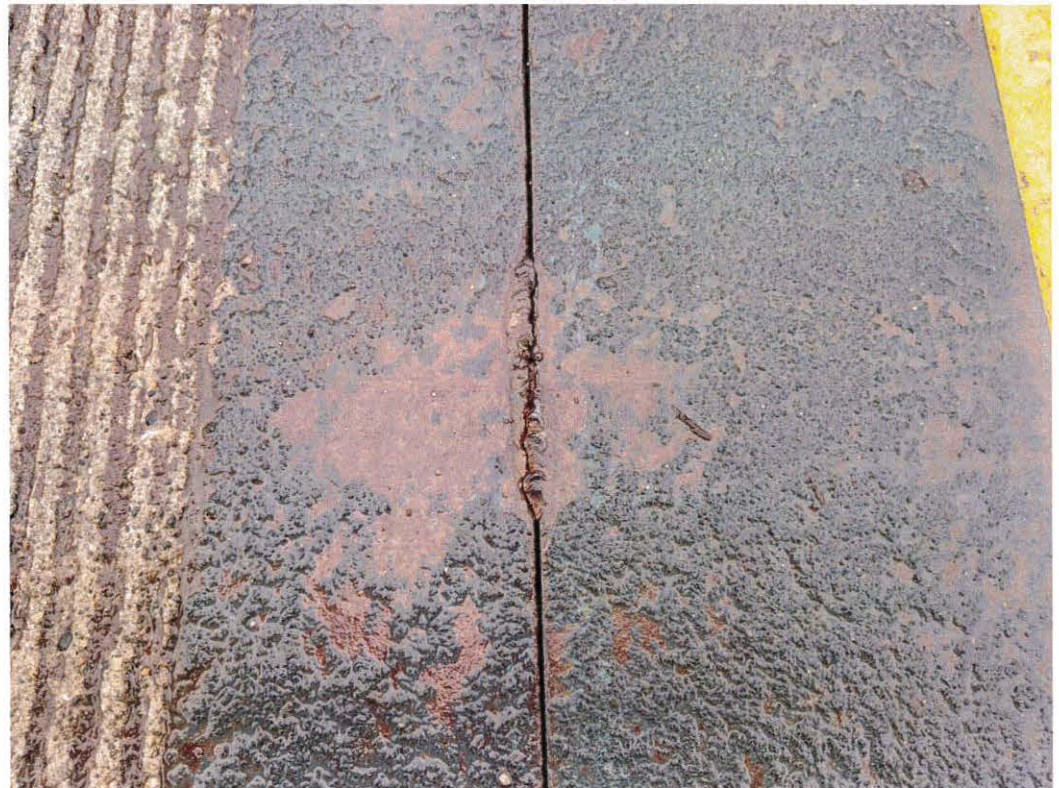
SI-10

Spot welds used to reset are now breaking apart

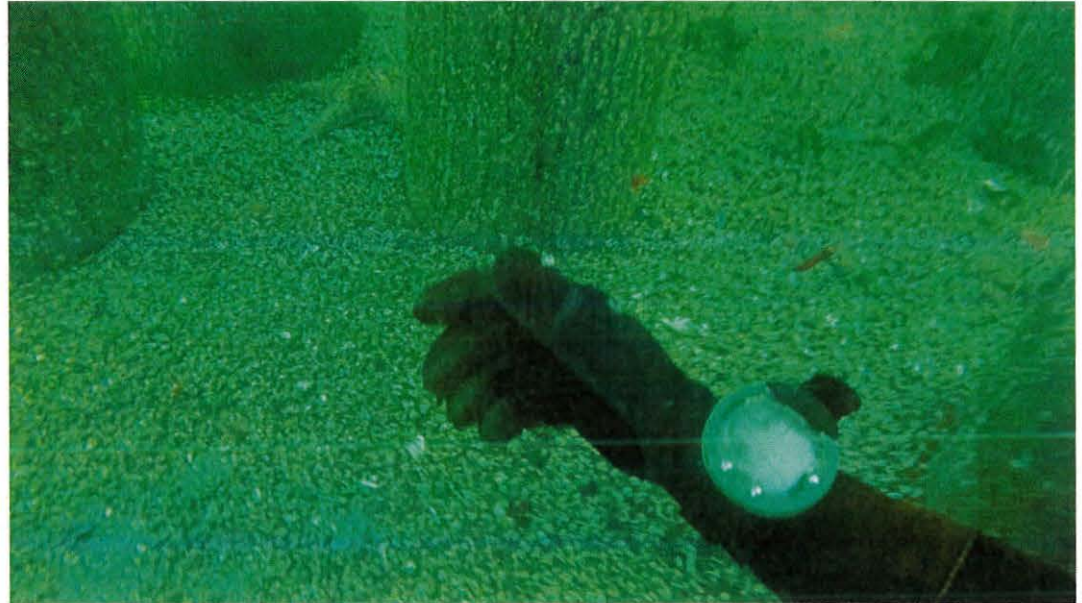
UW-7

Underwater Inspection Findings:
 The center pile has minor Limnoria striations.
 The pile group moves very easily even with light wave action. It appears to be due to the wraps being loose which doesn't make the dolphin act as a unit. The piles are not showing any distress at mudline (photo UW-7).

Timber dolphin at ground line. Note the minor Limnoria striations on the center pile.

-15	MDL		
Dolphin	Dolphin				-18.5	MDL. Seven pile dolphin. Center pile has Limnoria striations (photo UW-7).	UW	4/26/2021
Counts	Timber =	60	7	(dolphin piles)

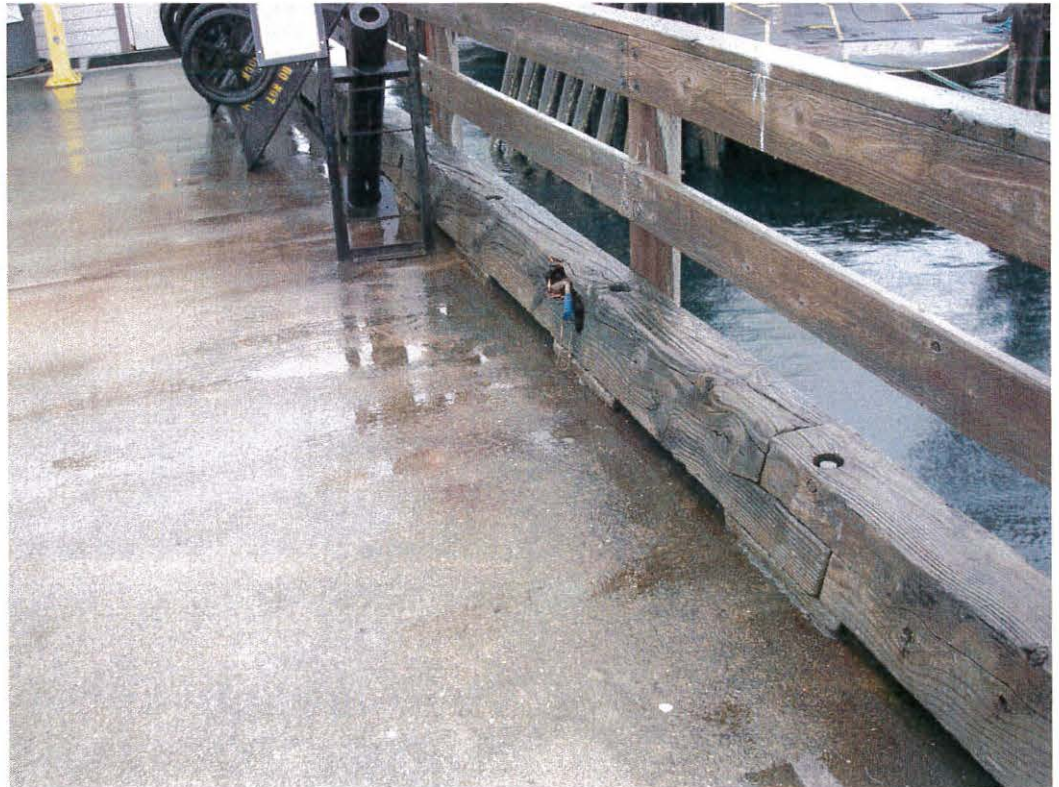
SI-6

8817 TIMBER PEDESTRIAN RAILING:
 Timber railing on walkway only.
 Timber curb not included in railing quantity, approximately half of all timber curbing is rotten (photo #6). REPAIR #10000.

Right side timber curbing is in poor condition. Several sections on the left are soft. (2021 - photo kept for clarity)

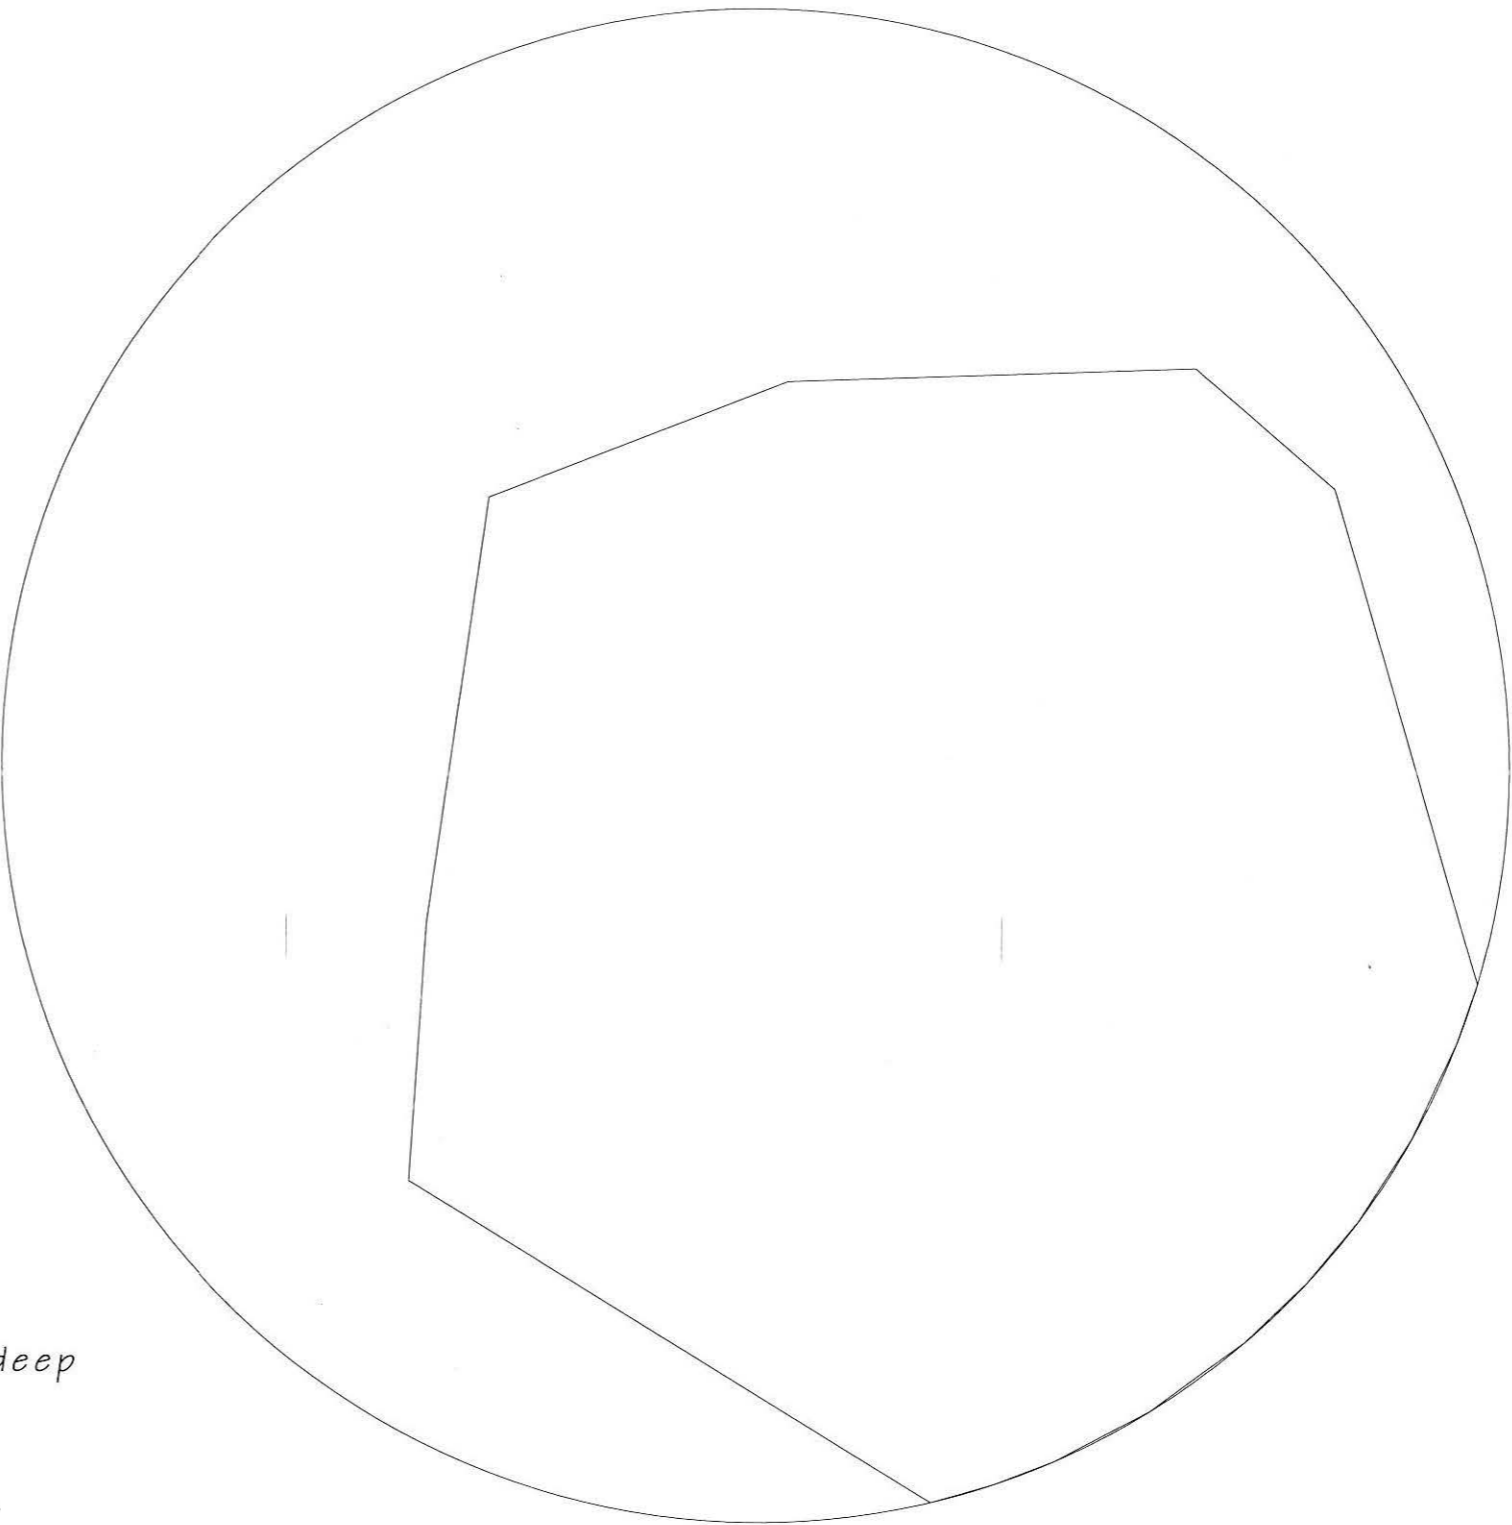
16"Ø PILE 8.9A ROT POCKET 12" W x 21" H x 12" deep
 APPROXIMATELY 50% SECTION LOSS
 AT 9' BELOW THE CAP.
 PILE LENGTH 36' AS ESTIMATED FROM PLANS.
