UNDERWATER INSPECTION REPORT FOR
STEILACOOM BLDG TRESTLE

BRIDGE NO. DOC-1

STRUCTURE ID 00200436

Inspection Date April 26, 2021

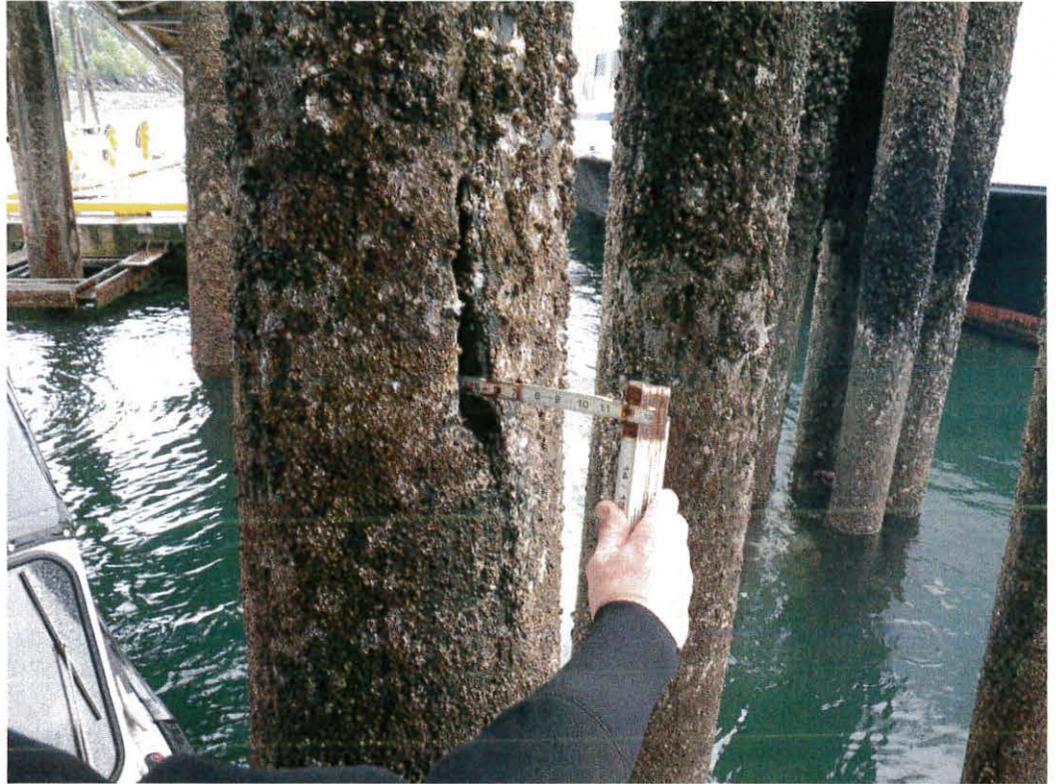
UW-3

8124 Timber Submerged Pile/Column
Photo Type: I - In Depth
Orientation: Left
Date: 5/22/2013
Repairs: 10002
Pile 8.9A: Rot cavity 6"W x 12"H x 6"D
(2013 photo)

8.1	A	100			MDL+12	MBE @ 3:00; 3/4" diam w/ 3" pen.	UW	4/26/2021
						Battered pile.	UW	4/26/2021
8.9	A	50	RT	50"	MDL+20	Battered pile. Two MBEs.		
					MDL+22	Rot cavity from 1:00 - 3:00: 11" W x 12" H x 7" deep. Photos #UW-3 and #UW-4.	UW	4/26/2021
9	H	100				Battered pile.	UW	4/26/2021
	A	100					UW	4/26/2021
					-15.5	MDL		
	B	75			MDL+17	Two MBEs @ 4:00 w/ up to 2" pen. Photo #UW-5		
					MDL+19	Two MBEs @ 4:00: 3/4" diam. w/ up to 3" pen.	UW	4/26/2021
					MDL+21	MBE @ 4:00: 3/4" diam. w/ up to 2" pen.		
	C	100				Battered pile has minor striations.	UW	4/26/2021
	D	75			Cap -5	4 holes @ 12:00: 1" W x 2" H x up to 4" deep.	UW	4/26/2021
	E	100				Battered pile.	UW	4/26/2021
	F	75			Cap -5	2 holes @ 12:00: 3/4" diam w/ up to 4/5" pen.	UW	4/26/2021
	G	100			-15	MDL. Battered pile.	UW	4/26/2021
	H	75			Cap -5	MBE @ 5:00 w/ 3" pen. And MBE @12:00 3/4" diam. w/ 4" pen.	UW	4/26/2021
Fenders	F1	100			MDL+2	2 MBEs @ 11:00; both 3/4" diam. w/ 1.5" pen.	UW	4/26/2021

Repair No	Pr	R	Repair Description	BMS	Noted	Maint	Verified
10002	1	B	Timber pile 8.9A has a significant rot pocket that substantially effects the capacity. 2019 inspection moved this pile from Yellow to Red Tagged. Evaluate capacity/demand and replace as required.	8124	4/8/2019

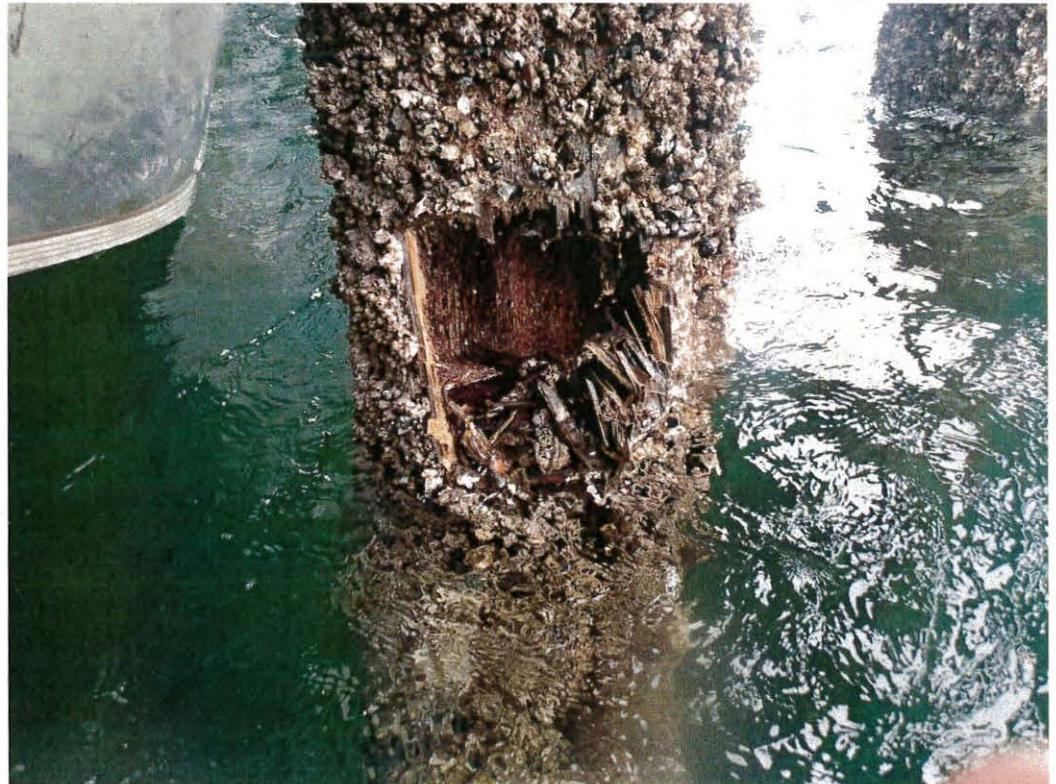
UW-4

8124 Timber Submerged Pile/Column
Photo Type: I - In Depth
Orientation:
Date: 4/24/2017
Repairs: 10002
8.9A: updated view of rot cavity (2017).

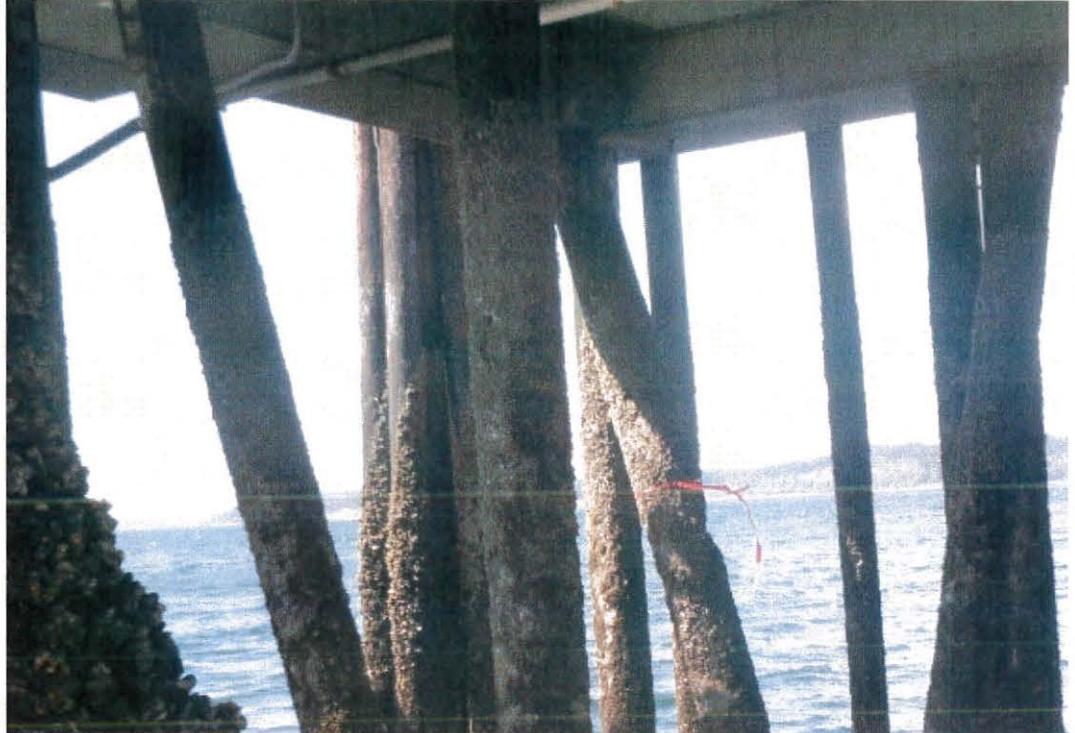
SI-8

Pile 8.9A: Measured 9" W x 16" H x 8" D (2019).

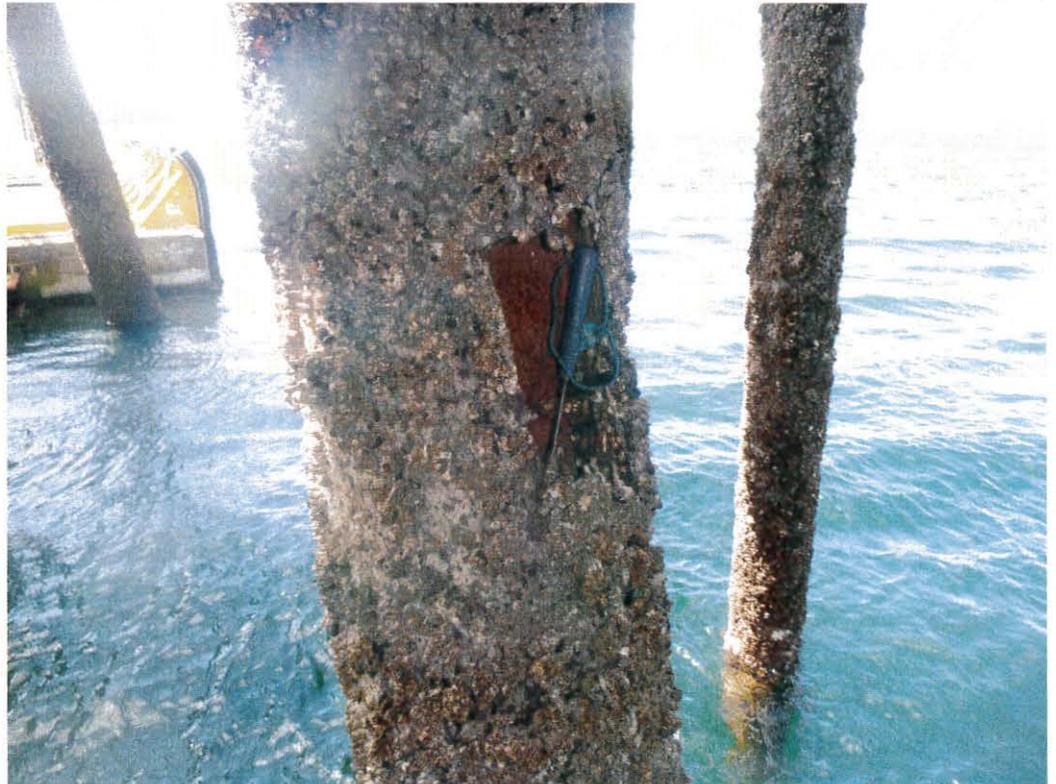
SI-11

Pile 8.9A: Measured 9" W x 16" H x 8" D (2019).

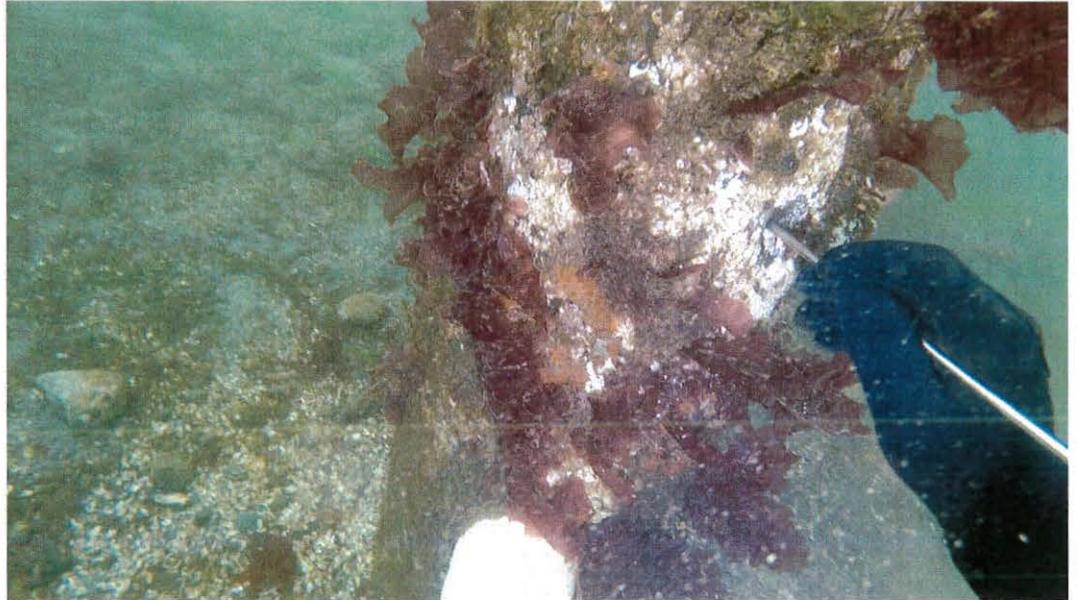
UW-1

Pile 3B: two marine borer entries (MBE's) near mudline.

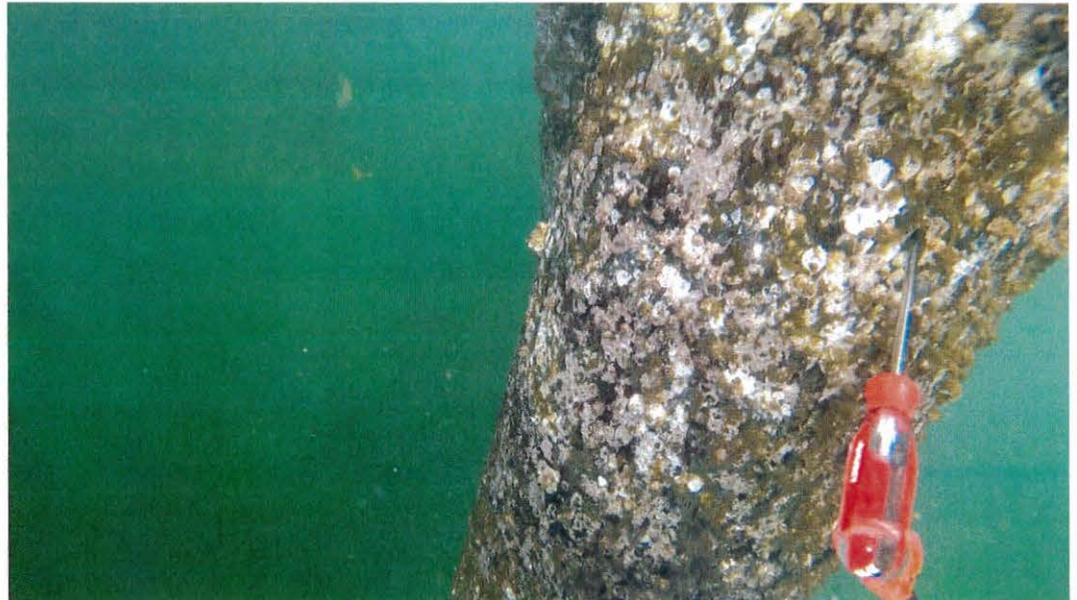
UW-2

Pile 7.1H: MBE with 2.5" penetration. Typical of MBE defects throughout the facility.

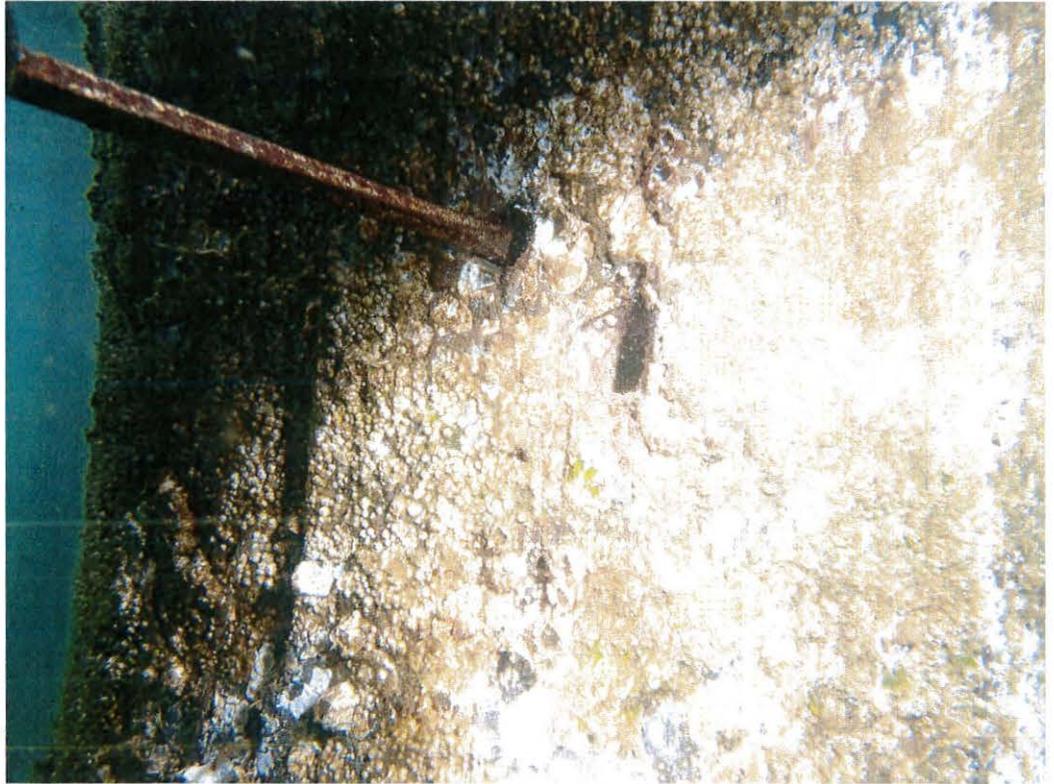
UW-5

Pile 9B: 3 marine borer entry holes. Up to 2" pen. Typical MBE defect.

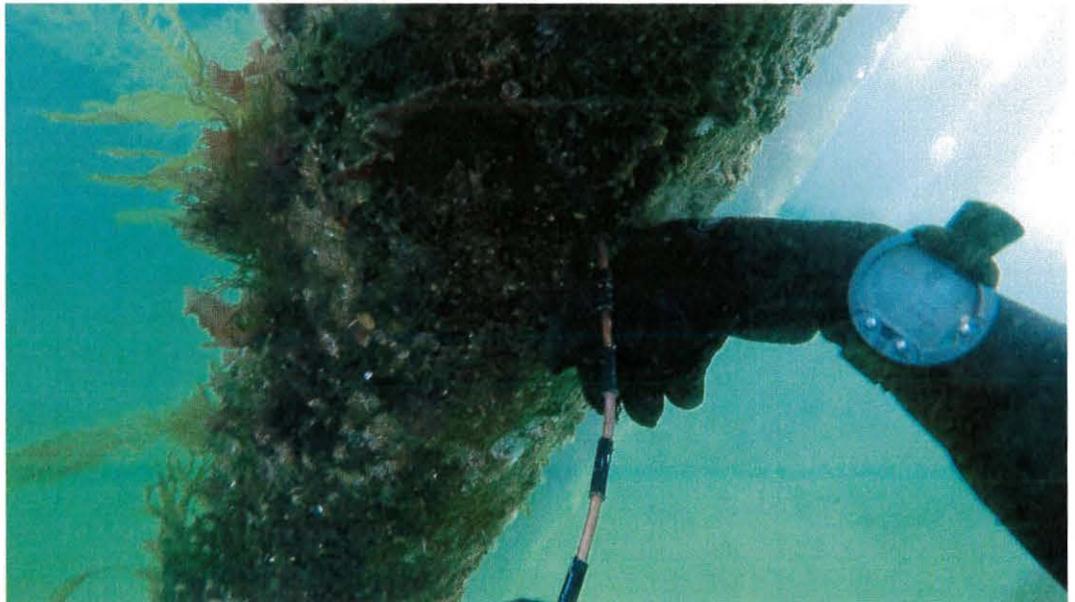
UW-6

Pile F7 has a 3/4" diameter MBE with 3" of penetration at 6:00 MDL +10.

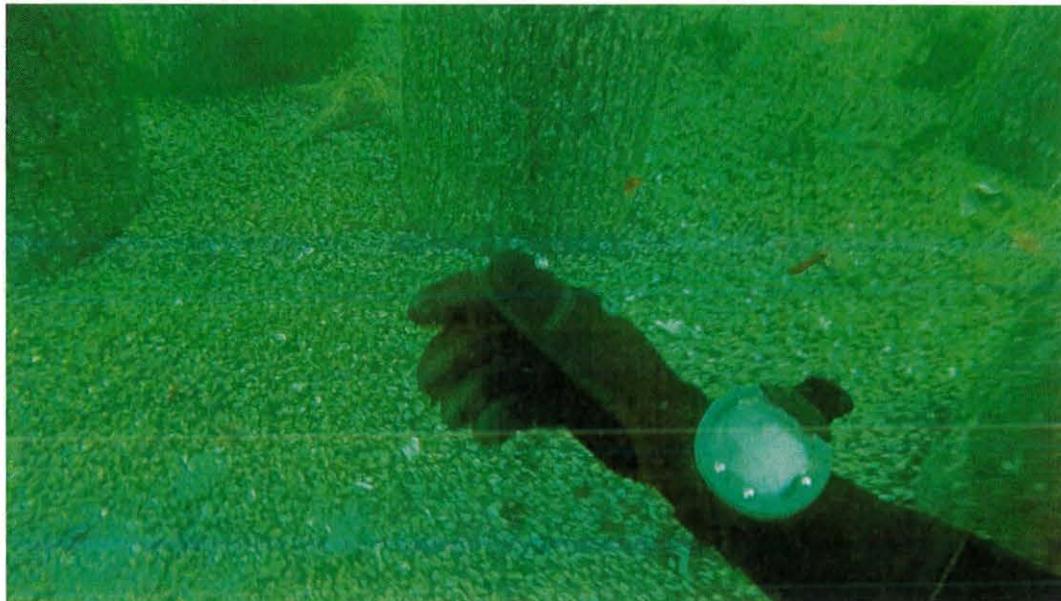
UW-7

8361	SCOUR (Field): Nine piers in the water. Underwater Inspection Findings: Water flow in the vicinity is tidal. No scour patterns or scour countermeasures were observed around the trestle bents.
8460	TIMBER PILE DOLPHINS: There is a seven pile timber dolphin near the left offshore end of the security building. Underwater Inspection Findings: The center pile has minor Limnoria striations. The pile group moves very easily even with light wave action. It appears to be due to the wraps being loose which doesn't make the dolphin act as a unit. The piles are not showing any distress at mudline (photo UW-7).

Timber dolphin at ground line. Note the minor Limnoria striations on the center pile.
