**BRIDGE INSPECTION REPORT**

**Br. No.** DOC-2

**Br. Name** STEILACOOM MOORING FLOAT

9 The WSDOT Dive Team performed an underwater inspection of the Steilacoom Mooring Float on April 26, 2021. Twelve steel pipe piles and the concrete floating pontoon exterior were inspected by diving.

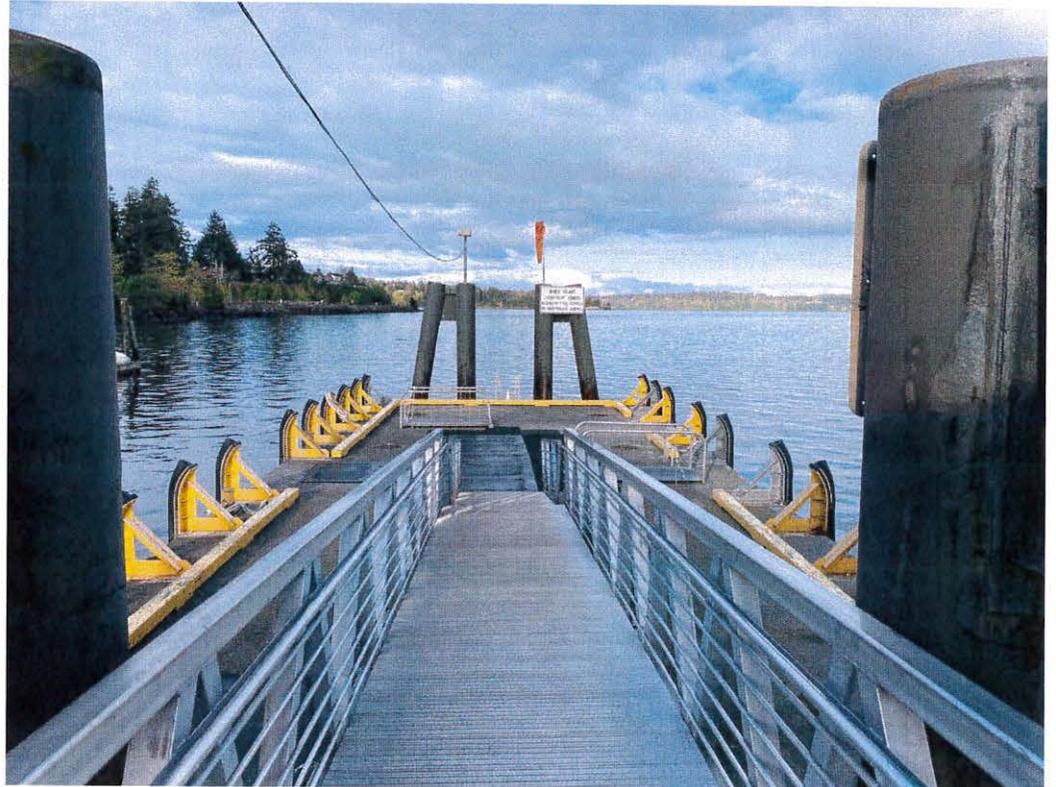
**SI-36**

0 Orientation  
Photo Type: D - Deck  
Orientation: Left  
Date: 4/26/2021  
Repairs:  
View looking down gangplank.  
Asphalt shingles have been replaced  
with aluminum surface.

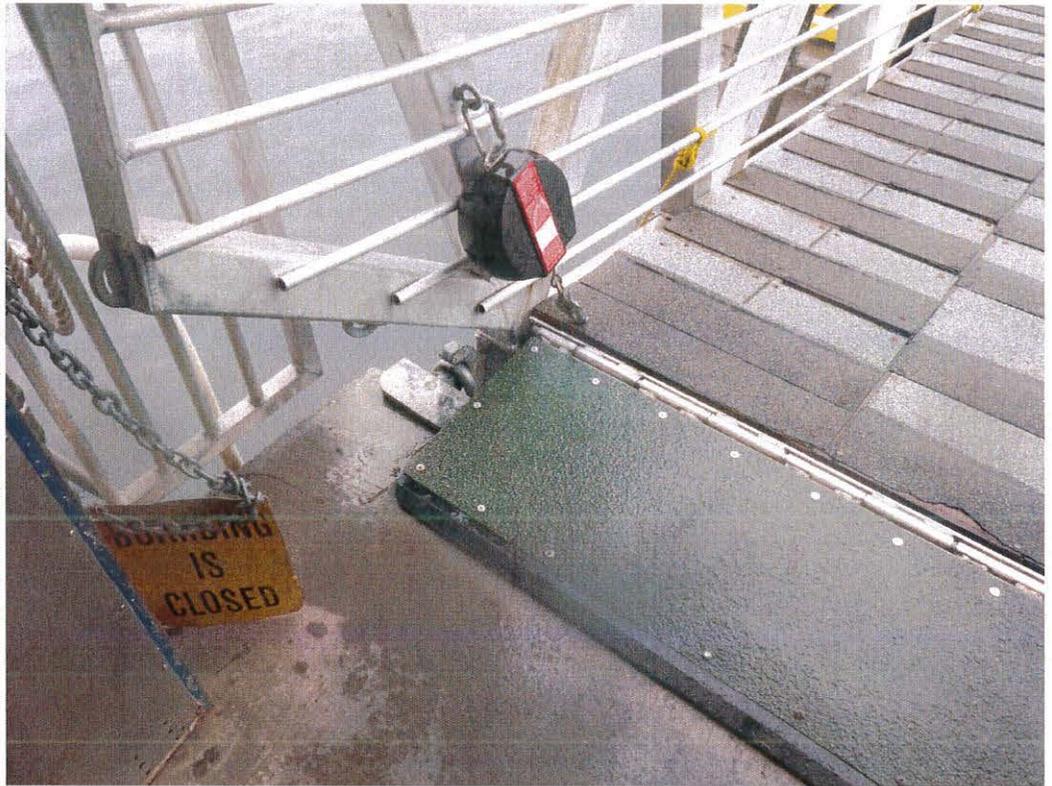
SI-3

8390 Fixed Bearing  
Photo Type: R - Repair  
Orientation: Shore  
Date: 5/22/2013  
Repairs: 10000  
Typical gangplank connection.

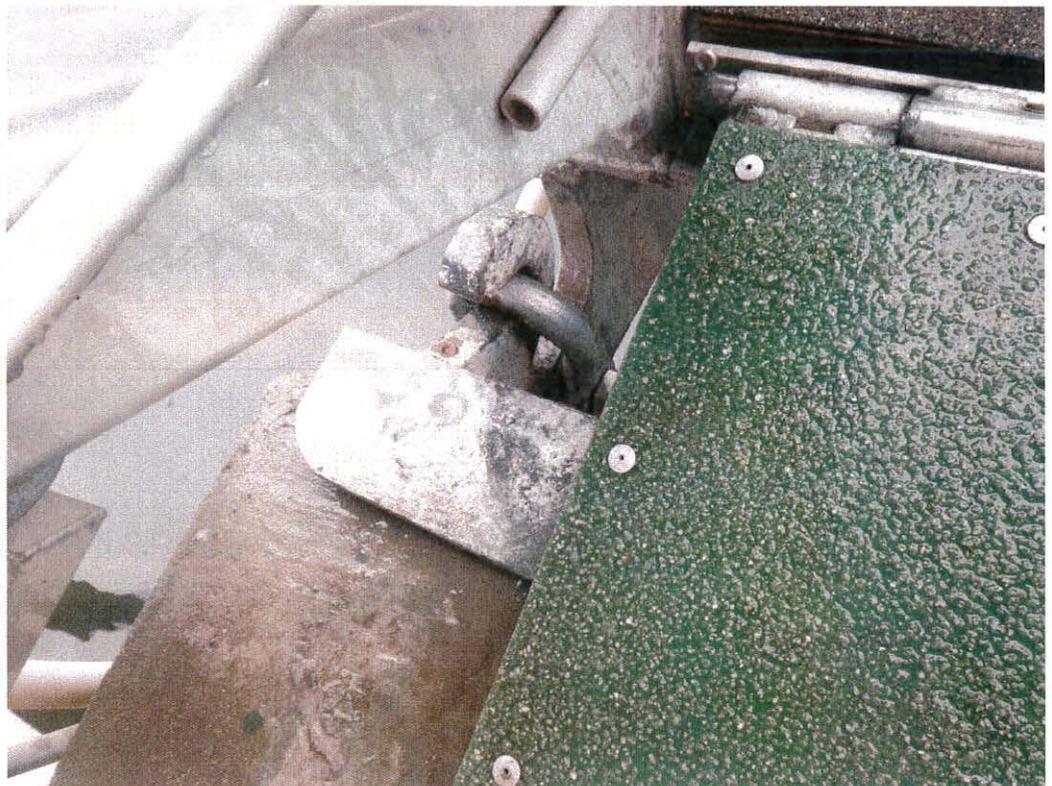
SI-4

8390 **FIXED BEARING:**  
The top of the gangplank connection to the building consists of two hooks and keeper bolts for holding in place. The left side keeper bolt head is broken off (photos #3 - #5). REPAIR #10000.

8390 Fixed Bearing  
Photo Type: R - Repair  
Orientation: Shore  
Date: 5/22/2013  
Repairs: 10000  
Keeper bolt is broken on left side gangplank connection.

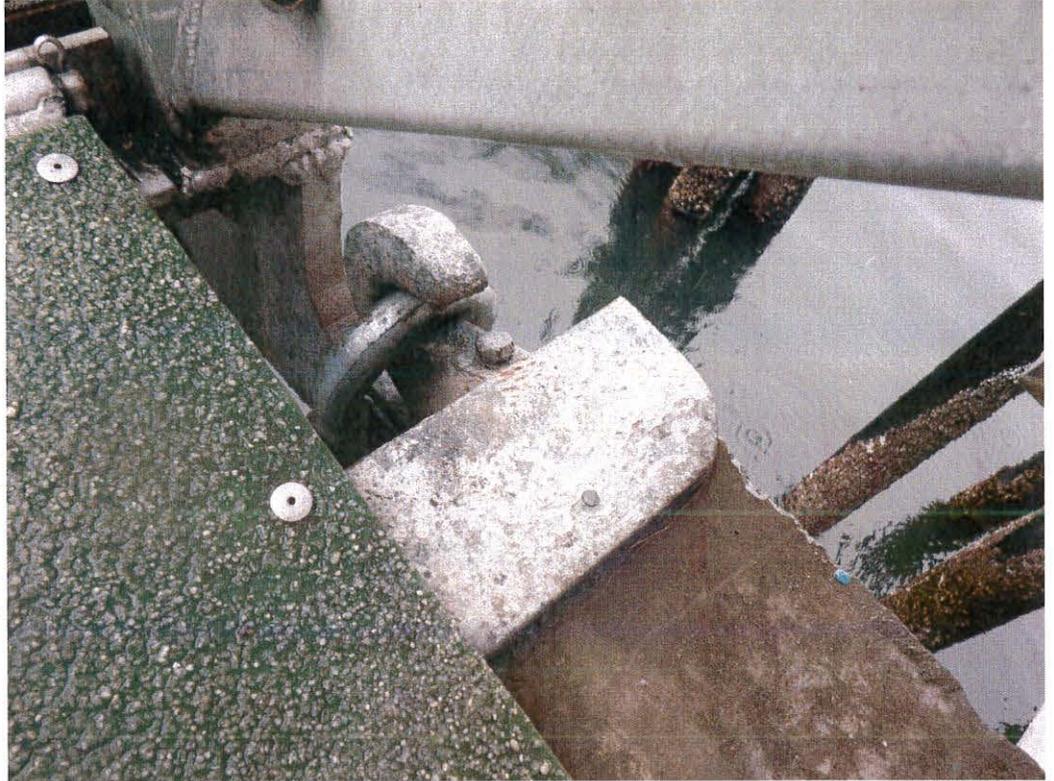
SI-5

8390 Fixed Bearing  
Photo Type: R - Repair  
Orientation: Sea  
Date: 5/22/2013  
Repairs: 10000  
Keeper bolt in place on right side gangplank connection.

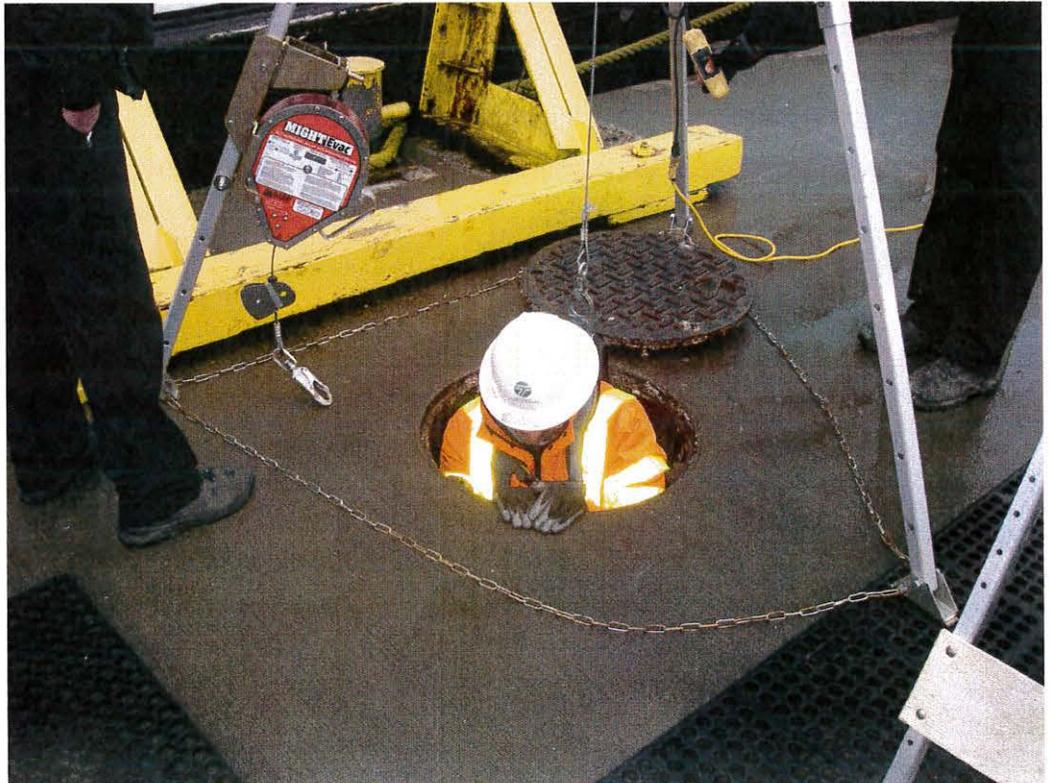
SI-7

All eight cells of the mooring float were entered during the 2021 inspection (see layout sheet for cell numbering) (photo #7). The spud well connections have been caulked. There are signs of past leakage, due to moisture in the cells it could not be determine if still actively leaking.

8701 Ferry Concrete Floating Pontoon  
Photo Type: G - General  
Orientation: Sea  
Date: 5/22/2013  
Repairs:  
Floater cell entry.

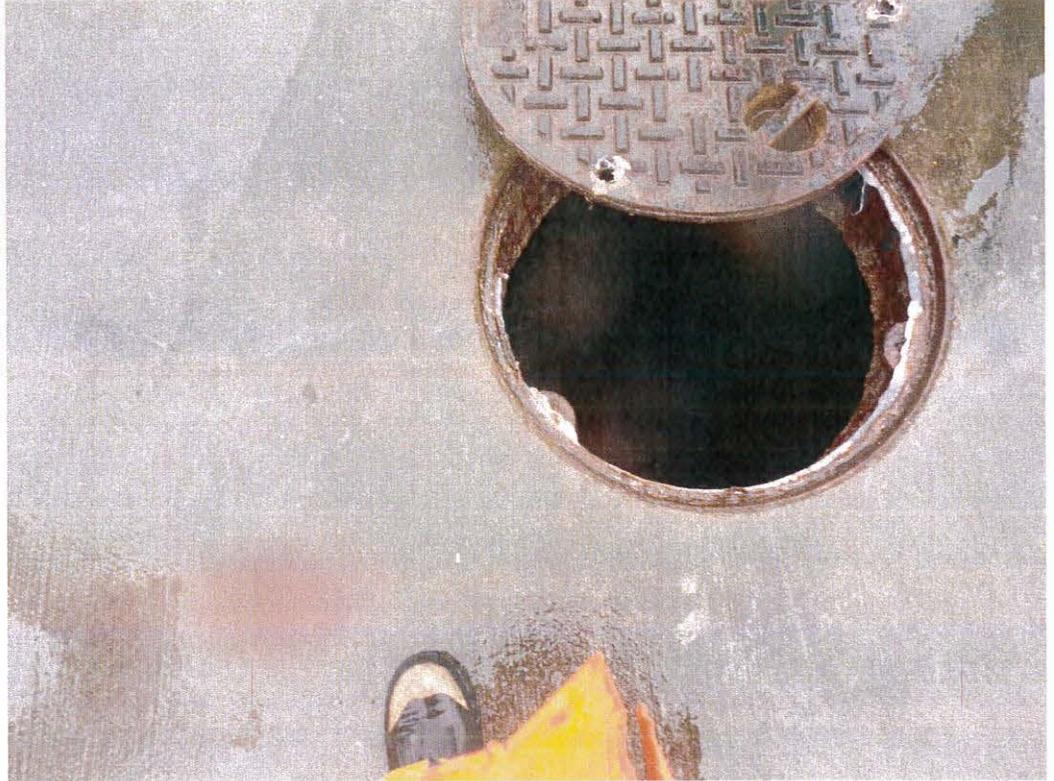
SI-11

Cell #4 has a broken hold down bolt stuck in the base tab and Cell #5 has a broken hold down tab (photos #11 and #12). REPAIR #10003.

Cell #4 has a broken hold down bolt stuck in the base tab.

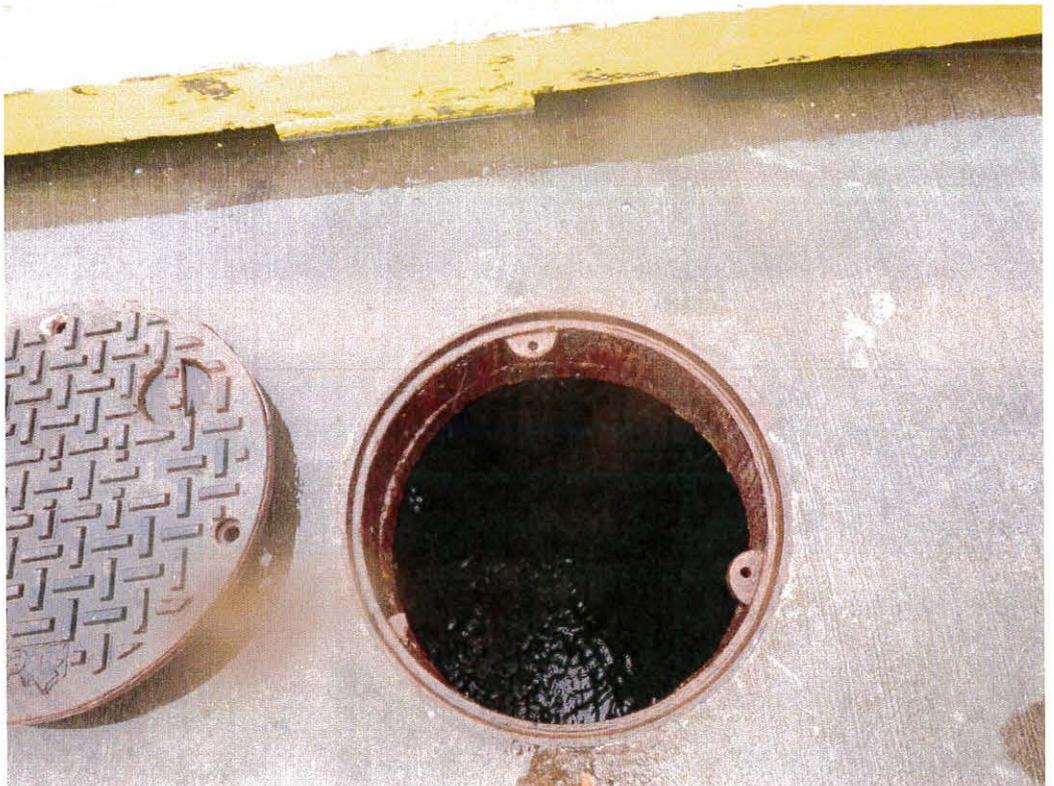
SI-12

Cell #5 has a broken hold down tab.

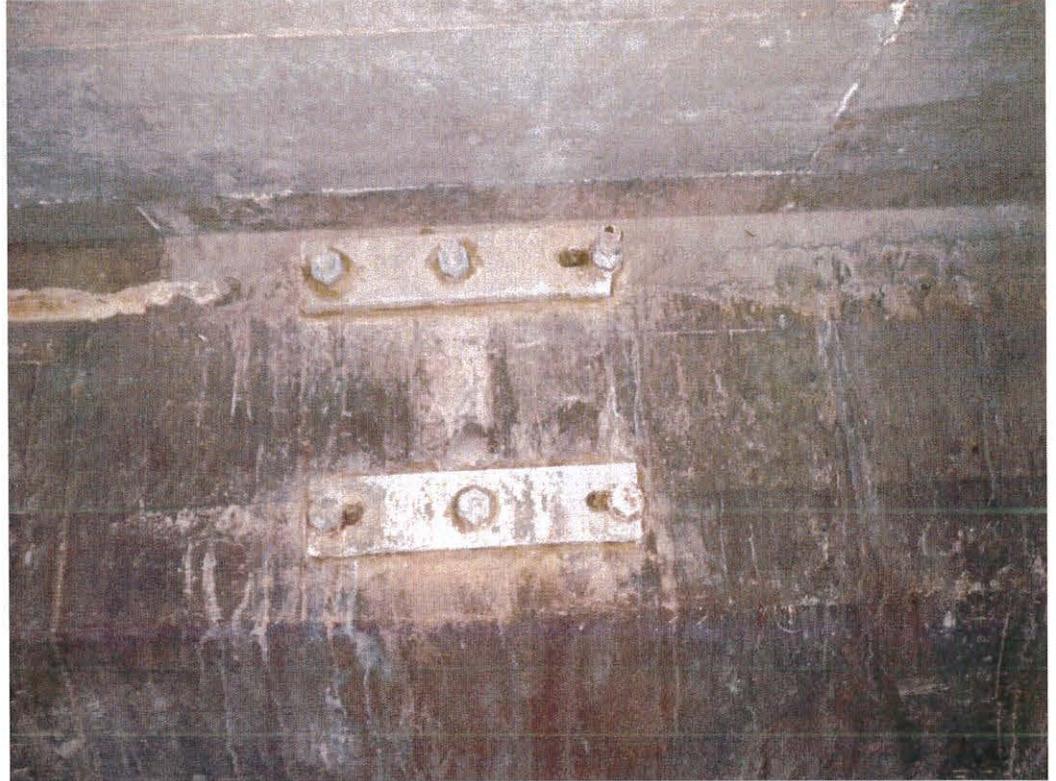
## SI-14

Cell #8 also has spud pile well connection plates on the interior. These plates are slightly undersized resulting in the bolts not having a solid anchor base (photo #14).

Cell #8 spud pile well connection plates are undersized, some bolts not fully on base plate. 2021-Caulking added to seal connection (not pictured)

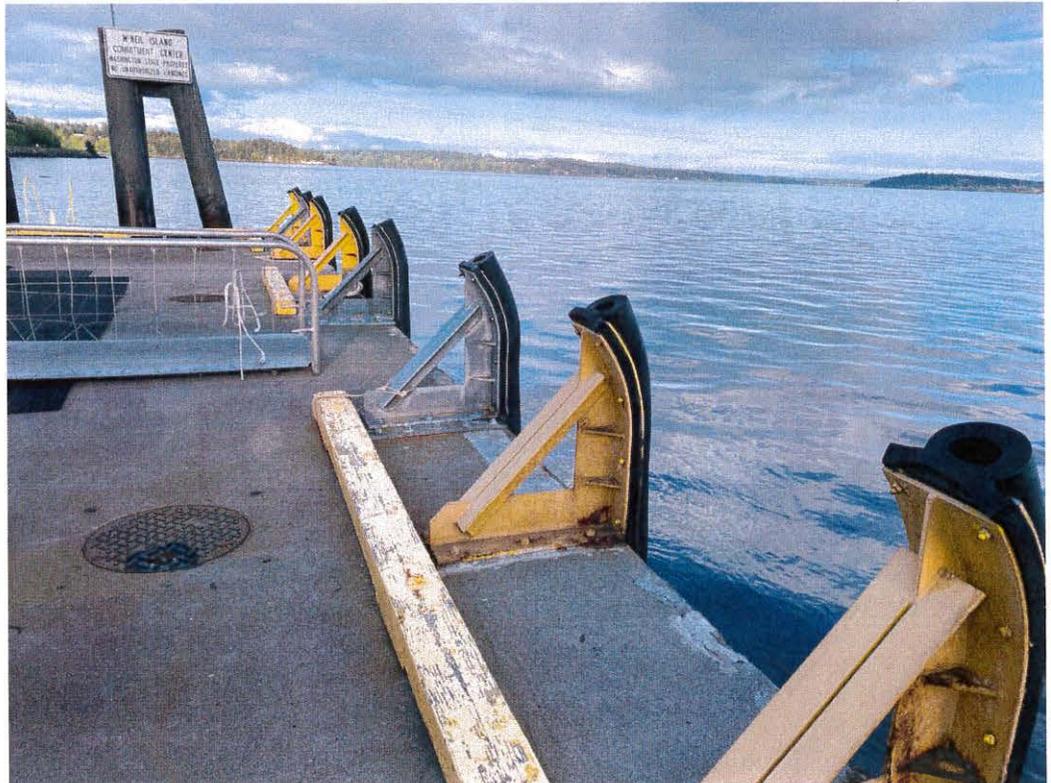
## SI-37

Many of the bumper attachments have minor distortions, repairs, or have been replaced (photo #37).

Replaced bumpers are galvanized instead of painted.

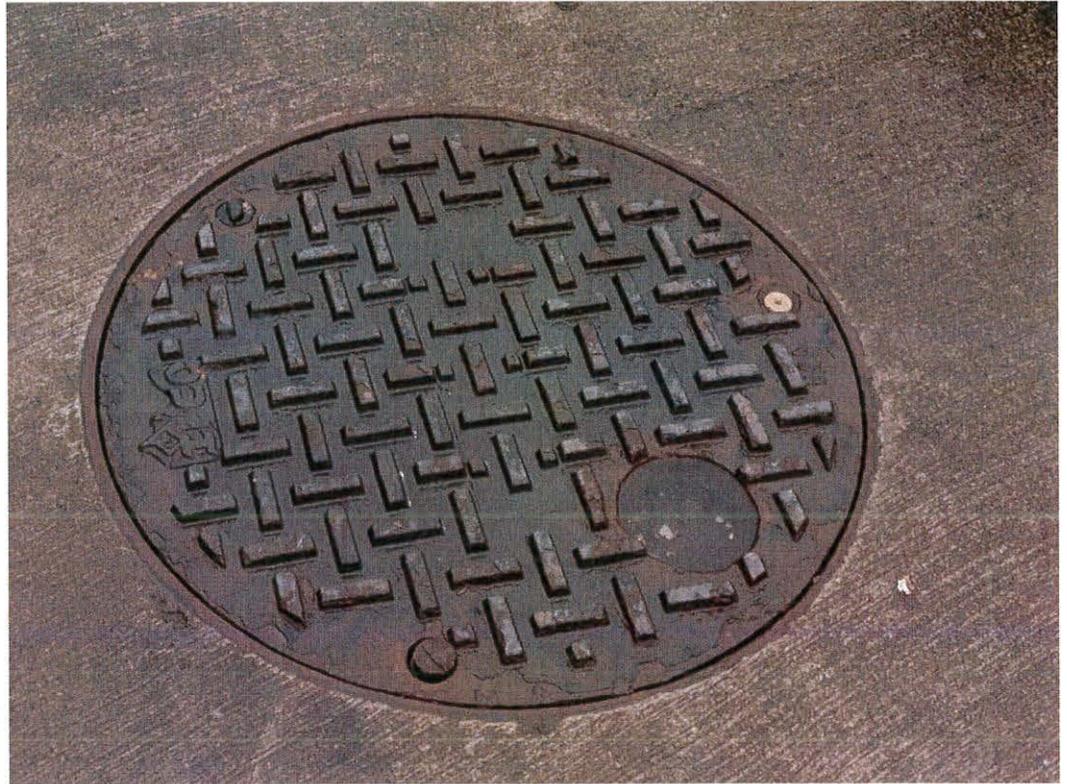
SI-33

Hatch bolts missing on all hatches in 2021. Holes have been corked (photo #33). Also noted in photo #33 of Cell #7, hatch lift handle is broken. REPAIR #10003.

Hatch bolts missing on all hatches in 2019. Holes have been corked. Cell #7 hatch shown, lift handle broken on hatch.

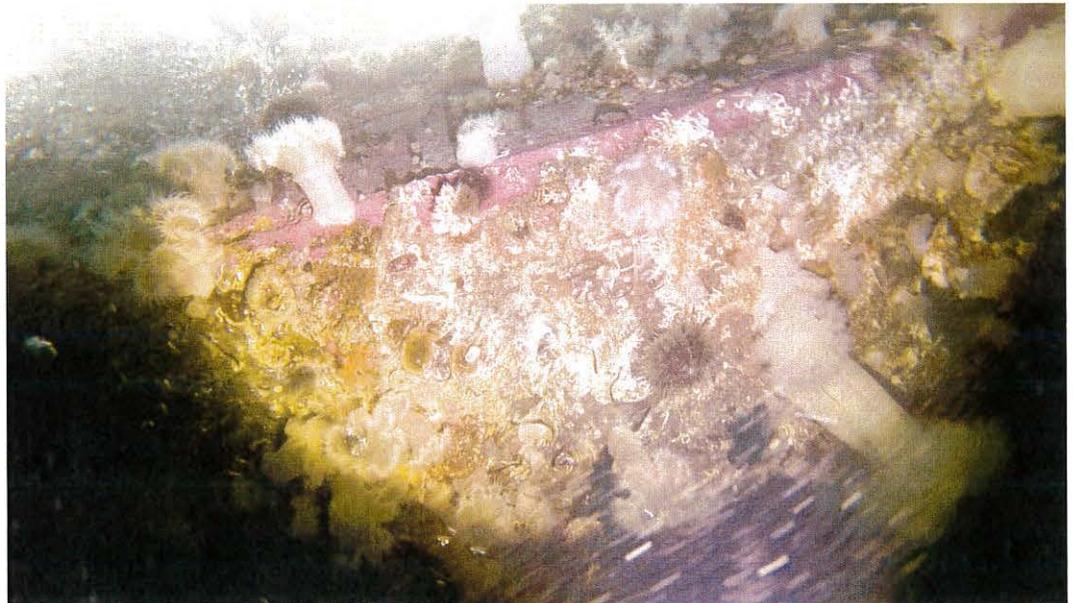
UW-5

The concrete pontoon surface below the waterline is typically about 80% covered in marine growth up to 1-ft. thick. Spot cleaning of growth revealed no defects (photo UW-5).

Heavy marine growth on concrete pontoon.

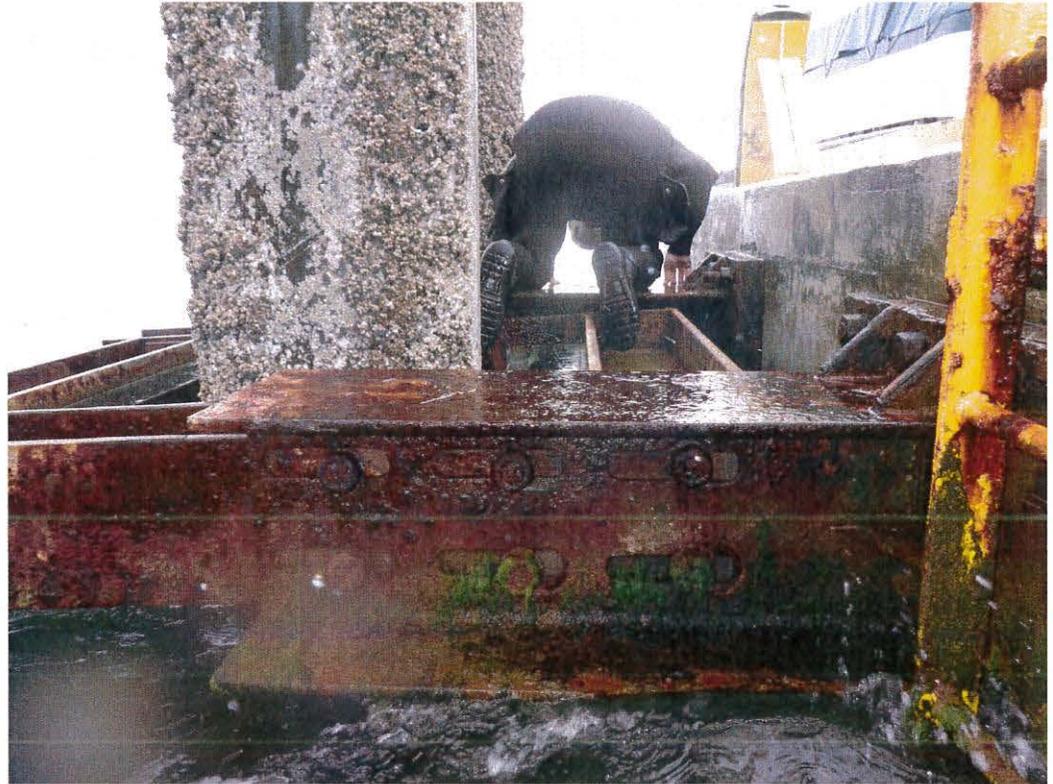
**SI-19**

Spud Pile #3 (SP3), typical well connection (photo #19).

Spud Pile #3 well (SP3), typical well connection.

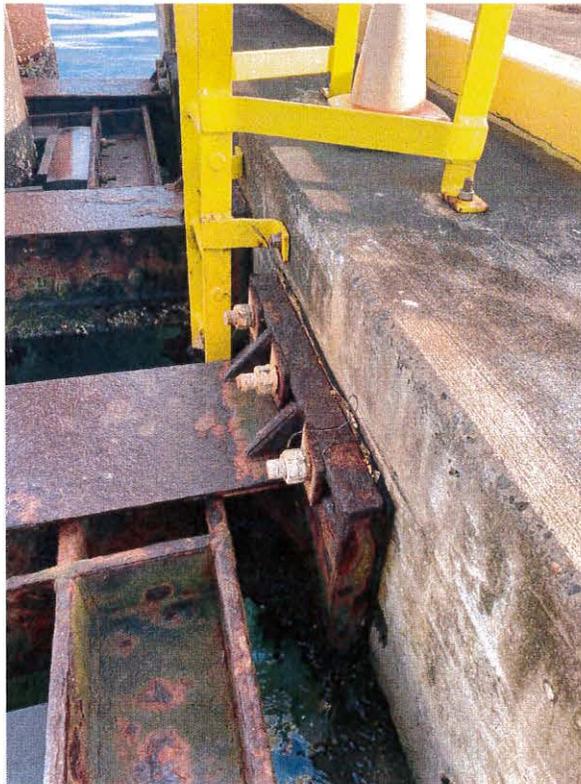
**SI-34**

Cell 4 considered CS4. REPAIR #10007 new gaskets added at exterior connection of Spud Pile group 4 (element 8703 photo #34), 6" water accumulation in cell, appears to still be actively leaking.

Spud Pile #4 (SP4), new gasket and bolts added, now sits flush to concrete float (photo #34).

Spud Pile #4 well (SP4) base plate has had rubber gasket and new bolts installed, and it now sits flush to the pontoon.

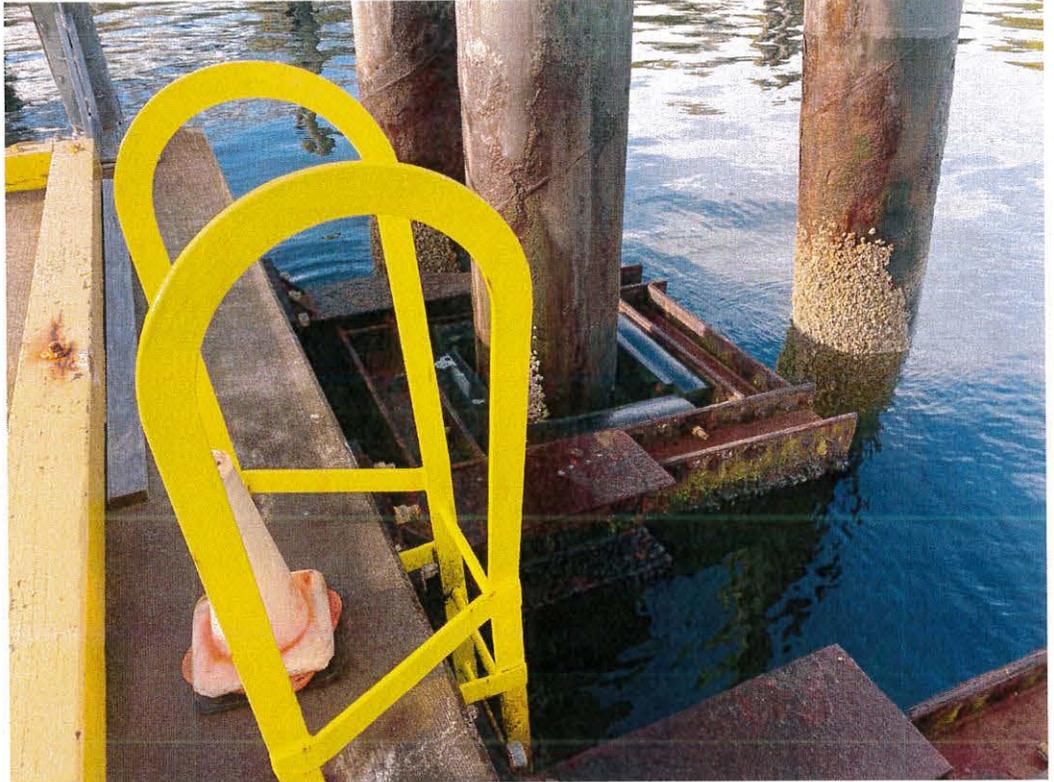
**SI-35**

Spud Pile #4 well (SP4) collar is slightly tipped, bolt are tight and no signs of movement (photos #35 and #31). REPAIR #10008 VERIFIED.

8703 Spud Piling & Wells  
Photo Type: C - Completed  
Orientation: Left  
Date: 4/26/2021  
Repairs: 10008  
Spud Pile #4 well (SP4) collar is slightly tipped. Ladder has been repainted.

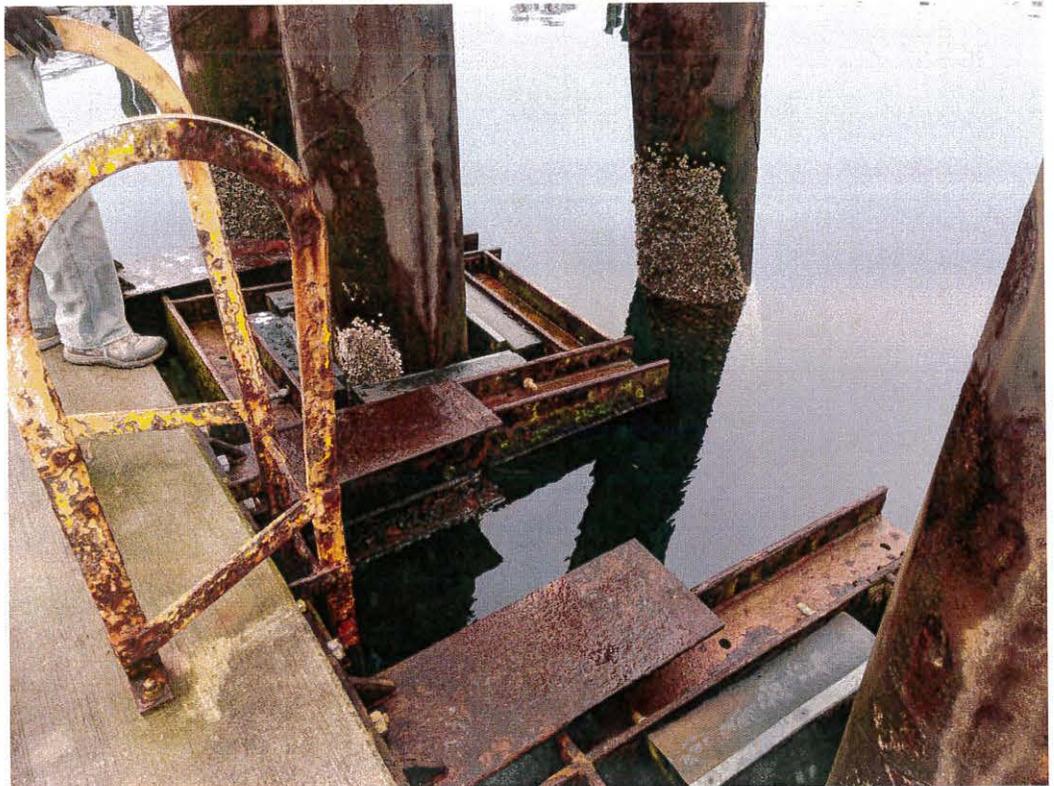
**SI-31**

8703 Spud Piling & Wells  
Photo Type: R - Repair  
Orientation:  
Date: 4/8/2019  
Repairs: 10008  
Pre-repair photo. See Photo #35. Spud Pile #4 well (SP4) collar is tipped due to loose sliding bolts. Archive next inspection.

10008	2	B	Spud Pile #4 well (SP4) collar is tipped due to loose sliding bolts, worn bolts, or worn slots. Remove and replace bolts, increase washer diameter, and double nut bolts. Do not clamp tight to channel allowing for movement. 2021 - LAW VERIFIED Complete. New bolts added with gasket at the pontoon connection. This lifted up the collar. All bolts are tight on the colar with no signs of movement.	8703	4/8/2019		4/26/2021

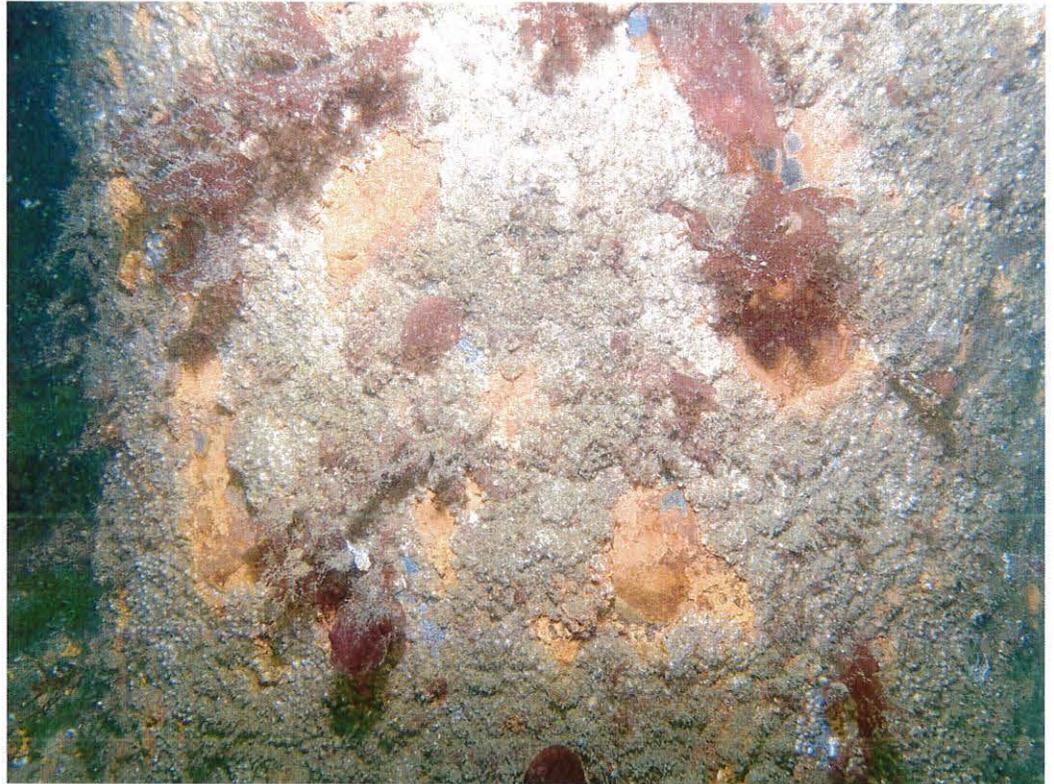
**UW-3**

Typical coating failure/rust blooming on spud piles (SP1A shown).

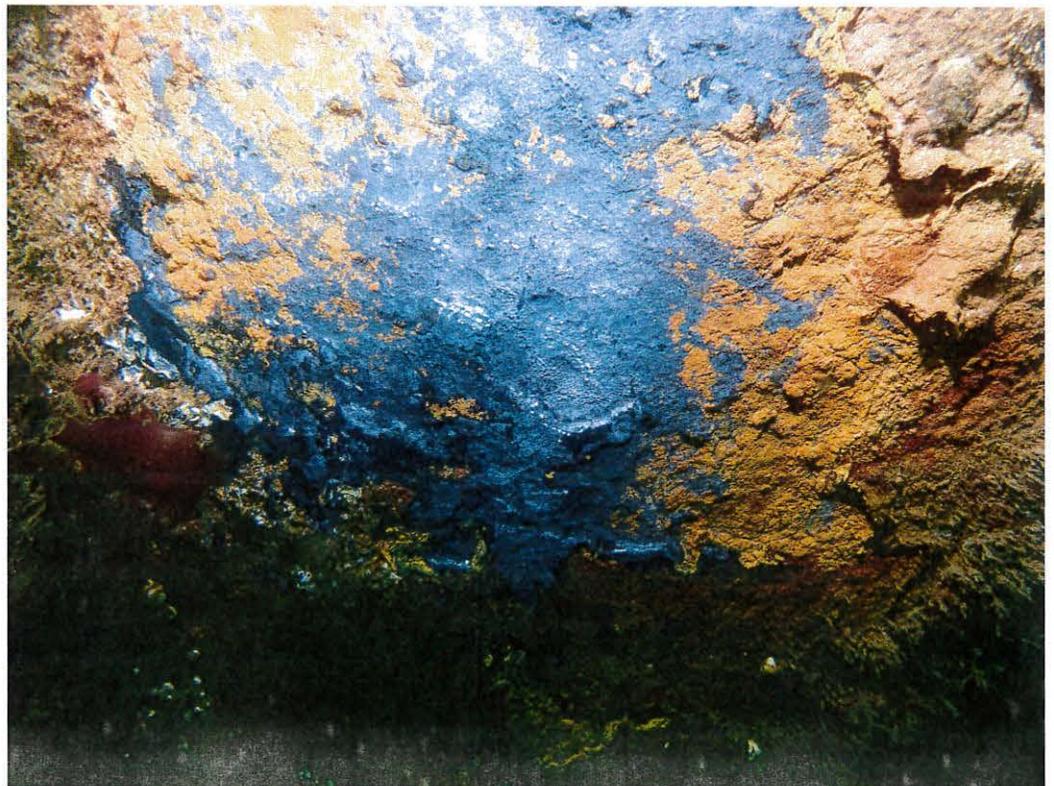
**UW-4**

More advanced corrosion and section loss on steel spud pile. SP3B thickness reading 0.300"

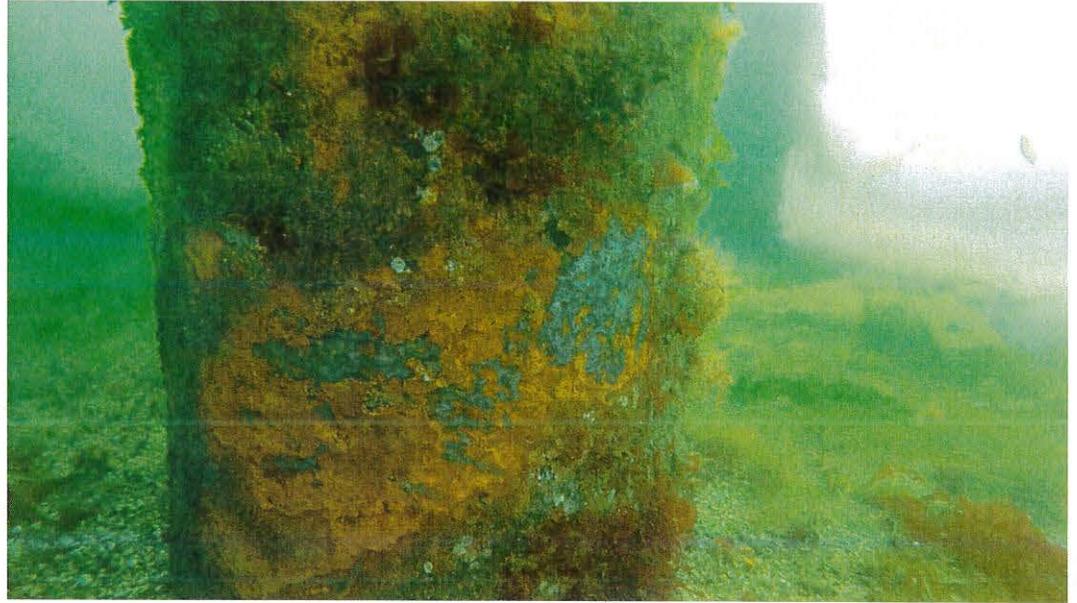
UW-7

SP4 Pile B has 50% coating failure from MDL to MDL +3.

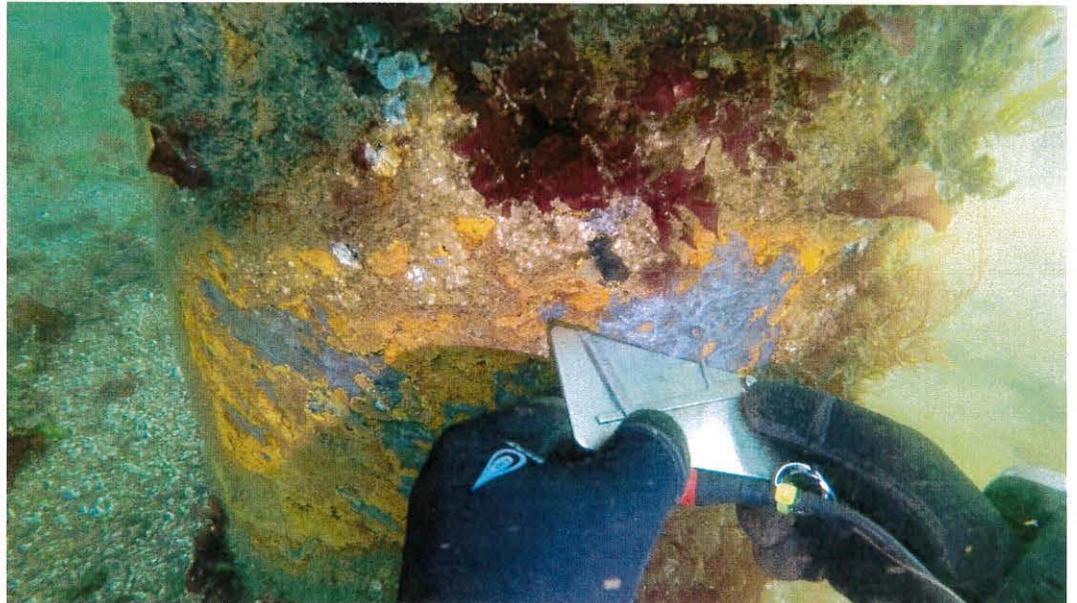
UW-8

SP4 Pile B has deep pitting at MDL +2.

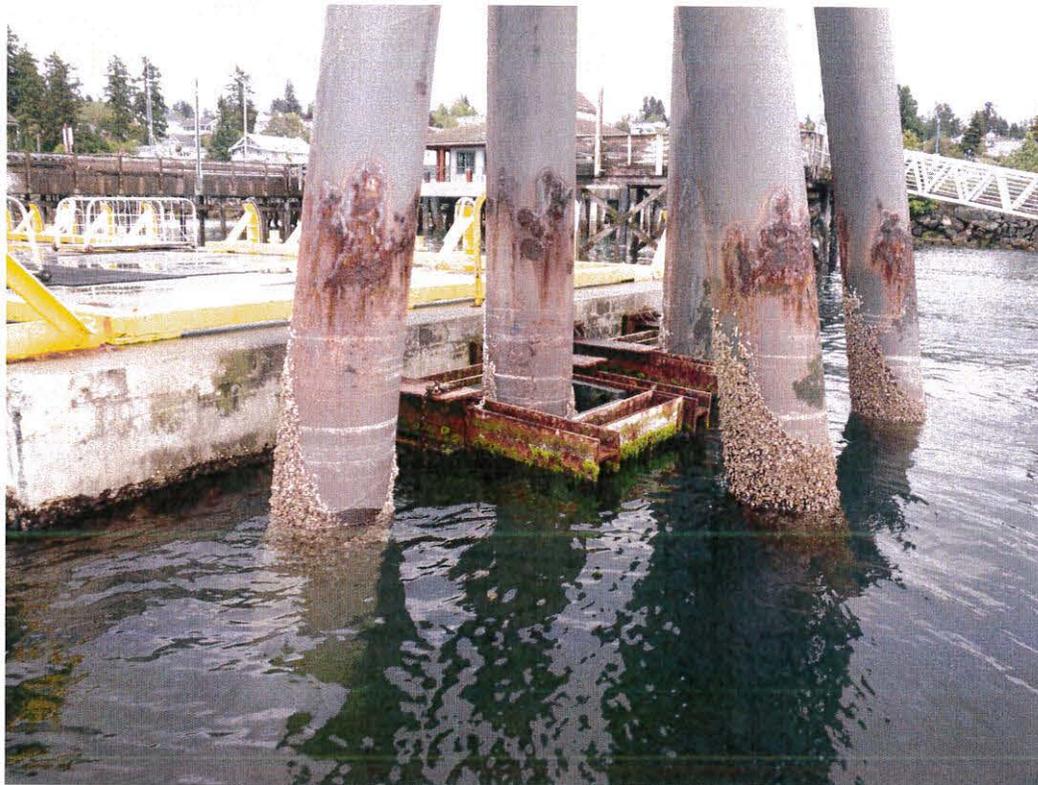
SI-20

Spud pile coating is missing with laminar rust in the intertidal zone (photo #20).

Steel Spud piles have lost protective coat in the intertidal zone.

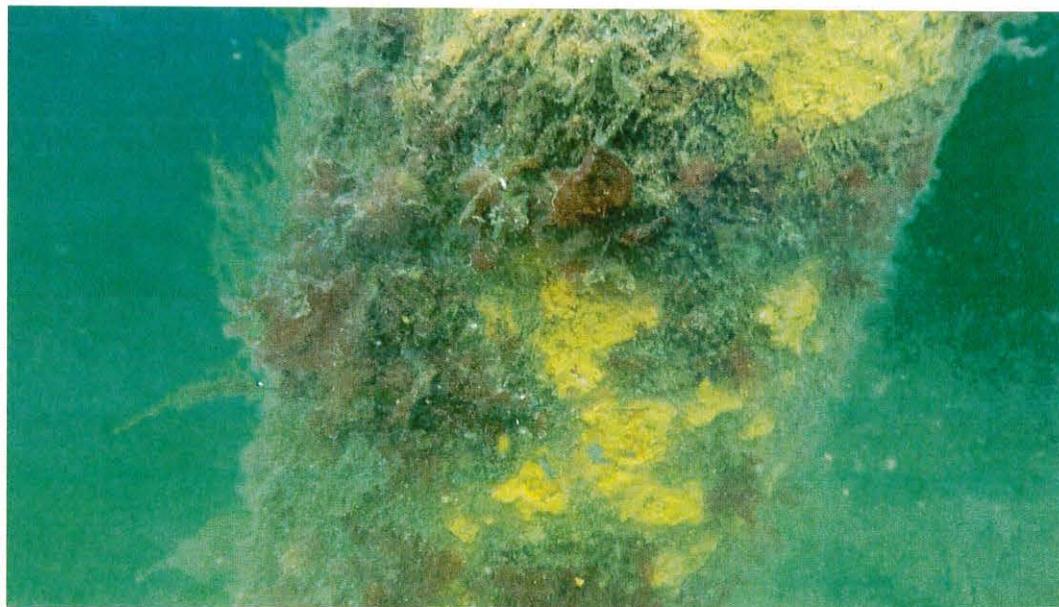
UW-6

Typical coating failure and corrosion occurring on spud piling underwater (approx. 50% failure shown).
