**UNDERWATER INSPECTION REPORT FOR  
MCNEIL IS. MOORING FLOAT**

**BRIDGE NO. DOC-3**

**STRUCTURE ID 00200438**

**Inspection Date** April 27, 2021

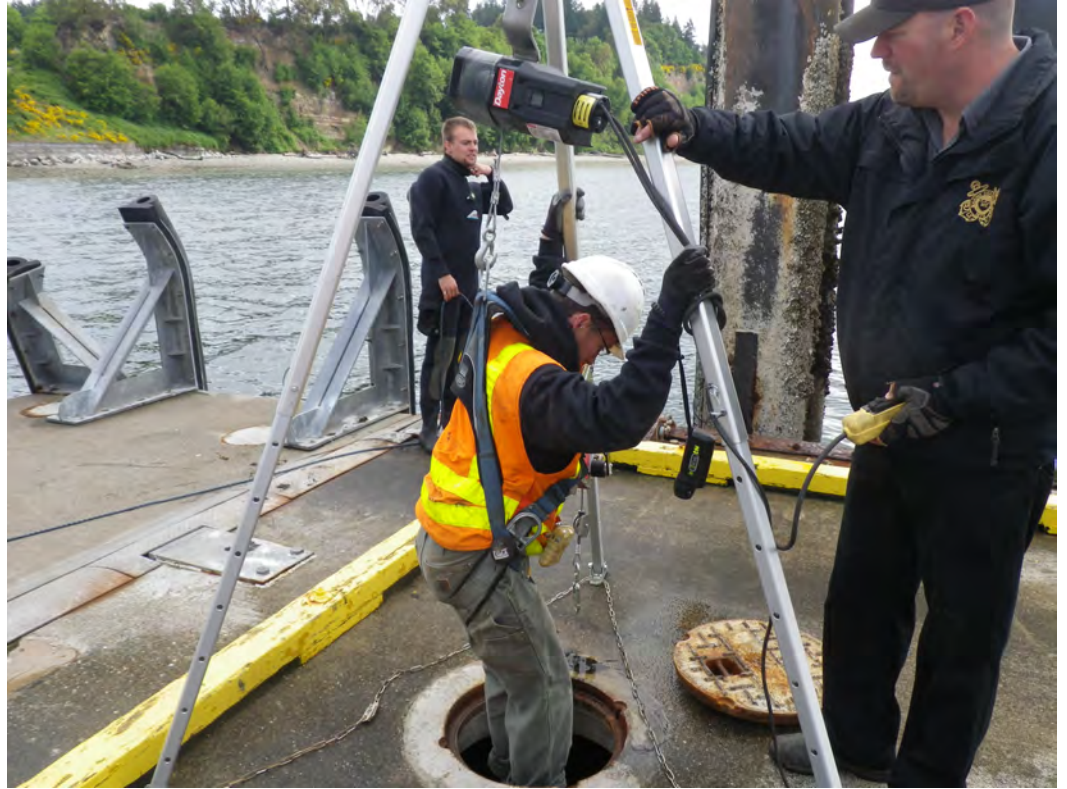
**SI-7**

All eight of the of the main pontoon cells were entered during the 2017 inspection (see layout sheet for cell numbering) (photos #7 and #8).

8701 Ferry Concrete Floating Pontoon  
Photo Type: G - General  
Orientation: Shore  
Date: 5/21/2013  
Repairs:  
Cell entry via tripod with winch.

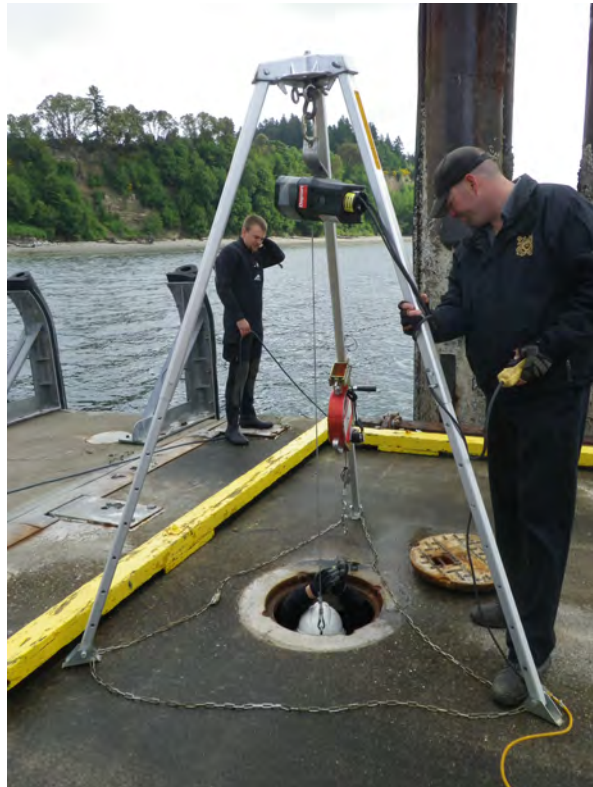
**SI-8**

8701 Ferry Concrete Floating Pontoon  
Photo Type: G - General  
Orientation: Shore  
Date: 5/21/2013  
Repairs:  
Cell entry via tripod with winch.

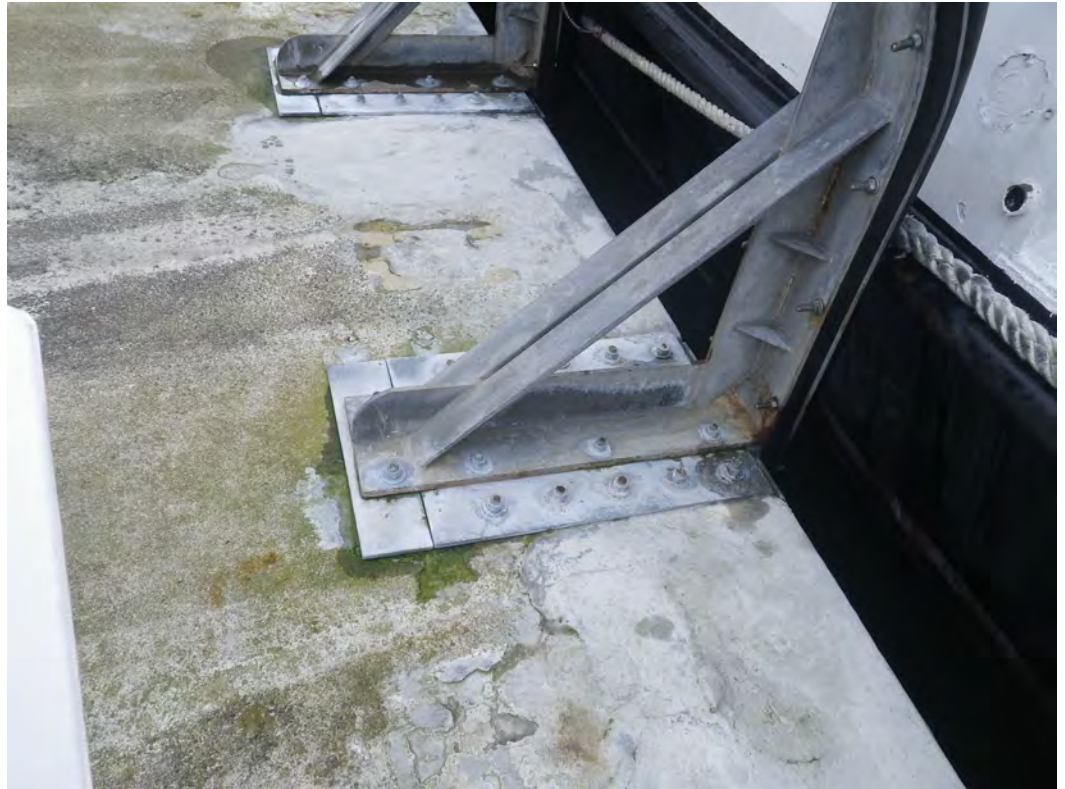
**SI-24**

Boat fender bumpers are in fair condition, many have had repairs (photo #24).

8701 Ferry Concrete Floating Pontoon  
Photo Type: G - General  
Orientation: Left  
Date: 5/3/2017  
Repairs:  
Most of the fender brackets have been repaired or replaced.

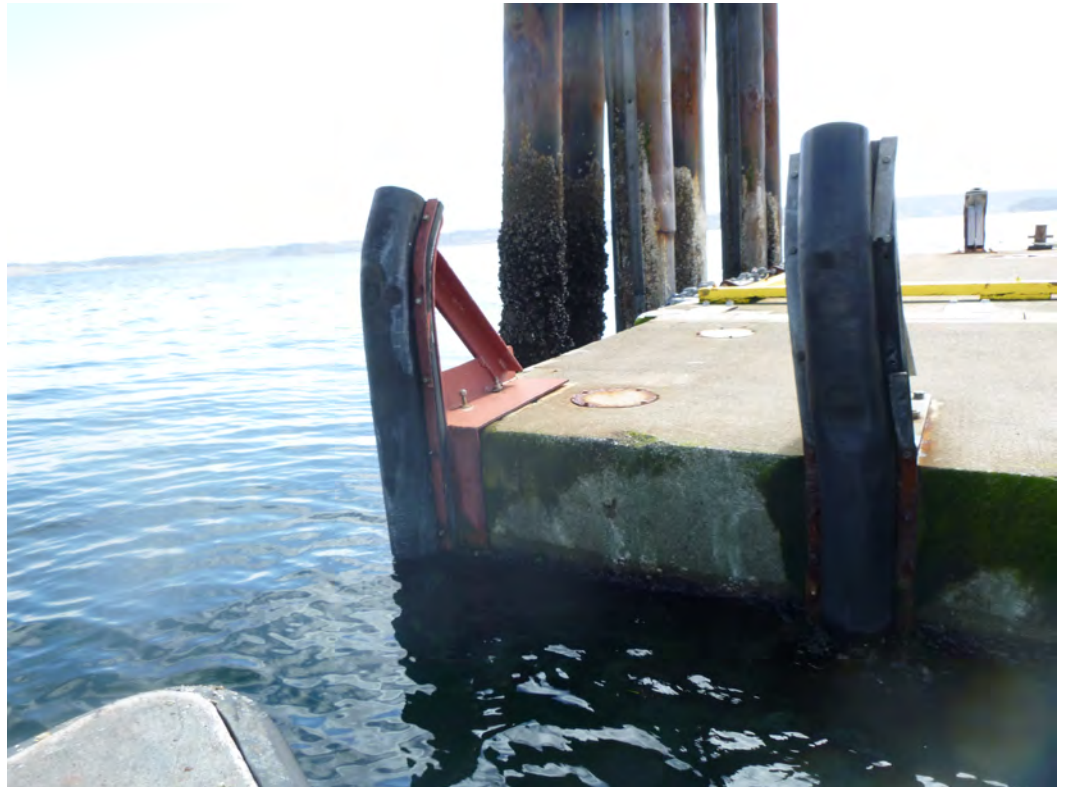
**SI-29**

The right flanker fender bracket at the right shore side corner has pulled out hold down bolts (photos #29 & #30). REPAIR #10004.

8701 Ferry Concrete Floating Pontoon  
Photo Type: R - Repair  
Orientation: Sea  
Date: 4/8/2019  
Repairs: 10004  
Right flanker pontoon fender bracket at the right shore side corner has pulled out hold down bolts.

Repair No	Pr	R	Repair Description	BMS	Noted	Maint	Verified
10004	1	B	Right flanker pontoon fender bracket at the right shore side corner has pulled out hold down bolts. Refasten anchor bolts to pontoon.	8701	4/8/2019		
10005	1	B	Spud pile SP3-D has a horizontal crack across a butt weld several feet below the high water mark. Weld cover plate over crack or replace pile.	8703	4/8/2019

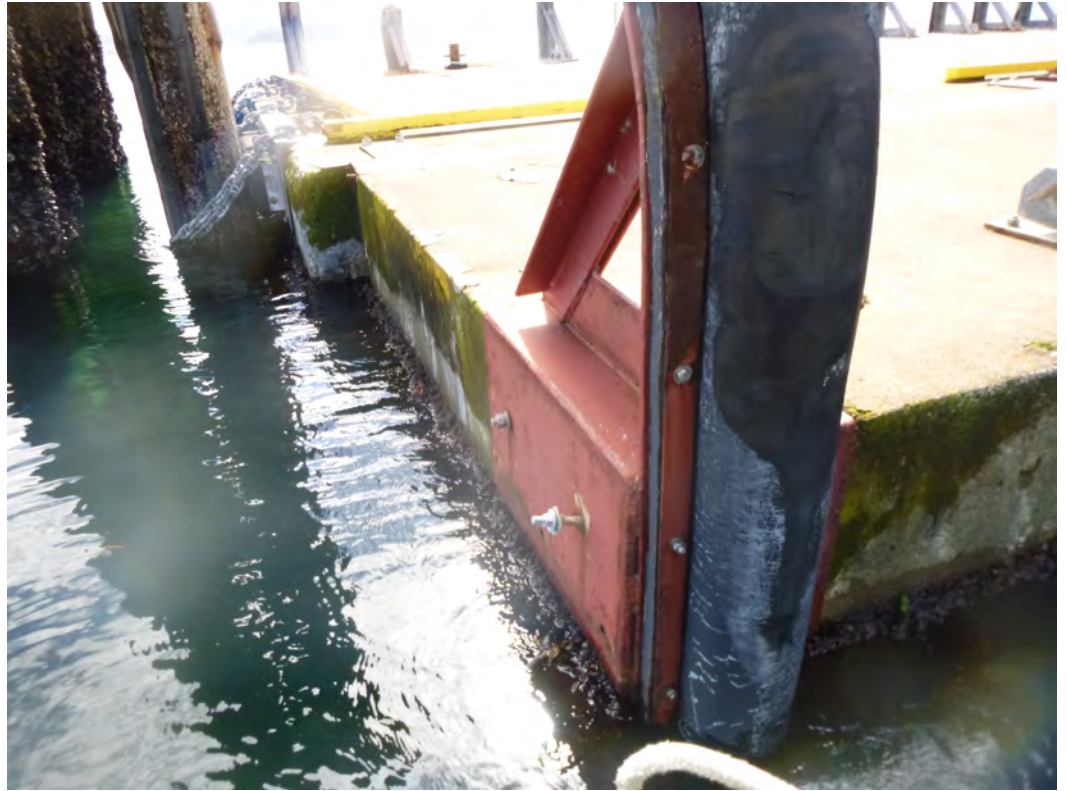
**SI-30**

Right flanker pontoon fender bracket at the right shore side corner has pulled out hold down bolts.

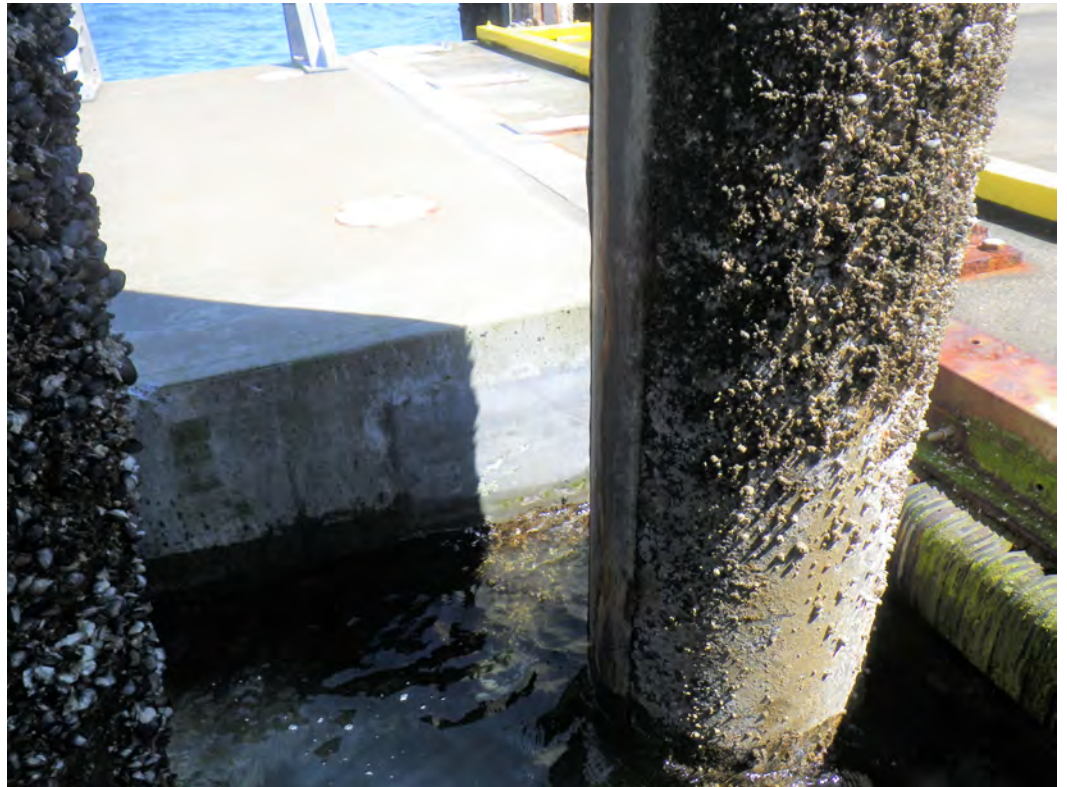
**SI-26**

The left flanker pontoon patched spall in the right exterior wall (CS2) (photo #26).

Left flanker pontoon has been repaired.

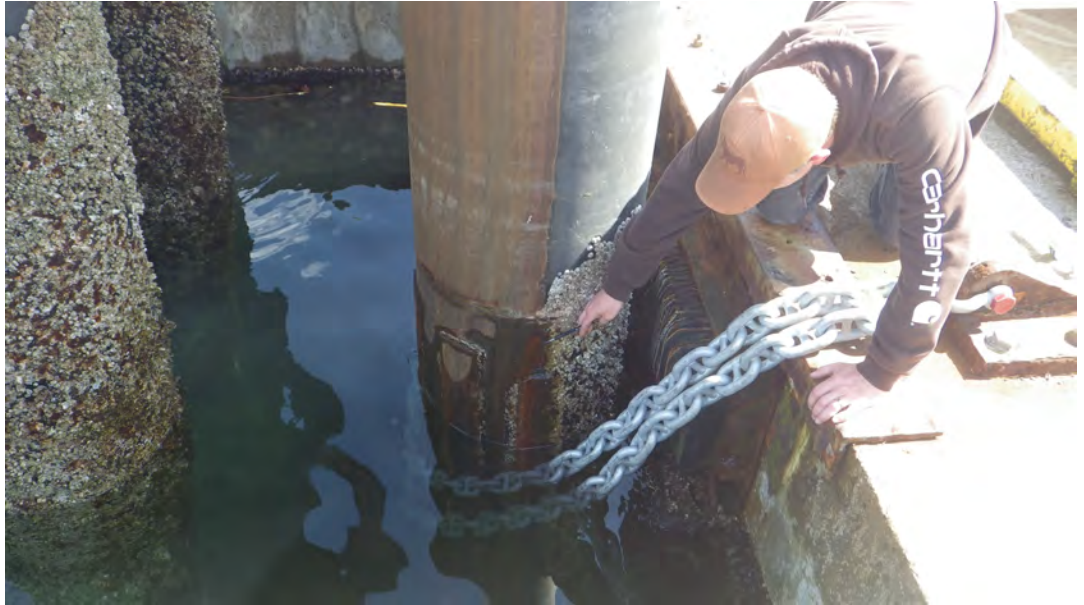
**SI-16**

Pile SP1-A has a dime sized hole from chain wear (upper ITZ).

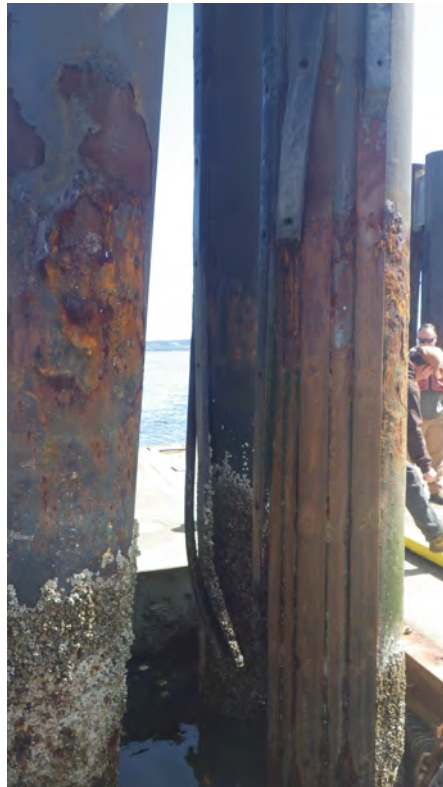
**SI-17**

Spud pile group SP2 has failing UHMW protection with steel backer plates remaining, typical for spud piles.

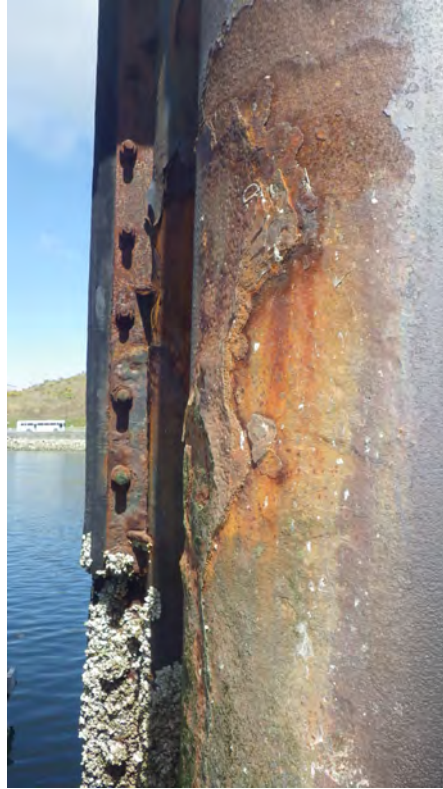
**SI-18**

8703 Spud Piling & Wells  
Photo Type: G - General  
Orientation: Shore  
Date: 4/22/2015  
Repairs:  
Spud pile SP2-B has heavy rusting and section loss at the high side of the tidal zone.

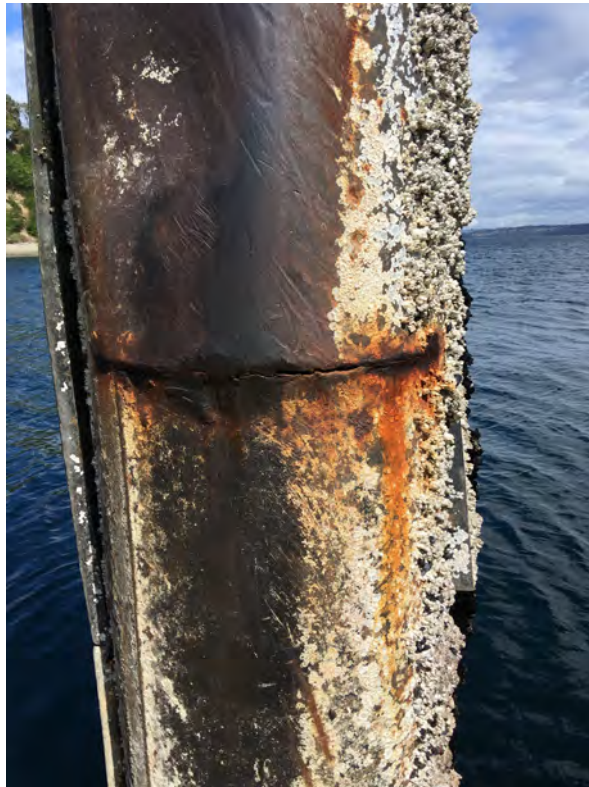
**SI-27**

8703 **SPUD PILING & WELLS:**  
 The Steel Spud Piles adjacent to the concrete float are showing their age. The piles are attached to the float via a chain. The tides and wave action move the chain up and down on the pile. The piles have steel backer plates with missing UHMW sheeting. There are locations of wear on the exposed structural surface.  
 Pile SP1-A has a dime sized hole from chain wear (photo #16).  
 Spud pile group SP2 has failing UHMW protection with steel backer plates remaining, typical for spud piles (photo #17).  
 Spud pile SP2-B has heavy rusting and section loss at the high side of the tidal zone (photo #18).  
 Spud pile SP3-D has a horizontal crack across a butt weld several feet below the high water mark (CS4) (photo #27).

8703 Spud Piling & Wells  
Photo Type: R - Repair  
Orientation: Left  
Date: 4/8/2019  
Repairs: 10005  
Spud Pile SP3-D is cracked at a butt splice.

**REPAIR #10005.**  
 Pile Inspection Data Sheets have 9 piles in CS3 due to minor section loss and 5 additional piles in CS4 due to holes in piling (6 total).

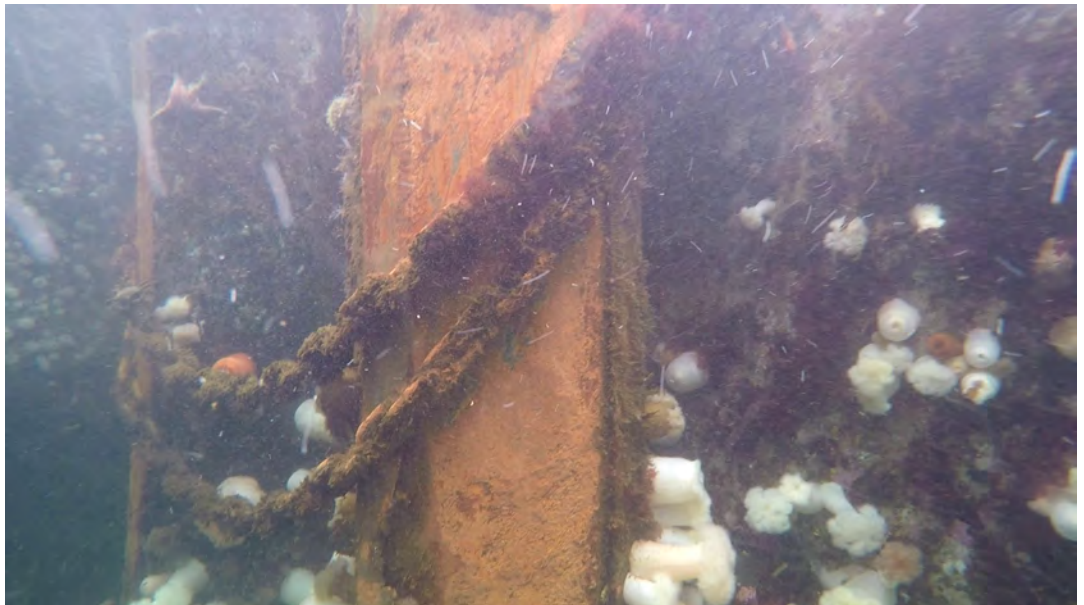
**UW-5**

Keeper chains fret directly on spud piles in the lower ITZ, causing holes in some locations.

Repair No	Pr	R	Repair Description	BMS	Noted	Maint	Verified
10006	2	B	Pumping records of the float cells should be recorded and tracked. This should include cell # (see layout sheet), date, and depth of water removed. Infiltration rates can be tracked and used for future repair work scheduling.	8701	4/8/2019		
10007	1	B	The following Spud Piles have holes in the pile wall and are susceptible to failure during extreme wind/wave events: SP1-A, SP1-D, SP3-B, SP3-C, and SP4-A These piles should be repaired (if possible) or replaced.	8703	4/27/2021

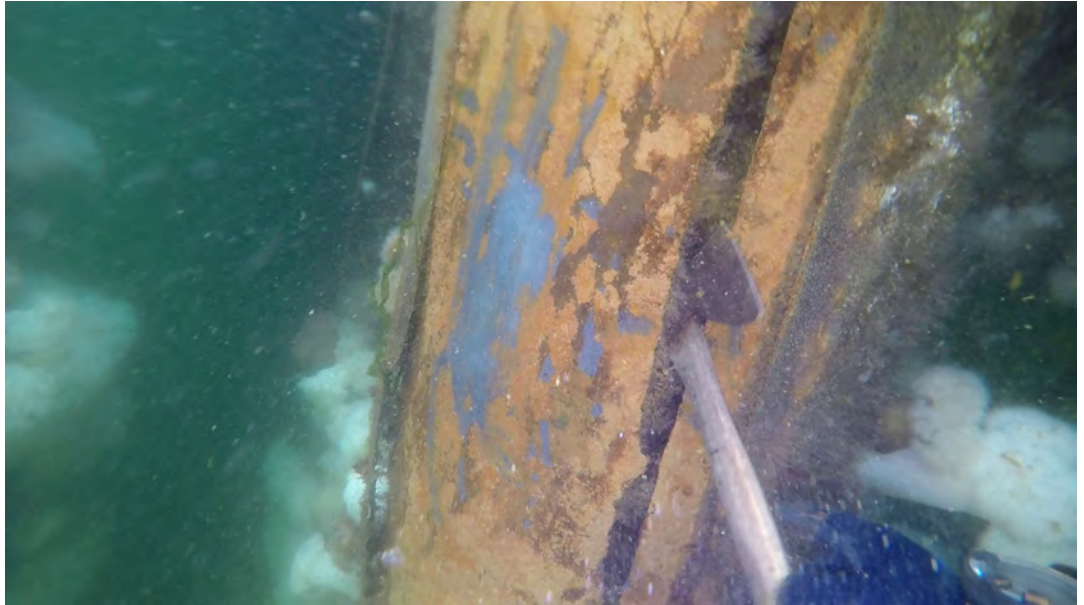
## UW-8

**Underwater Inspection Findings (2021):**  
 The steel pipe pile spuds are in generally fair to poor condition underwater with some areas showing more advanced deterioration. Coating failure with corrosion and steel section losses including holed thru piles were the most common defects noted. Thickness measurements of the steel were taken in localized areas of corrosion and pitting as well as in good areas for comparison (photo #UW-6). The most extreme cases of section losses are typically in the spud piles closest to the floats that have keeper chains around them (photo #UW-5). The majority of the rub strips have failed in the lower intertidal zone (ITZ) and the chains rub directly on the pile causing large areas of corrosion and section loss, including holes worn thru the pile wall from chain fretting. Minor section losses (CS3) are not a structural concern since the spud piles are for pontoon positioning only. However piles with holes may be susceptible to failure during extreme events such as heavy wind/wave events (CS4), and should be repaired or replaced REPAIR #10007.

8703 Spud Piling & Wells  
Photo Type: I - In Depth  
Orientation: SE  
Date: 4/27/2021  
Repairs: 10007  
Spud Pile SP1-A holed thru from keeper chain fretting.

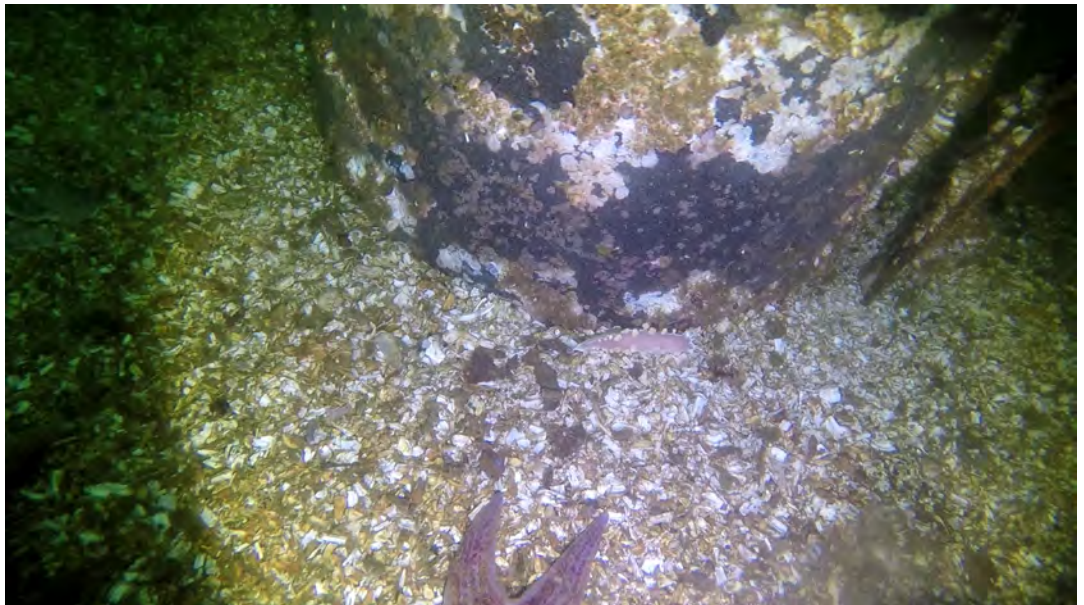
## UW-9

8703 Spud Piling & Wells  
Photo Type: G - General  
Orientation:  
Date: 4/27/2021  
Repairs:  
Most spud piles have good coating below the ITZ. Pile SP1-B shown near mudline (MDL).

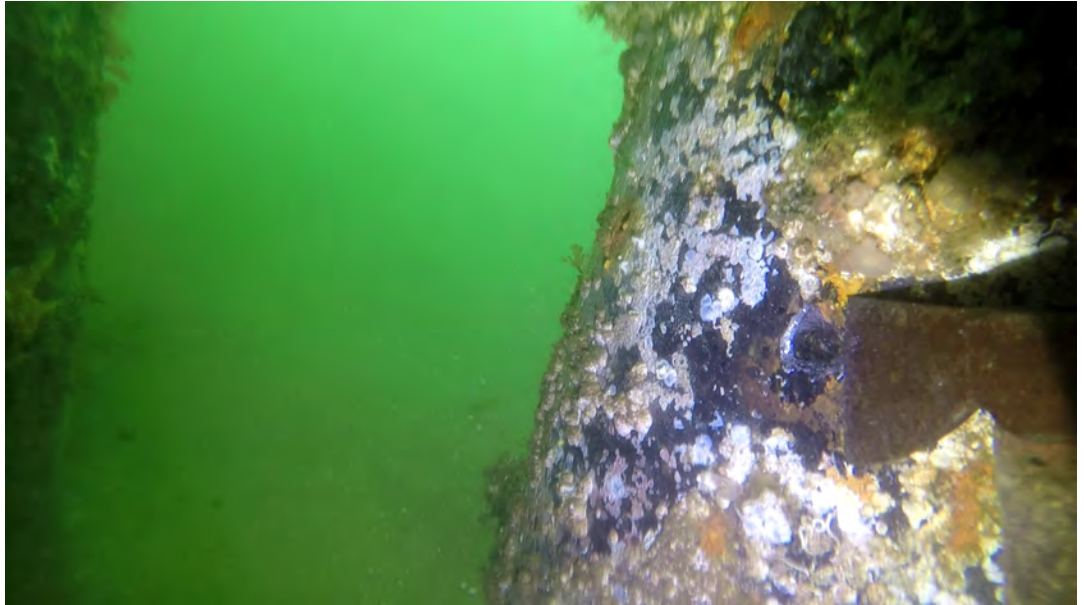
**UW-10**

8703 Spud Piling & Wells  
Photo Type: I - In Depth  
Orientation:  
Date: 4/27/2021  
Repairs:  
Localized deep pitting in Pile SP1-C;  
typical of other piles in localized areas.

C	Steel	CS3	MDL+2 MDL+3 ITZ	Thickness = 0.485" (2017) 1" dia. localized pit @1:00; 0.41" deep. Thickness = 0.480"(2021) in adjacent good area. Typical of other areas of localized deep pitting (Photo #UW-10). 5%-10% area general coating loss/failure.	UW	4/27/2021
	D	Steel	CS4	MDL MDL+1 MDL+2 ITZ	3'(h) x 5"(w) hole thru pile @4:00 (Photo #UW-11). Thickness = 0.490" (2021) in adjacent good area. 3/4" dia. pits up to 0.25" deep in Level II cleaned area @4:00 Thickness 0.490" (2013). 5%-10% area general coating loss/failure.	UW	4/27/2021
SP2	A	Steel	CS3	MDL+1 MDL to MDL+1.5 ITZ	Thickness = 0.495" (2021) 18"(h) x 9"(w) area of coating failure with pitting up to 3/8" deep @2:30 Up to 50% coating failure and heavy corrosion from chain fretting (Photo #UW-12). Thickness readings were 0.130" & 0.270" in fretted area (2021).	UW	4/27/2021
	B	Steel	CS3	MDL+1 ITZ	Thickness = 0.480" (2021) 10% area general coating loss/failure. Pontoon chains are fretting on pile and causing heavy corrosion and section loss. Thickness readings were 0.300" & 0.340" in fretted area from 6:00-9:00 (2021)	UW	4/27/2021

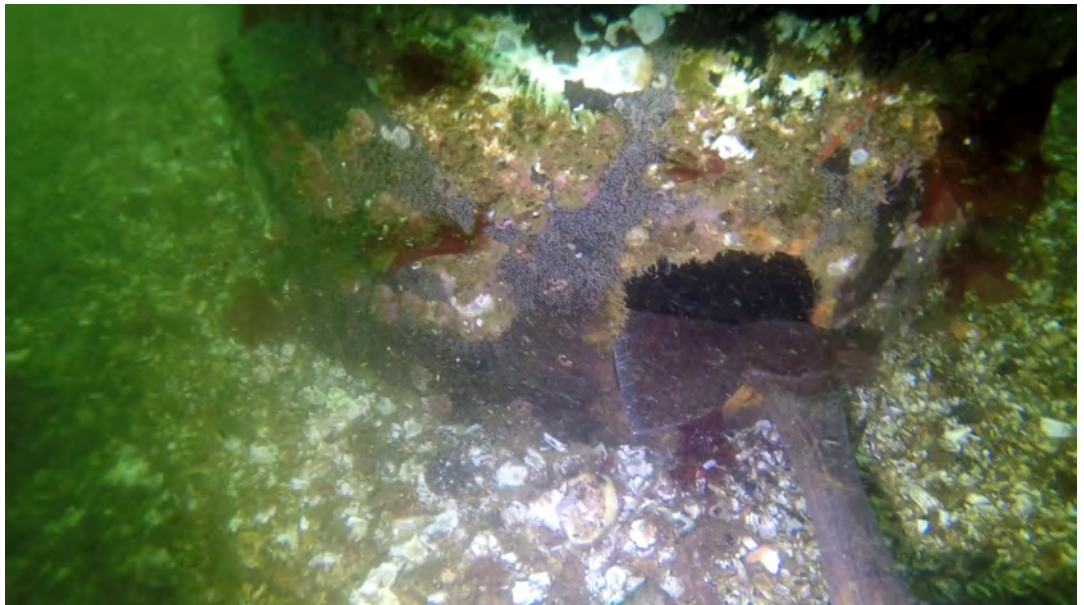
**UW-11**

8703 Spud Piling & Wells  
Photo Type: I - In Depth  
Orientation: SE  
Date: 4/27/2021  
Repairs: 10007  
Spud Pile SP1-D holed thru near  
mudline.

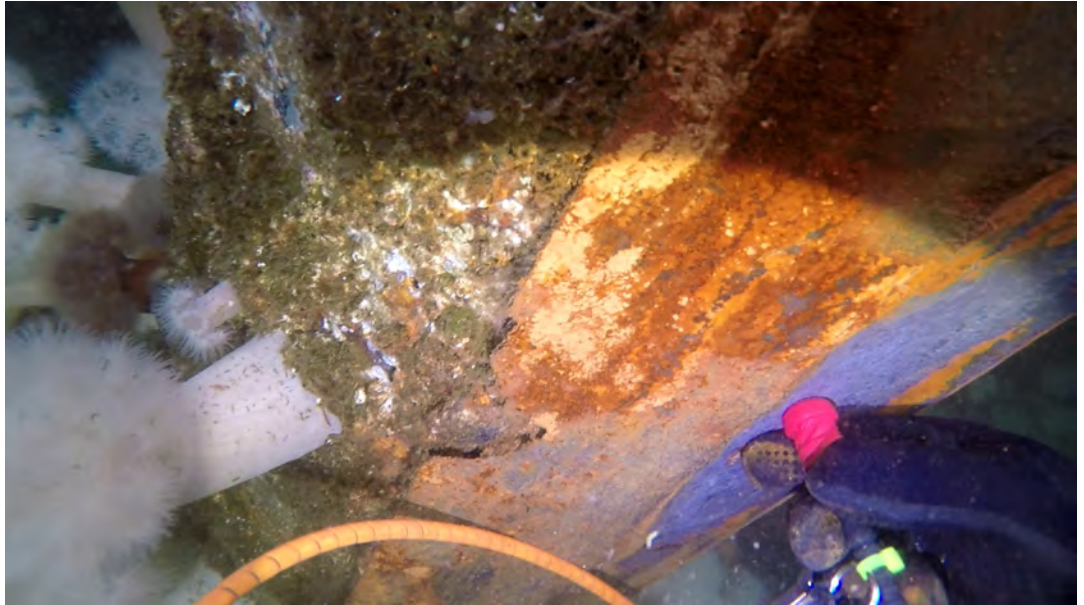
## UW-12

Heavy corrosion and section loss in SP2-A from chain fretting. Only about 1/8" section remaining in this location.

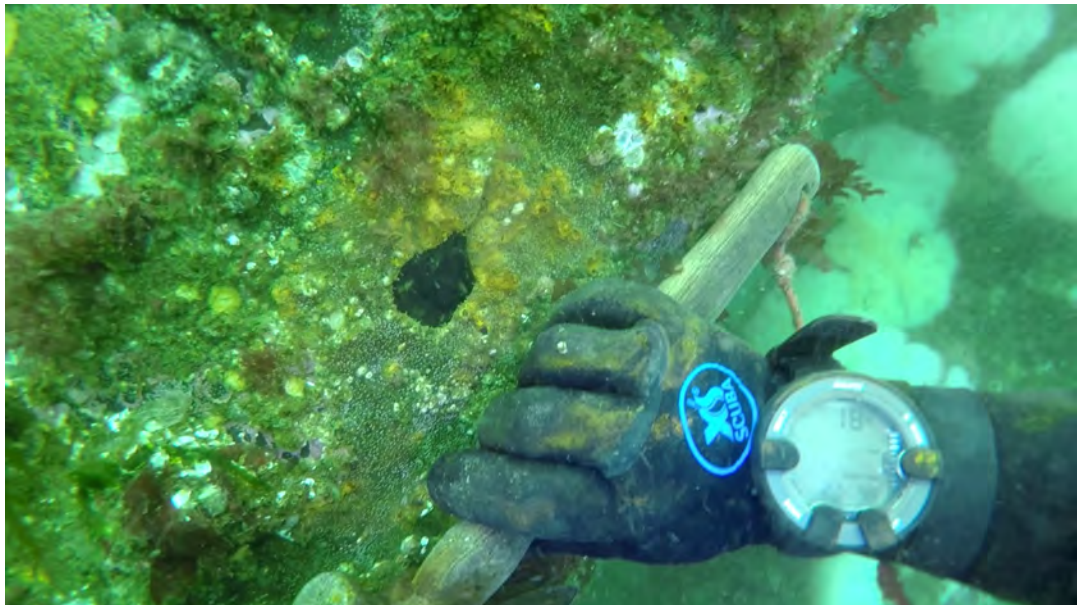
## UW-13

Spud Pile SP3-B holed thru at MDL+4

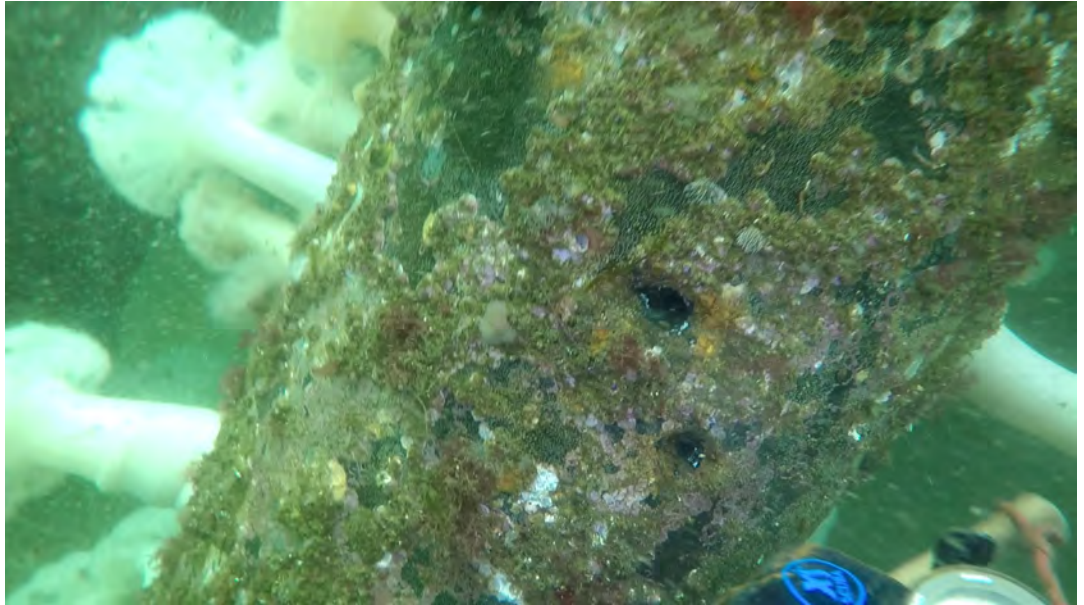
## UW-14

8703 Spud Piling & Wells  
Photo Type: I - In Depth  
Orientation: W  
Date: 4/27/2021  
Repairs: 10007  
Spud Pile SP3-C deeper pits holed thru at MDL+4

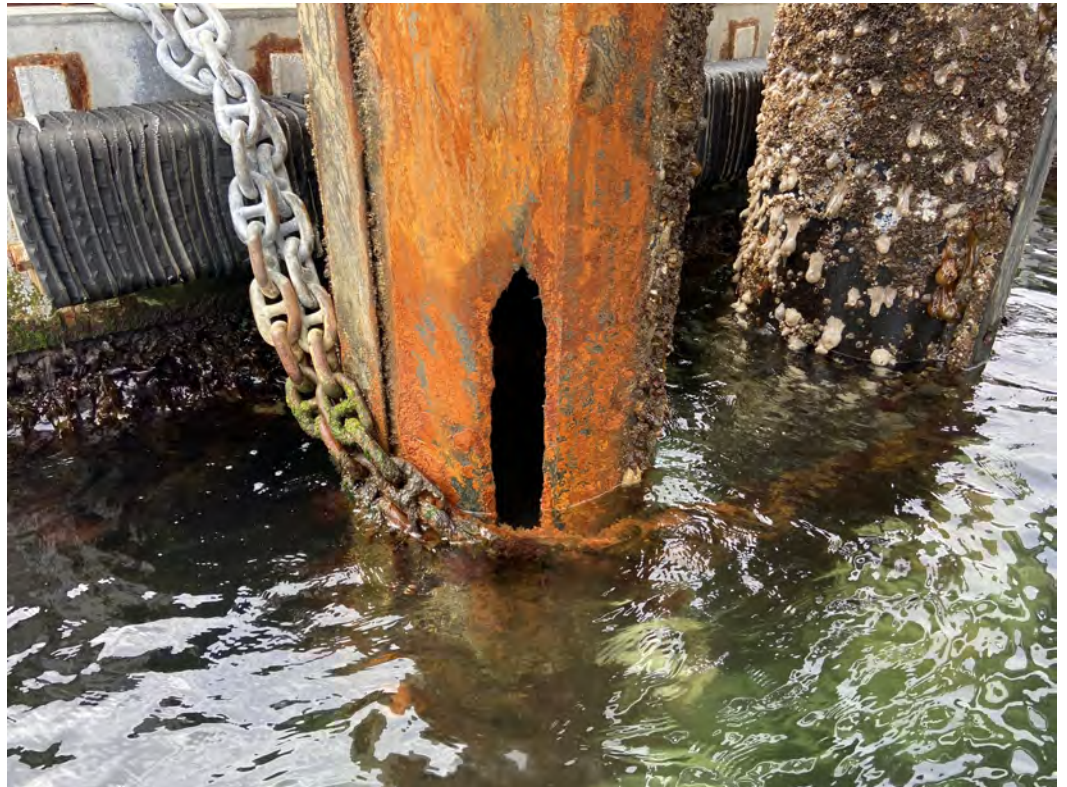
## UW-15

8703 Spud Piling & Wells  
Photo Type: I - In Depth  
Orientation: NW  
Date: 4/27/2021  
Repairs: 10007  
Spud Pile SP4-A holed thru in the ITZ from chain fretting.

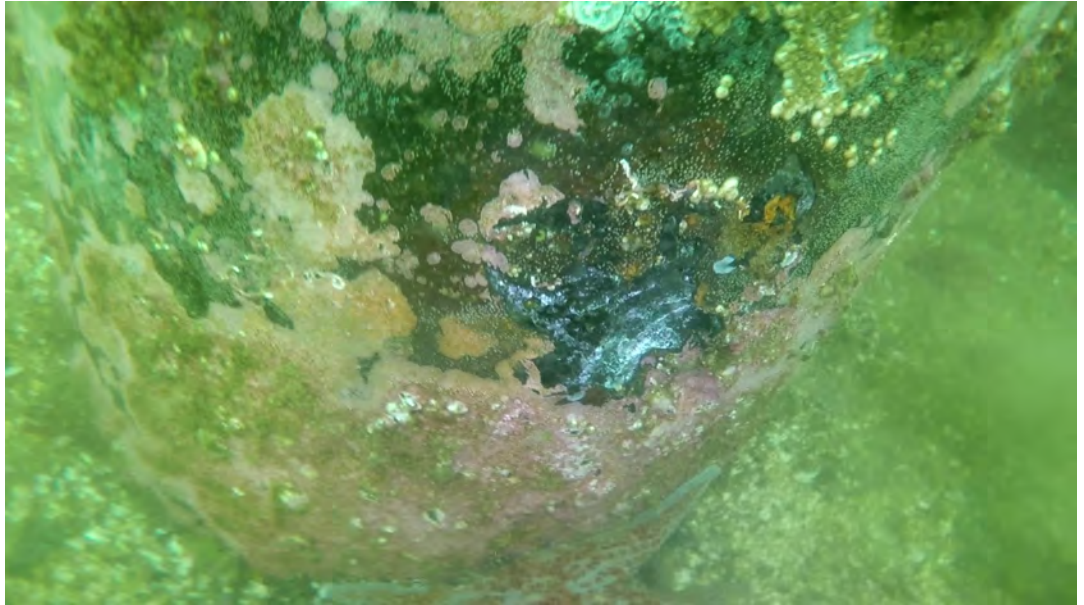
**UW-16**

8703 Spud Piling & Wells  
Photo Type: I - In Depth  
Orientation: W  
Date: 4/27/2021  
Repairs:  
Localized deep pitting near MDL in Spud Pile SP4-B.

D	Steel	CS4	MDL+1 ITZ	Thickness = 0.495" (2017); 0.490" (2021). Approx. 20% area coating failure near mudline. 10% area general coating loss/failure. 3'(h) x 6"(w) area of corrosion and section loss due to chain fretting. Thickness = 0.300"(2021). Horizontal crack across butt weld several feet below high water mark (Photo #27; REPAIR #10005)	UW	4/27/2021
SP4	A	Steel	CS4	MDL+1 MDL+3 to +5 MDL+16 to +19.5 ITZ	Thickness = 0.470"(2017); 0.460"(2021). Corr. band w/ concentrated localized pitting. Hole 3.5'(h) x 4"(w) @10:00 centered in larger corrosion band (Photo #UW-15). 10% area general coating loss/failure. Pontoon chains are fretting on pile.	UW	4/27/2021
	B	Steel	CS3	MDL MDL+1 ITZ	Photo #UW-7 shows typical coating condition near mudline. Thickness = 0.515"(2021) in good coating area. Localized pits up to 0.280" deep around 9:00 (Photo #UW-16) 5%-10% area general coating loss/failure.	UW	4/27/2021

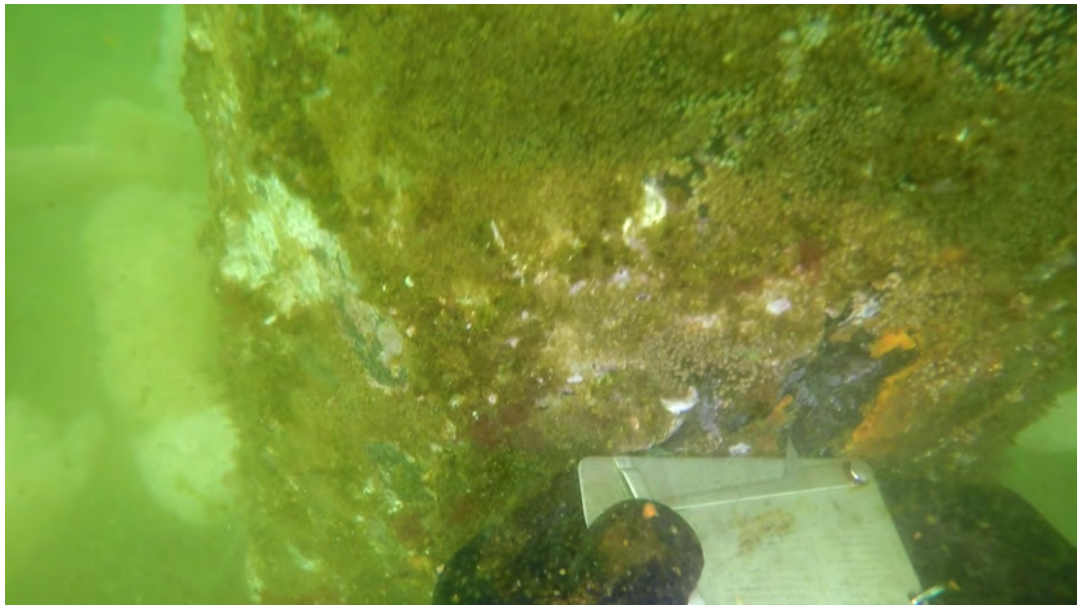
**UW-17**

8703 Spud Piling & Wells  
Photo Type: I - In Depth  
Orientation:  
Date: 4/27/2021  
Repairs:  
Spud Pile SP4-C deep pits mid-height.

C	Steel	CS3	MDL MDL+5 ITZ	Thickness 0.515"/0.260" (good/bad)(2013). Deeper pitting up to 0.350" deep (Photo #UW-17). Thickness = 0.505" in adjacent good area (2021). 5%-10% area general coating loss/failure.	UW	4/27/2021
	D	Steel	CS3	MDL+1 MDL+5 to +6 ITZ	Thickness = 0.510" (2021). Corr. band w/ concentrated localized pitting. 5%-10% area general coating loss/failure. UHMW/Steel stand-offs mainly intact and protecting pile from chain fretting.	UW	4/27/2021

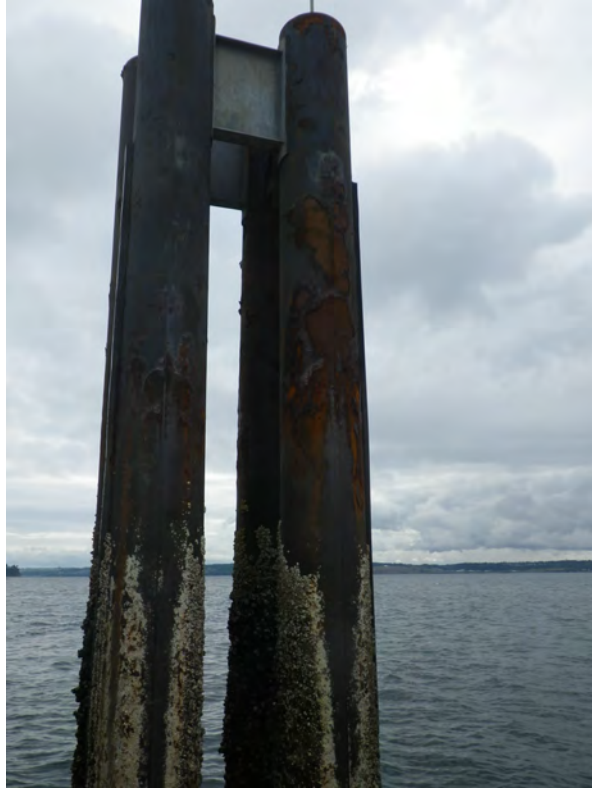
## SI-15

8902 **INORGANIC ZINC VINYL/PAINT:**  
 The spud piles have rust blooms in the intertidal zone (photo #15).

8902 Inorganic Zinc Vinyl Paint  
Photo Type: G - General  
Orientation: Left  
Date: 5/21/2013  
Repairs:  
Spud pile paint has many rust blooms.

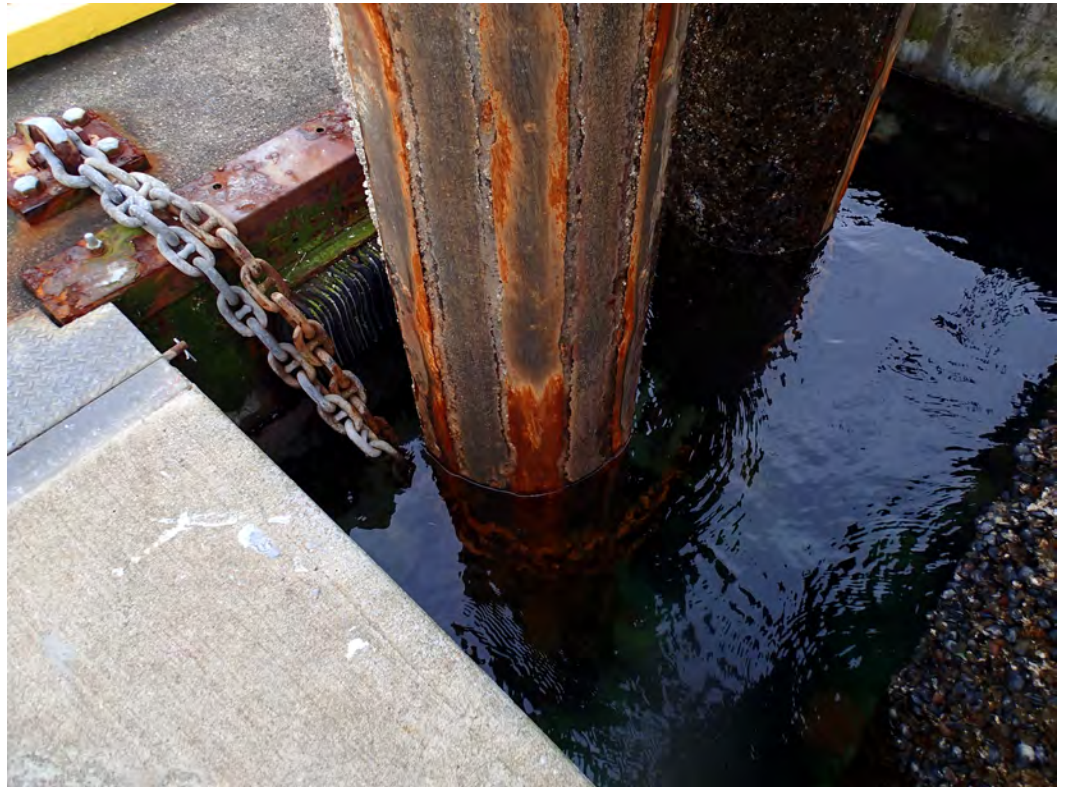
## UW-3

**Underwater Inspection Findings (2021):**  
 The spud pile coating is largely failed in the intertidal zone (ITZ) mainly from pontoon positioning chains rubbing directly on the piles (photo #UW-3). Underwater coating condition below the ITZ is largely intact with only about 5%-10% of the pile surface area showing corrosion on most piling (photo #UW-7).

8902 Inorganic Zinc Vinyl Paint  
Photo Type: G - General  
Orientation: DN  
Date: 4/25/2017  
Repairs:  
Typical spud pile condition in the upper intertidal zone (ITZ)

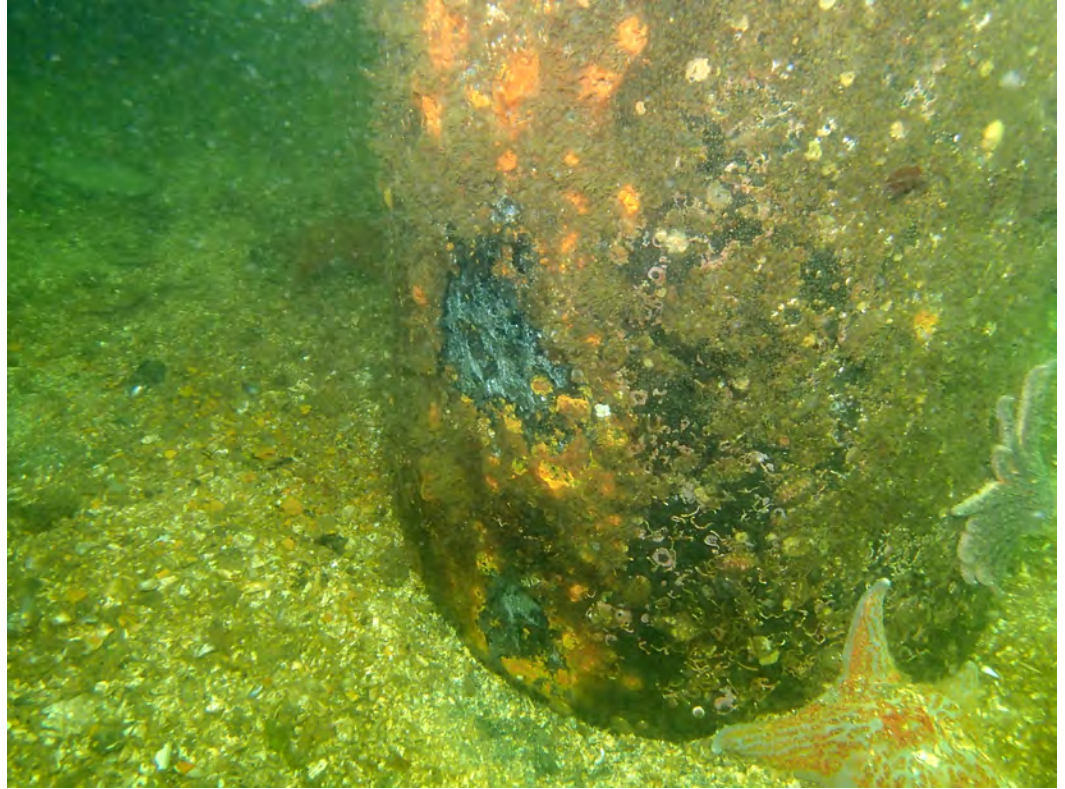
**UW-7**

8902 Inorganic Zinc Vinyl Paint  
Photo Type: I - In Depth  
Orientation: DN  
Date: 5/21/2013  
Repairs:  
5%-10% coating failure with rusting.  
SP4-B shown; typical of other piles.
