WSBIS Field Inventory Report

1001	2009	2132	1019	1021	2023	1156	1188	1196
Structure ID	Bridge Number	Bridge Name	Owner	County	City	Location	Latitude	Longitude
00200440	DOC-5	MCNEIL IS. BARGE DOCK	21	27	0000	MCNEIL ISLAND	47° 11' 28.17"	122° 40' 54.92"

BRIDGE INSPECTION REPORT

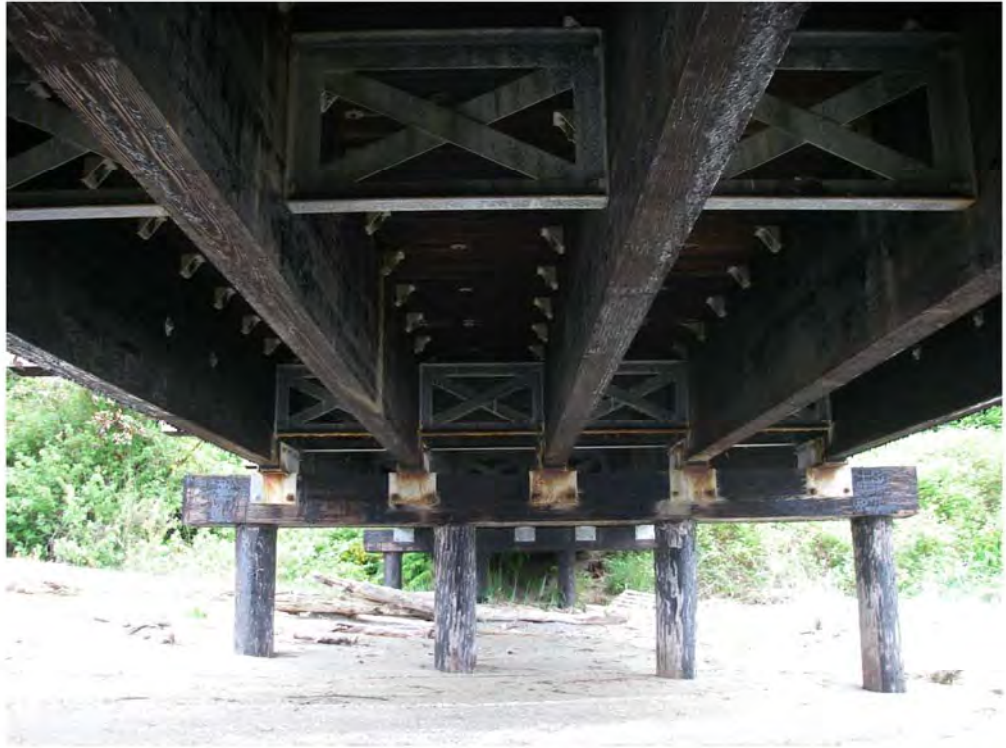
Timber Laminated Girders located in the three approach spans.
Girder hold down plates at Pier 3 are rusty (photo #4).
Girder 4D at Pier 4 hold down plate has holed through (photo #5). REPAIR #10005.

Laminated girders on Pier 3 timber cap, note rusty hold down brackets.

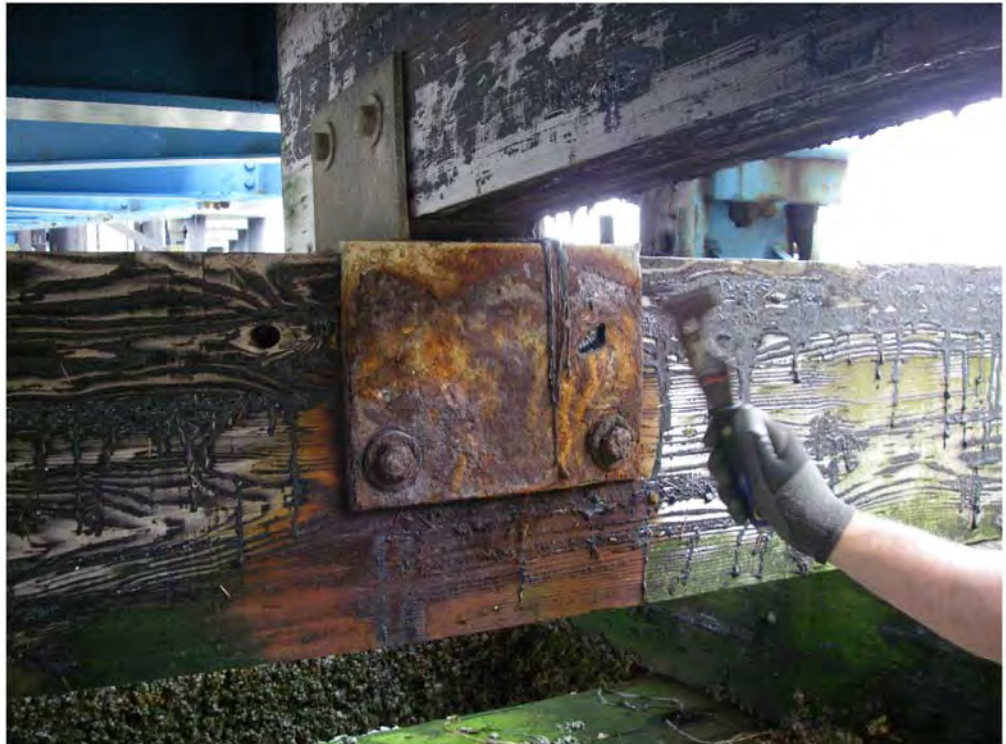
SI-5

Pier 4 girder hold down bracket at Pier 4 Girder D has holed through.

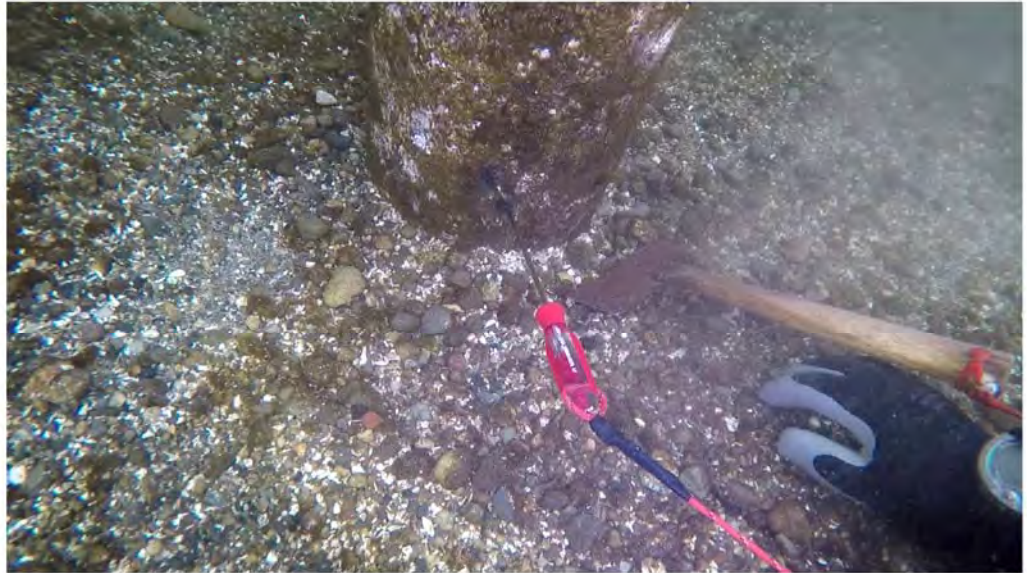
UW-1

8124 Timber Submerged Pile
Photo Type: I - In Depth
Orientation:
Date: 4/25/2017
Repairs:
Right Tower Pile 2C: Lower defect, MBE at mudline.

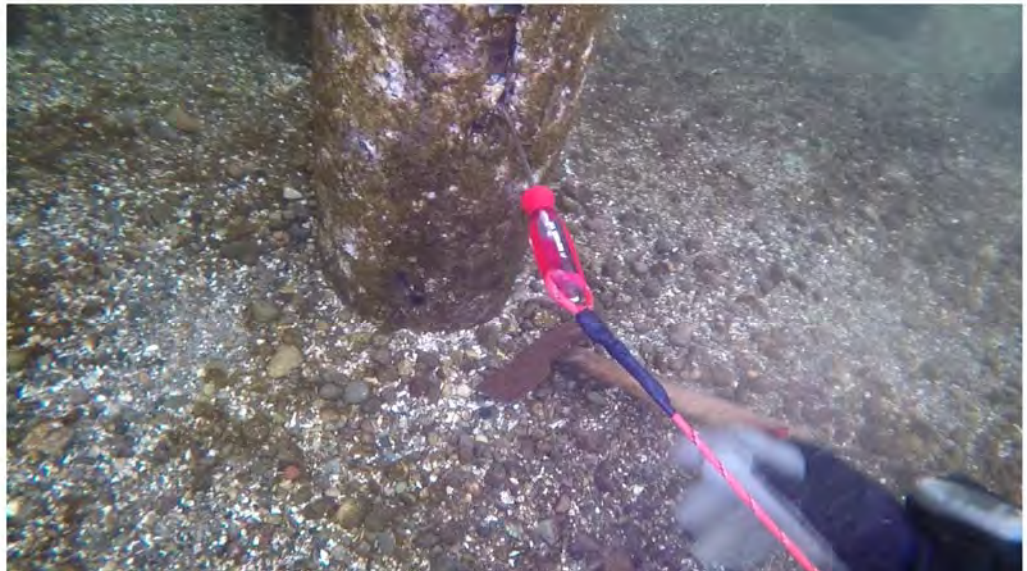
UW-2

8124 Timber Submerged Pile
Photo Type: I - In Depth
Orientation:
Date: 4/25/2017
Repairs:
Right Tower Pile 2C: Upper defect, 2 MBE's

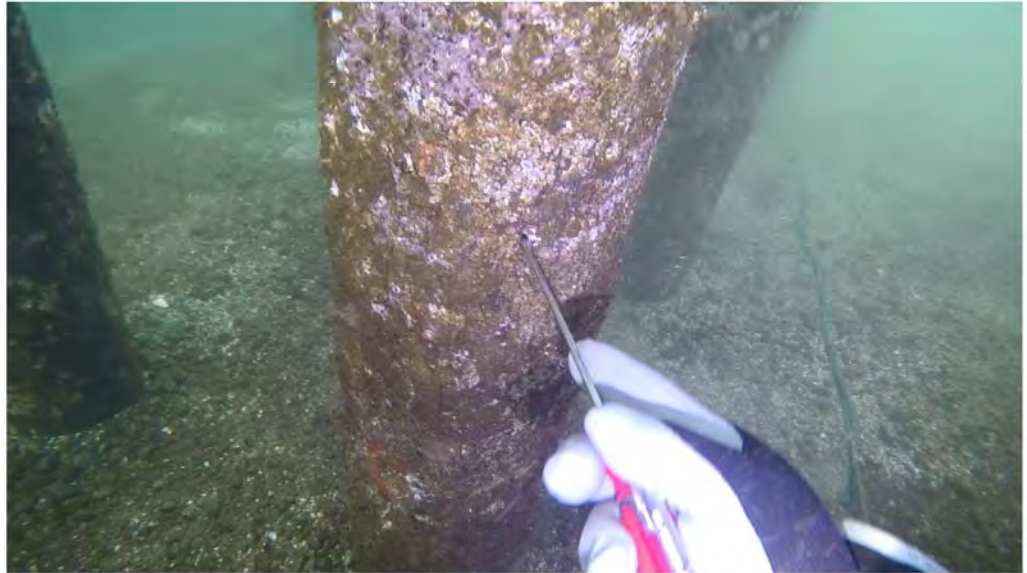
UW-3

8124 Timber Submerged Pile
Photo Type: I - In Depth
Orientation:
Date: 4/25/2017
Repairs:
Right Tower Pile 4A: MBE at MDL+2

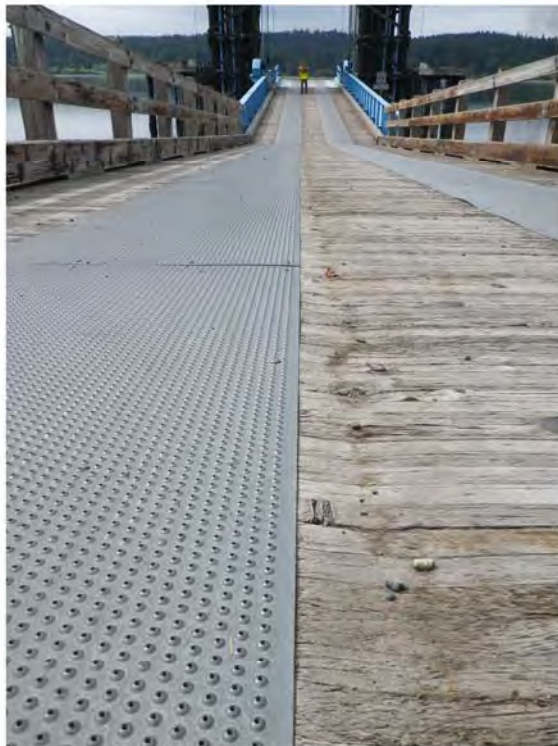
SI-10

Timber decking is nail laminated and has a depth of 3". The deck is rutting up to 5/8" deep, leaving 2-3/8" of depth. Decking spans between timber girders. Consideration should be made to widen the metal running boards to reduce any more rutting (photos #10 and #11). REPAIR #10010.

8221 Timber Deck
Photo Type: G - General
Orientation: Sea
Date: 5/20/2013
Repairs: 10010
Timber deck is rutting.

Repair No	Pr	R	Repair Descriptions	BMS	Noted	Maint	Verified
10010	3	B	The deck is rutting up to 5/8" deep, leaving 2-3/8" of depth. Decking spans between timber girders. Consideration should be made to widen the metal running boards to reduce any more rutting.		4/8/2019

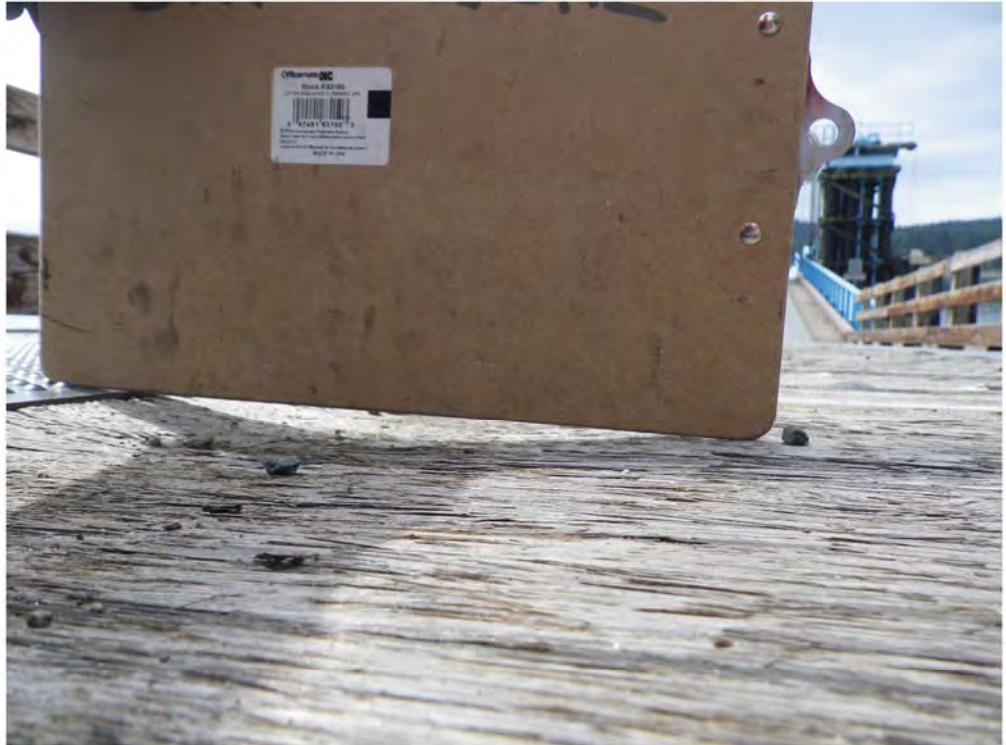
Timber deck is rutting up to 5/8" deep.

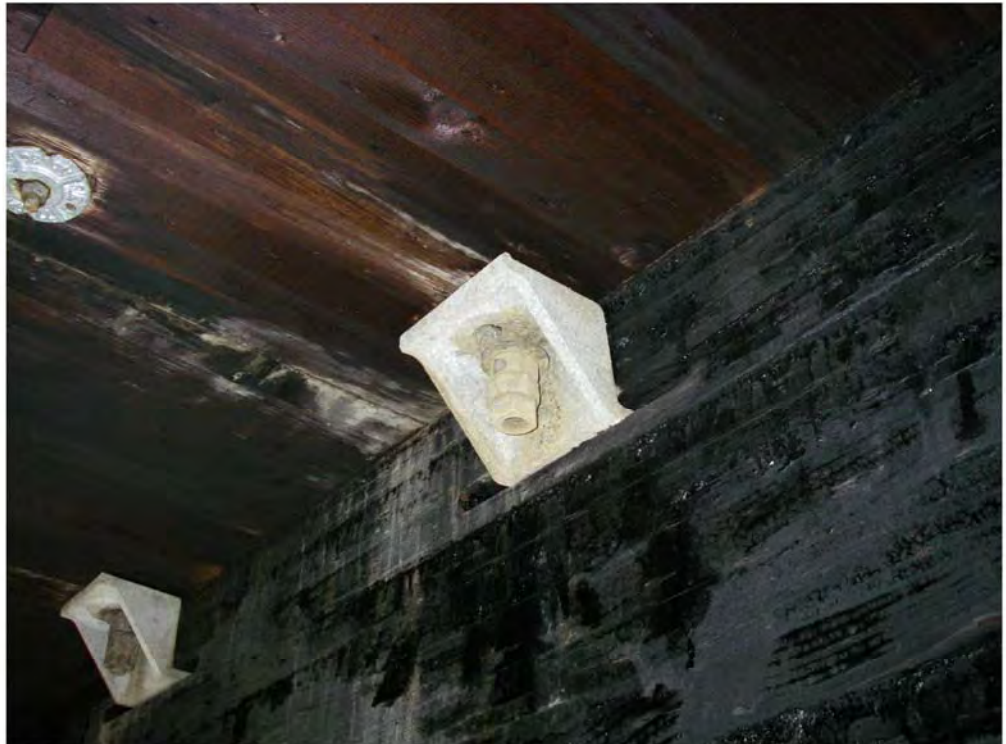
SI-12

Many of the timber deck hold down bolts are loose (photo #12). REPAIR #10004.

Many of the timber deck hold down bolts are loose.

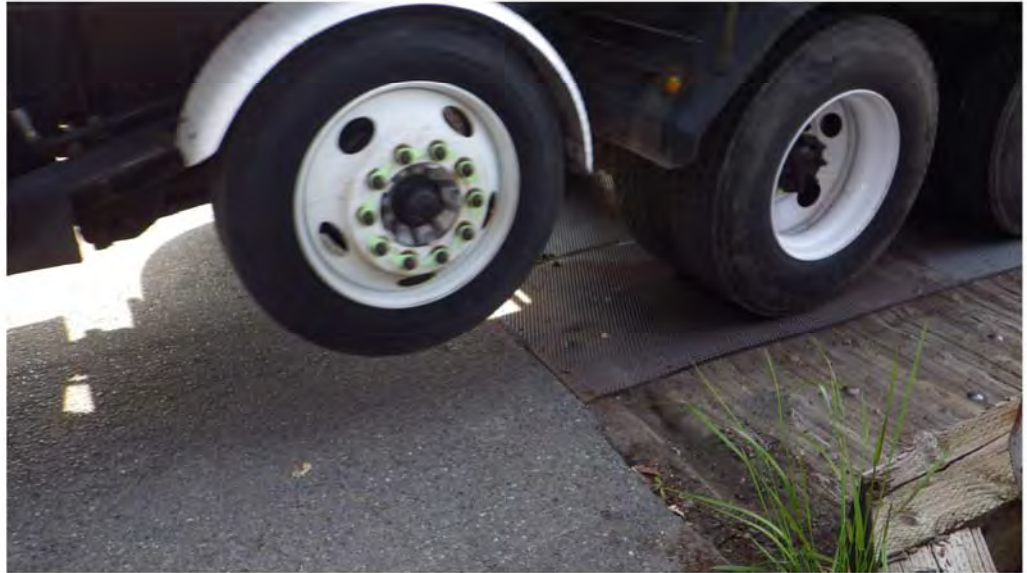
The timber decking near the abutment deflects 3/4"± with heavy wheel loads when observed from above (photo #33). Inspection below without live load found nothing abnormal.

The timber decking near the abutment defects 3/4"± under heavy wheel loads.

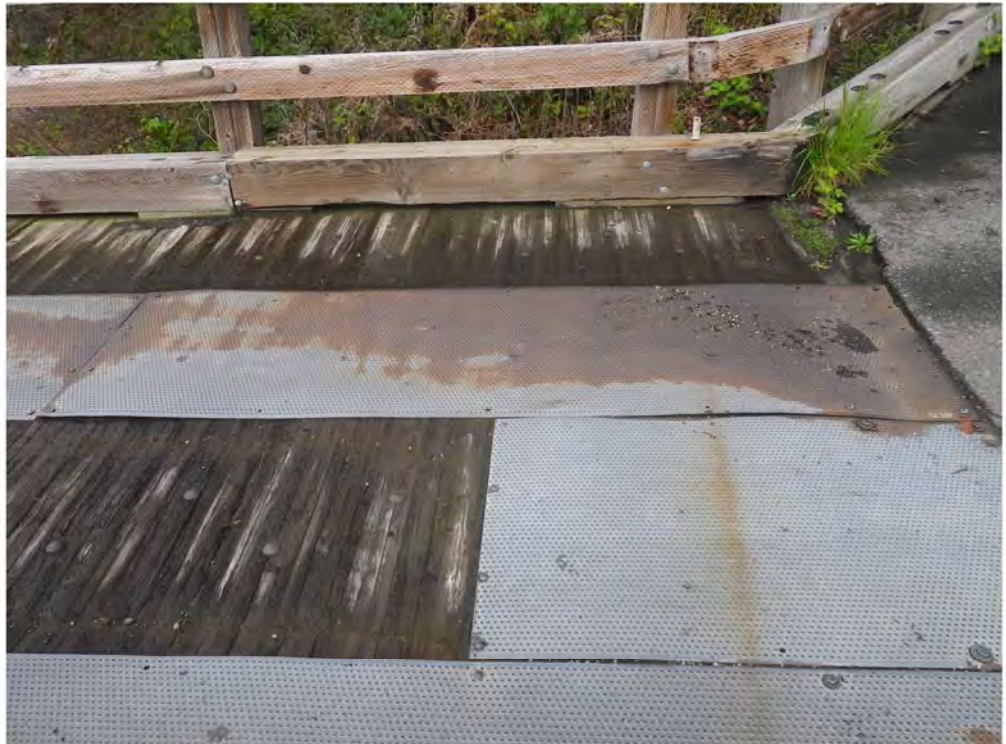
SI-38

The perforated metal running boards on the approach slip on the timber decking have fastening bolts which are loose, missing, and/or not sufficient to fully tighten the metal to the timber (photos #38 & #42). REPAIR #10008.

The perforated metal plates at the top of the approach are loose.

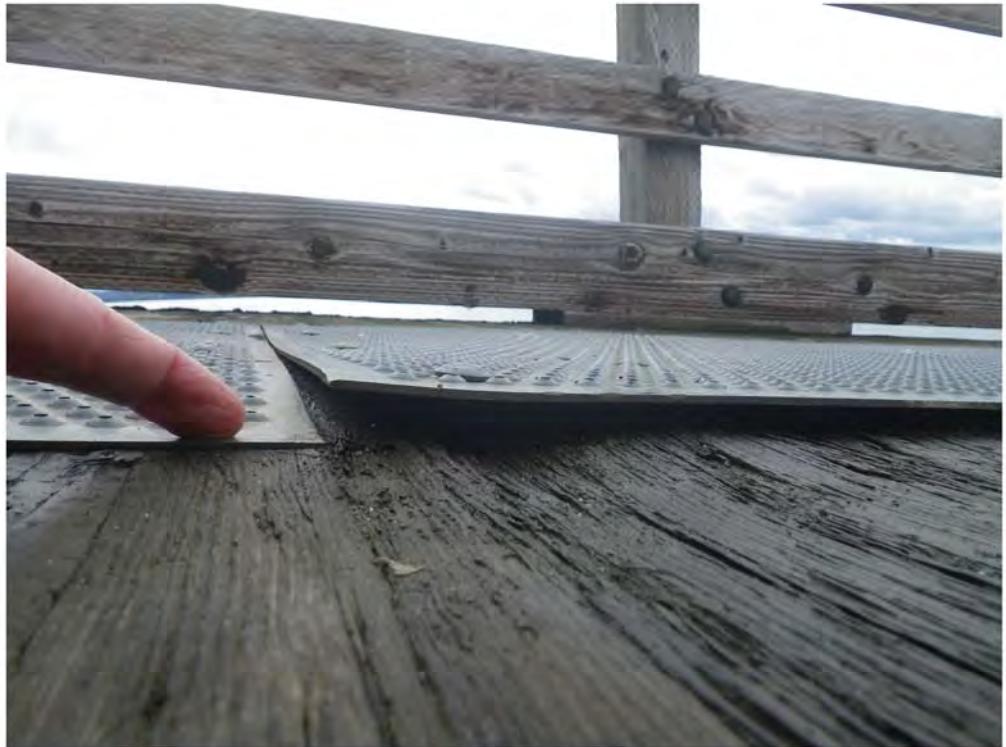
Left wheelline plate, near 2/3 span, is loose; bolts are not holding down plate.

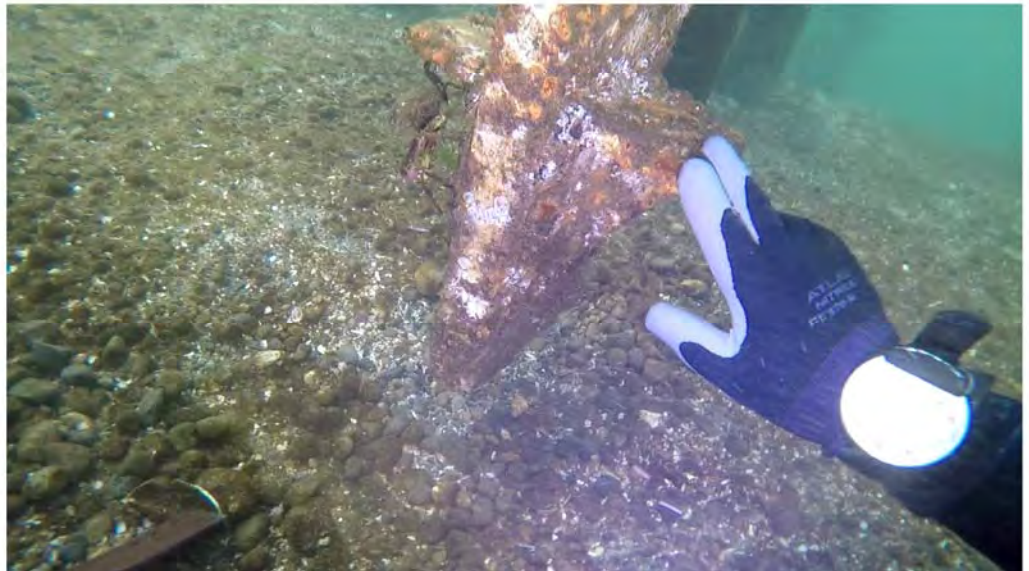
UW-4

The live load hanger stops are intact both left and right (photos #UW-4 and #UW-5). Both hanger bars and stops have minor surface corrosion with some shallow pitting. Right hanger contacts the gravel at the groundline.

Left LL hanger stops intact. Minor corrosion and pitting.

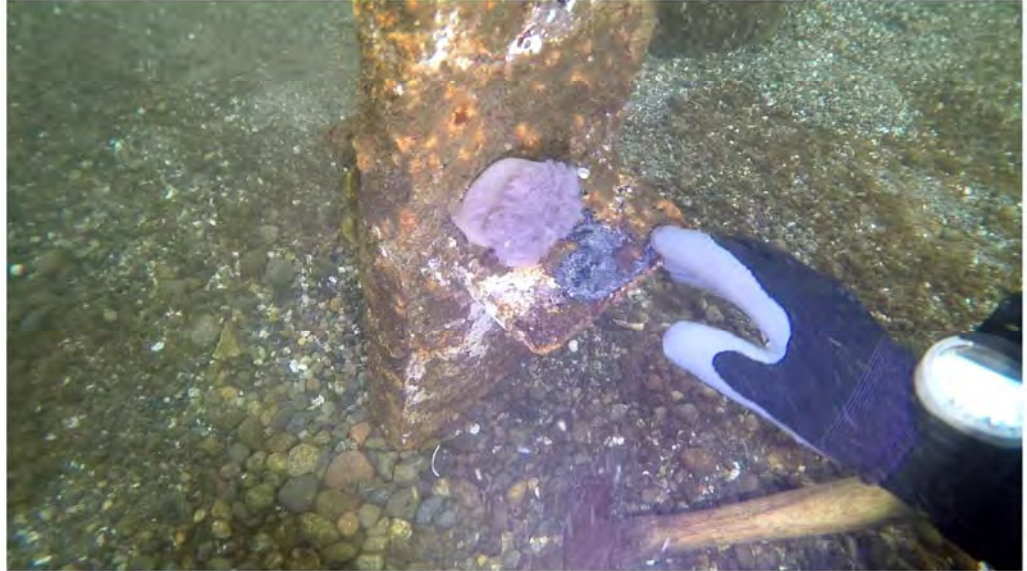
Right LL hanger stops intact. Minor corrosion and pitting. Bar end contacts groundline.

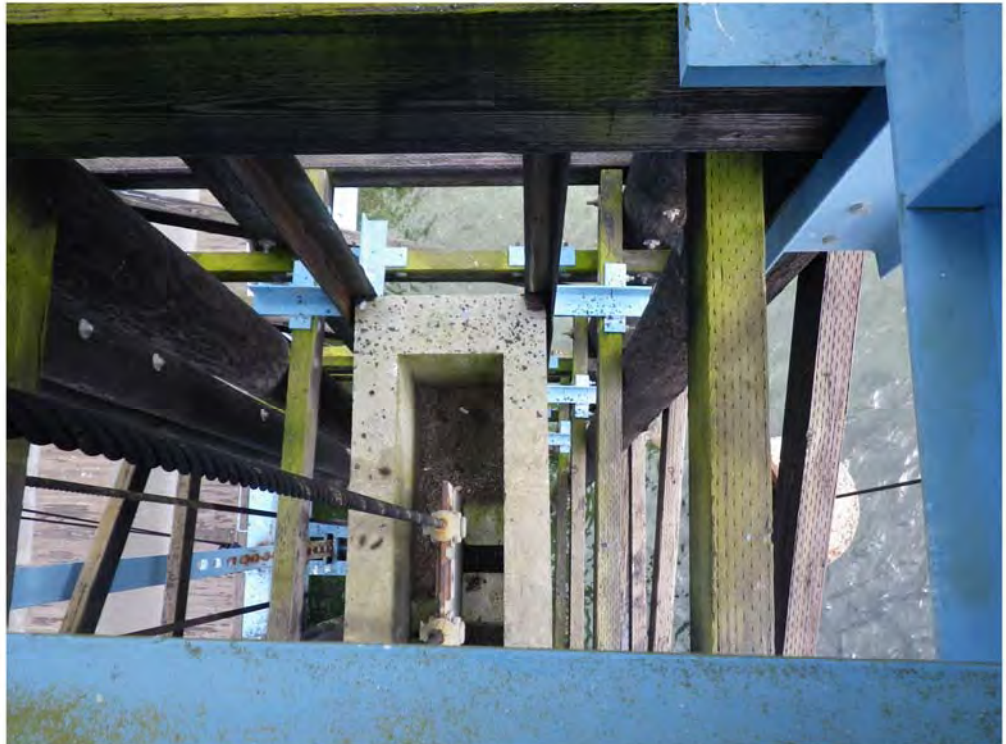
SI-18

The cables are lacking lubrication throughout, some surface rust showing (photos #18 & #37). REPAIR #10001. The apron counterweight cable has no thimble at the connection to the apron (photo #40). REPAIR #10009.

Counterweight cable has very little to no grease remaining.

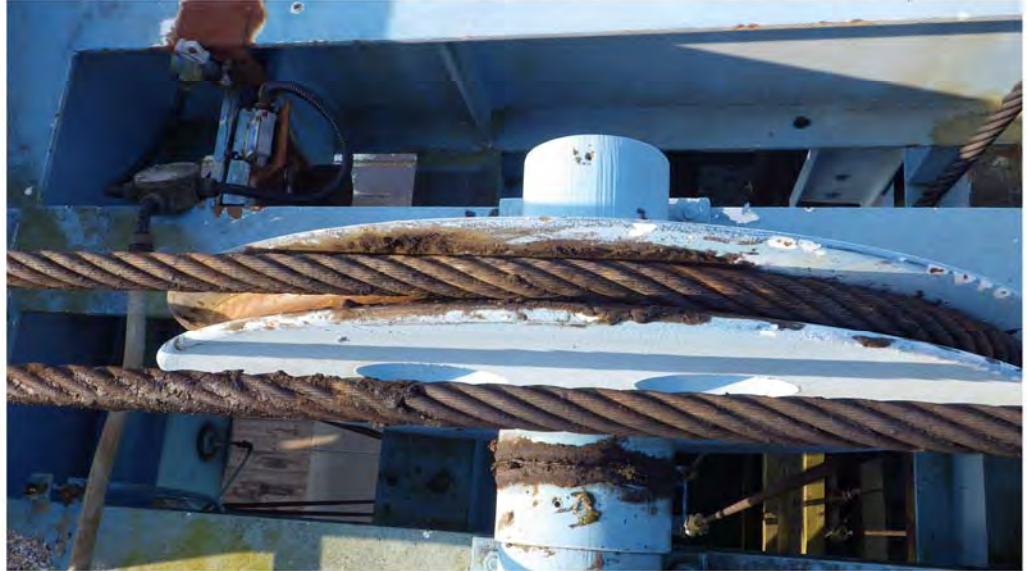
The cables are lacking lubrication throughout, some surface rust showing.

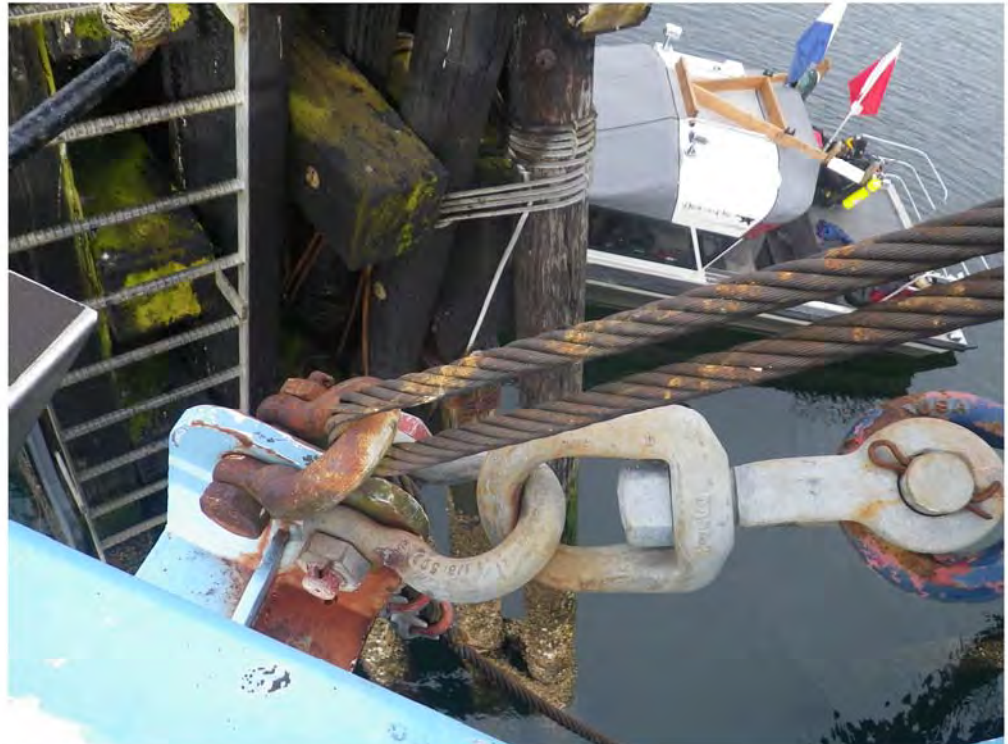
SI-40

Transfer span counterweight cable has no thimble, is lacking lubrication/protection.

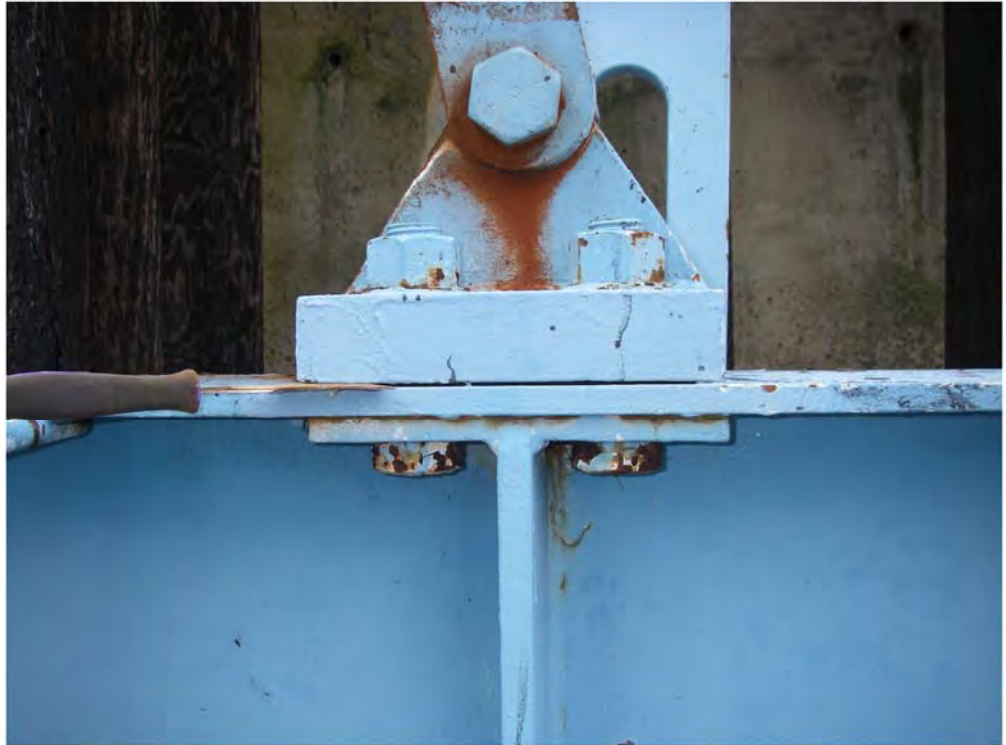
Left girder lifting shackle connection is gapped.

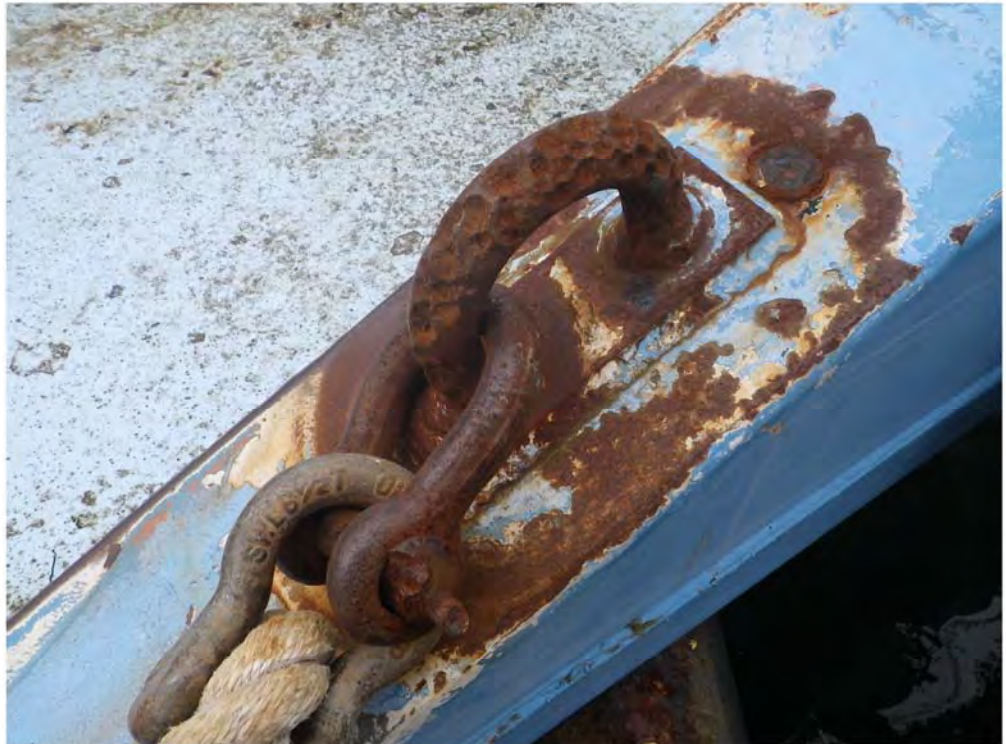
SI-43

Tie rings for securing docked boats have section loss from previous corrosion (photos #43 & #44). REPAIR #10007.

Left tie ring, with section loss

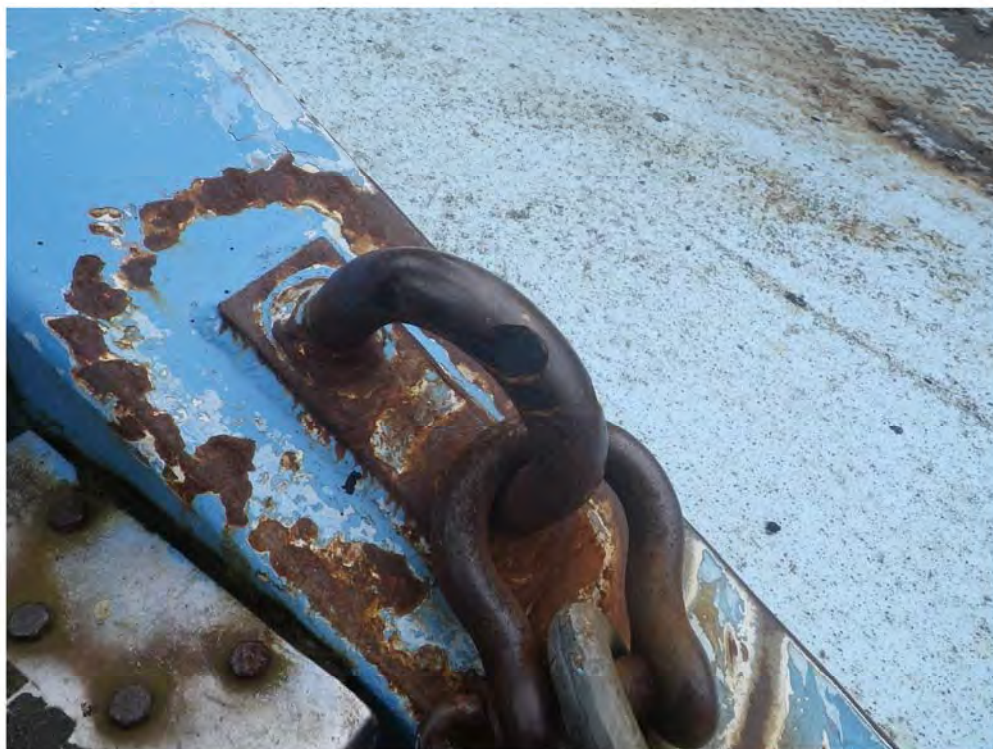
Right tie ring, with section loss.

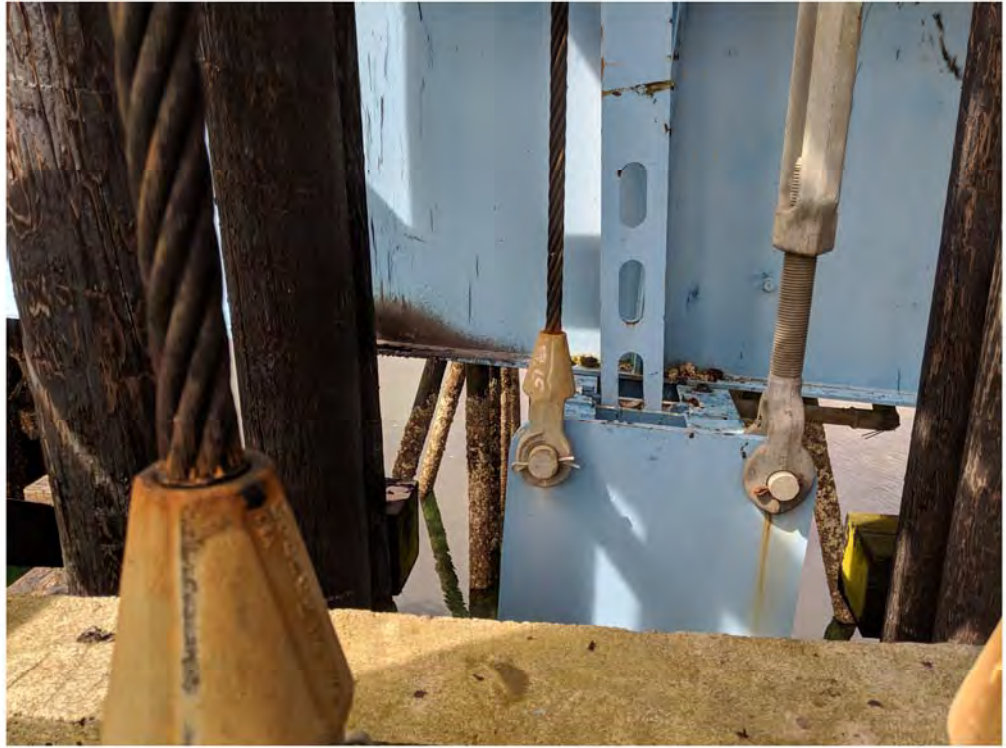
Lift span cable sockets show some sign of slippage and degradation of zinc filler (photos #48 & #49).

Lift span cable sockets show some sign of slippage and degradation of zinc filler.

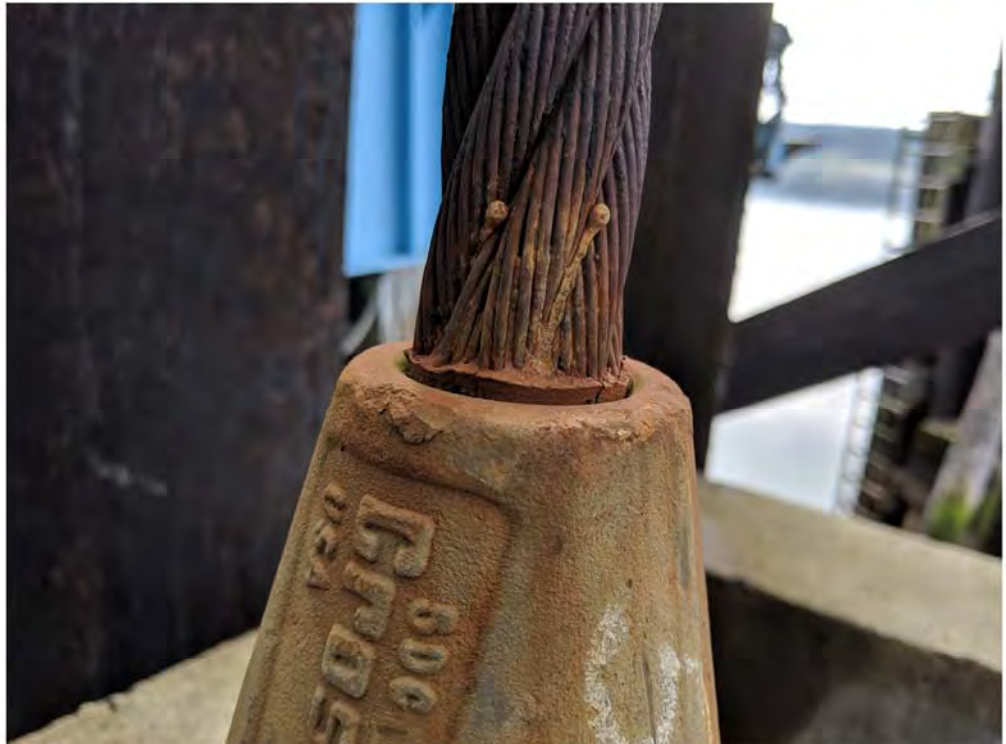
SI-49

Lift span cable sockets show some sign of slippage and degradation of zinc filler, close up view shows slippage at right side socket.

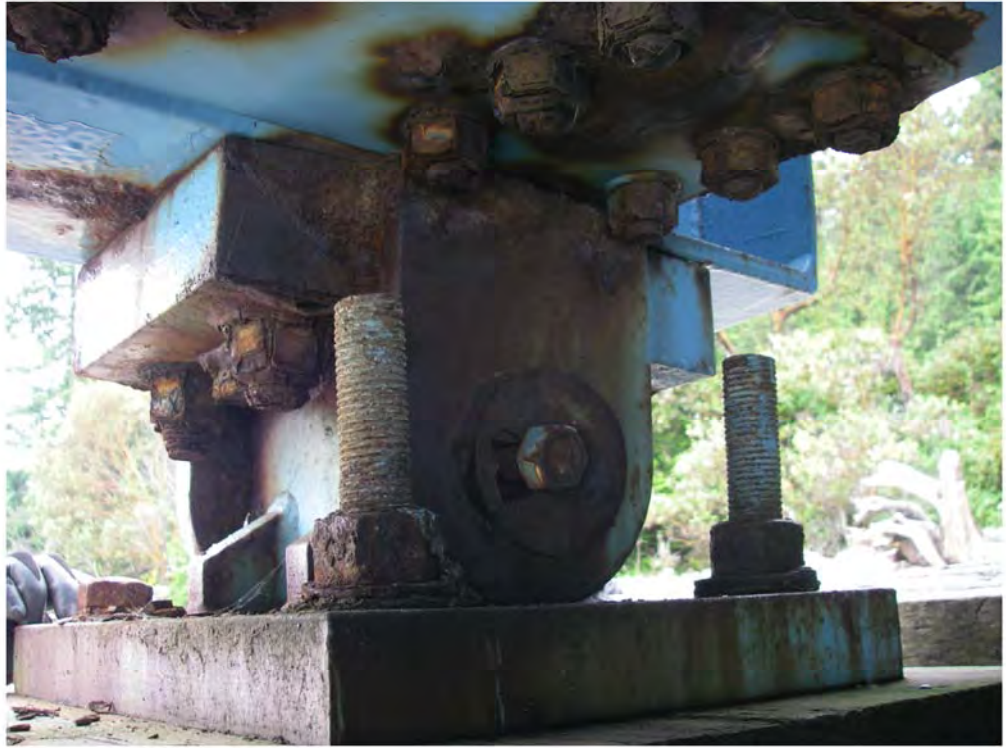
Pier 4 bearings supporting the transfer span are in poor shape. The hold down through pins are missing nuts and washers. The anchor nuts and washers have laminar rust and section loss. Lack of grease has caused fretting corrosion (wear). This has shortened the height of the bearing so that the hold down plates now ride on the base plate (photos #20 - #23). REPAIR #10002.

Pier 4 transfer span right bearing, hold down through pin and anchor nuts need replacing.

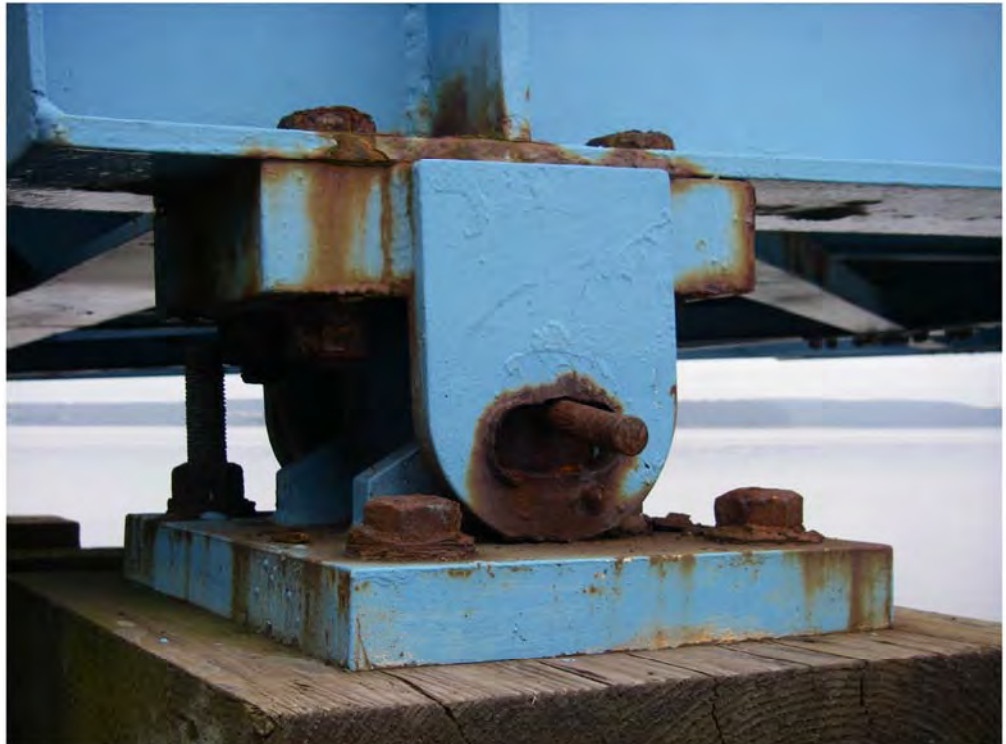
SI-21

Pier 4 transfer span right bearing, hold down through pin and anchor nuts need replacing.

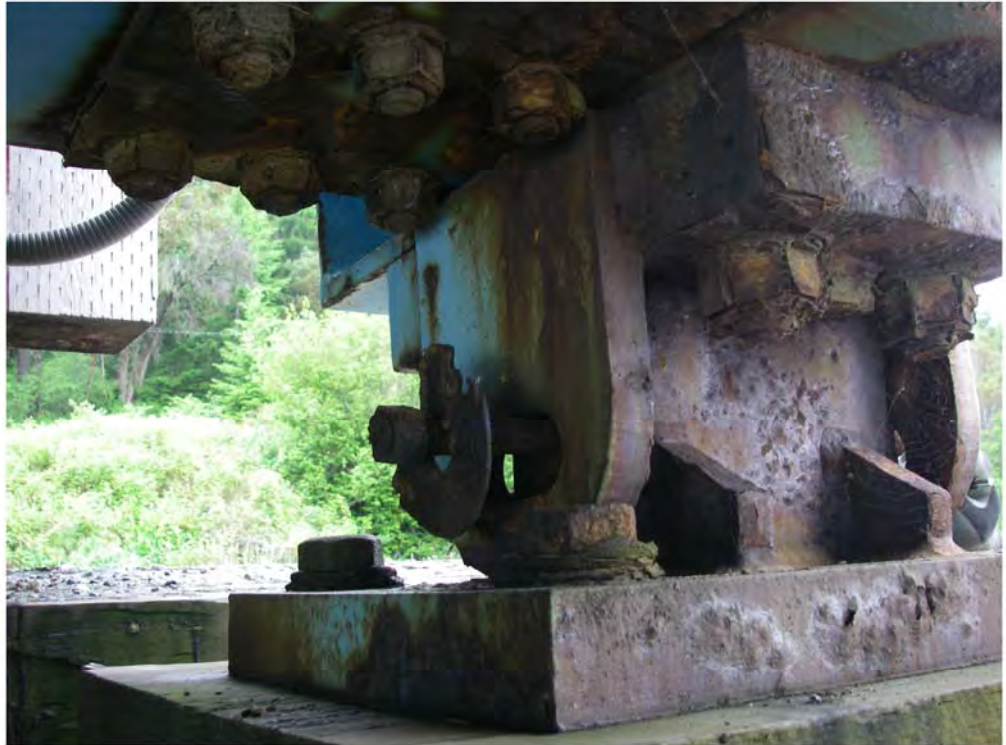
Pier 4 transfer span left bearing, hold down through pin and anchor nuts need replacing.

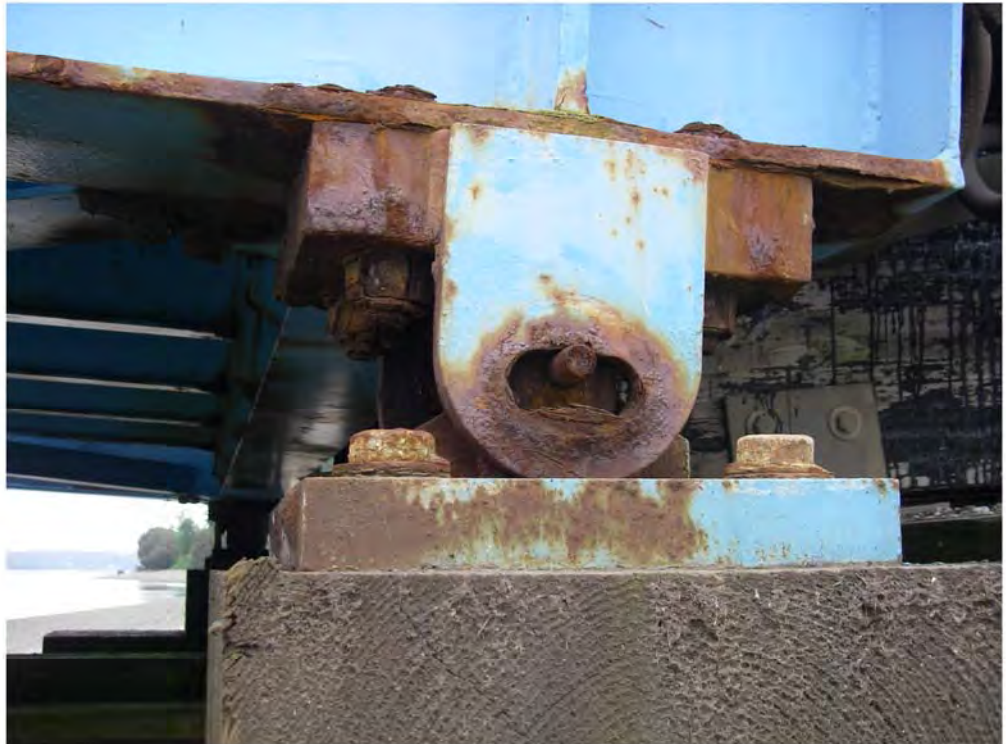
SI-23

Pier 4 transfer span left bearing, hold down through pin and anchor nuts need replacing.

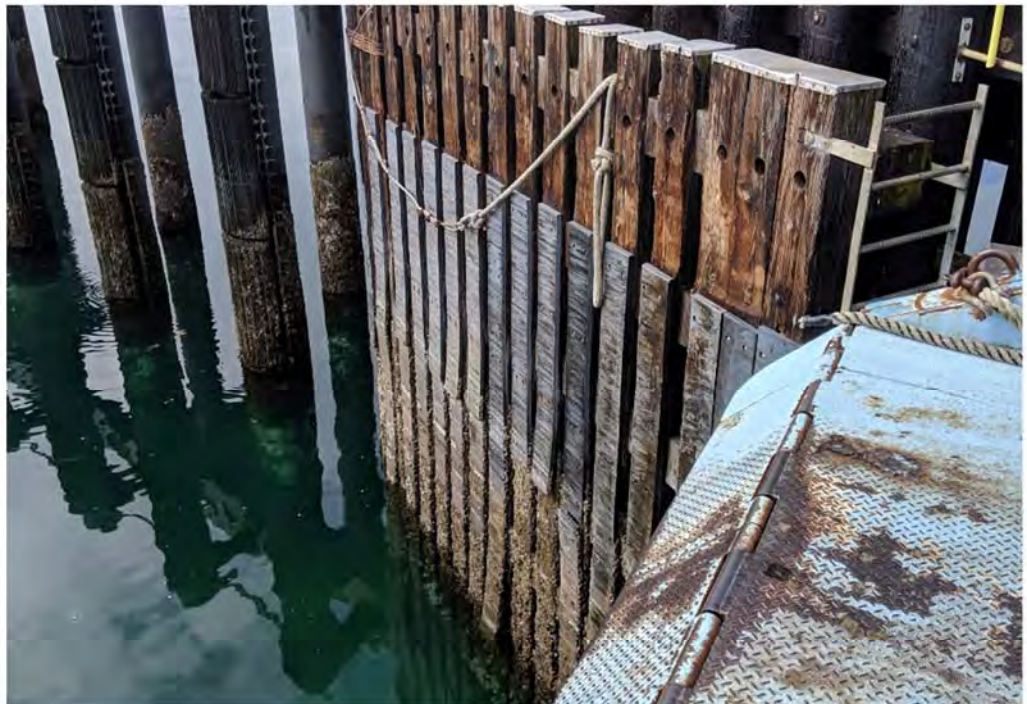
SI-46

Right timber wingwall is missing several UHMW sheets. The lower facing timbers are also in poor condition (photo #46). REPAIR #10006.

Right timber wingwall is missing several UHMW sheets. The lower facing timbers are in poor condition also.

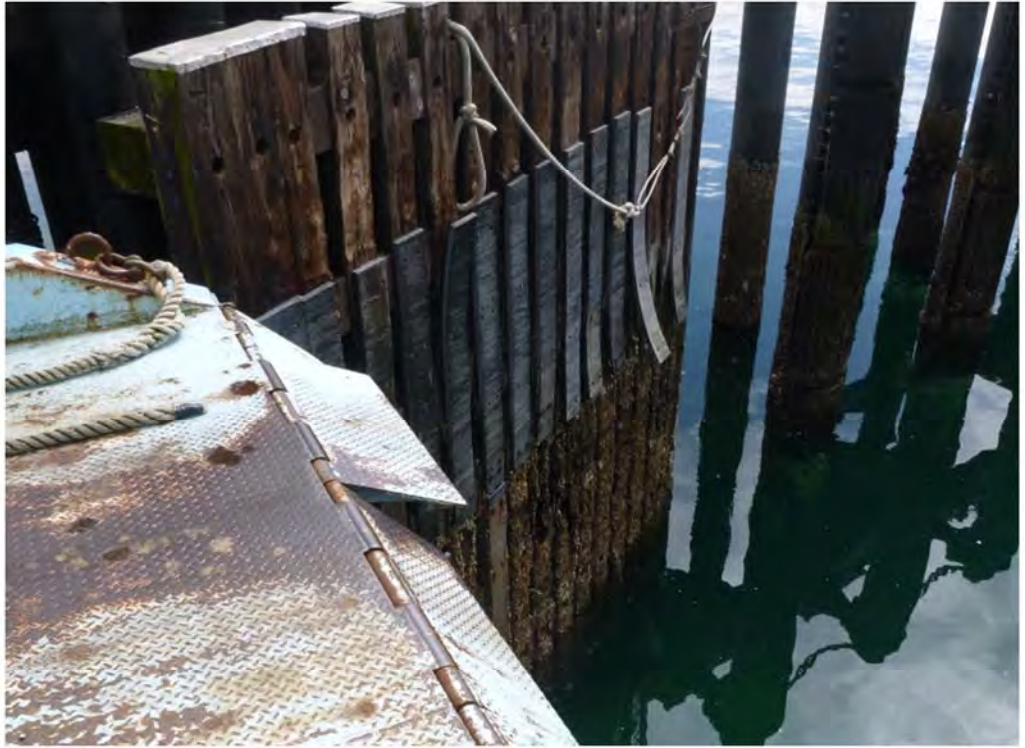
Left timber wingwall is missing all lower UHMW sheets. The lower facing timbers are also in poor condition (photo #47). REPAIR #10006.

Left timber wingwall is missing all lower UHMW sheets. The lower facing timbers are in poor condition also.

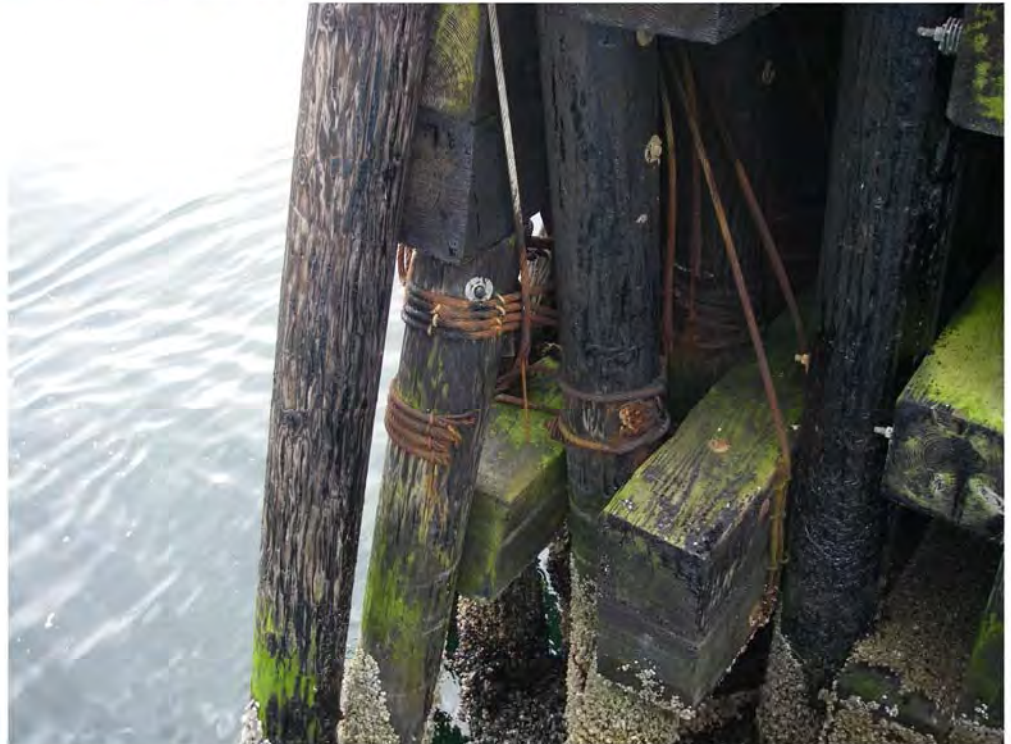
SI-27

Left timber wingwall has broken cables; possibly redundant.

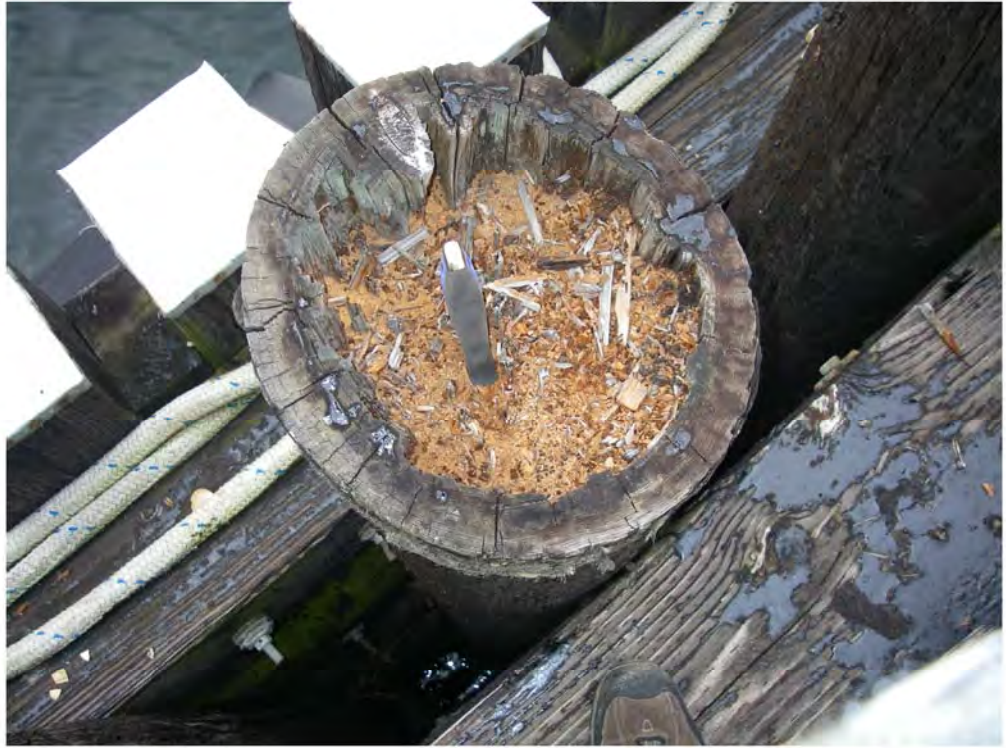
Many of the wingwall piles have top end rot (photos #28 and #29).

Many of the wingwall piles have top end rot.

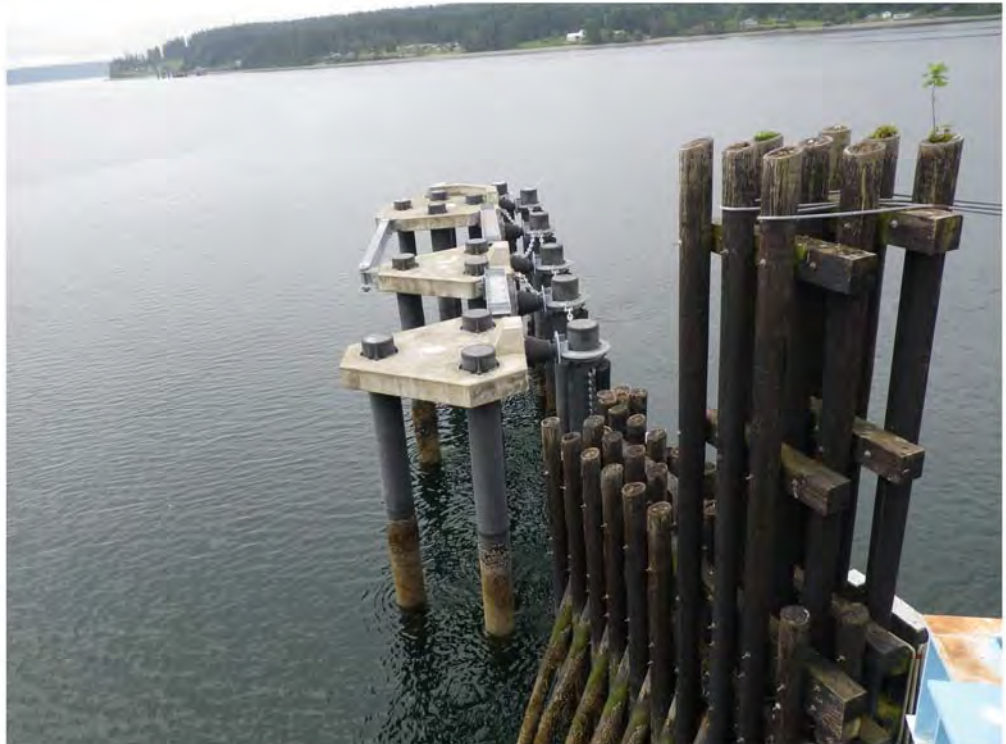
SI-29

Many of the wingwall piles have top end rot.

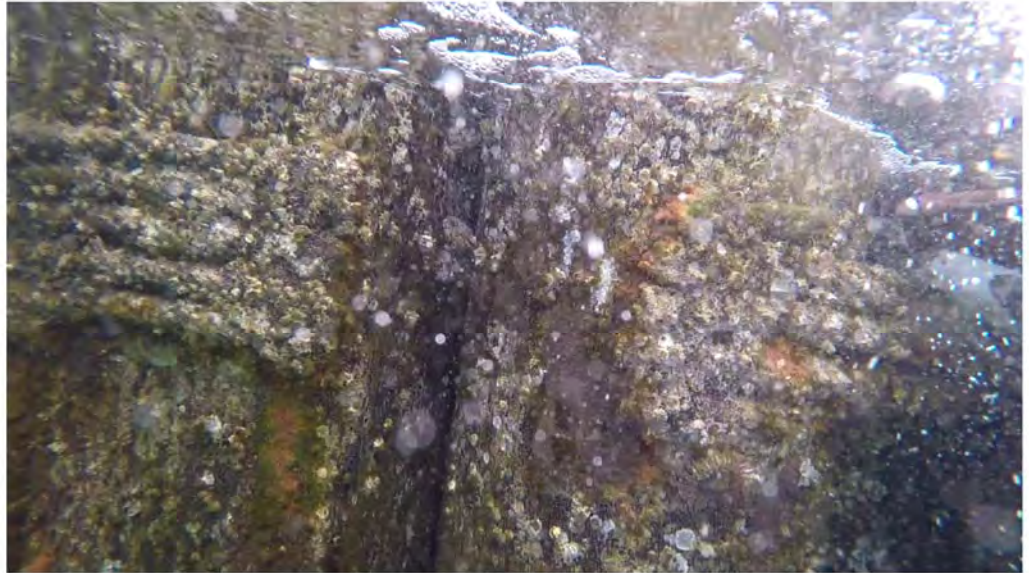
In general, the timber wingwalls are in good condition underwater. The offshore end 5-pile groups on each wingwall have broken lower wraps (photos #UW-6 and -7). The right wingwall has one pile with MBE's noted near mudline (photos #UW-8 and -9). See attached Layout drawing and Pile Data Sheets for more information.

LWW end dolphin lower wraps broken
