WSBIS Field Inventory Report

1001	2009	2132	1019	1021	2023	1156	1188	1196
Structure ID	Bridge Number	Bridge Name	Owner	County	City	Location	Latitude	Longitude
00200440	DOC-5	MCNEIL IS. BARGE DOCK	21	27	0000	MCNEIL ISLAND	47° 11' 28.17"	122° 40' 54.92"

BRIDGE INSPECTION REPORT

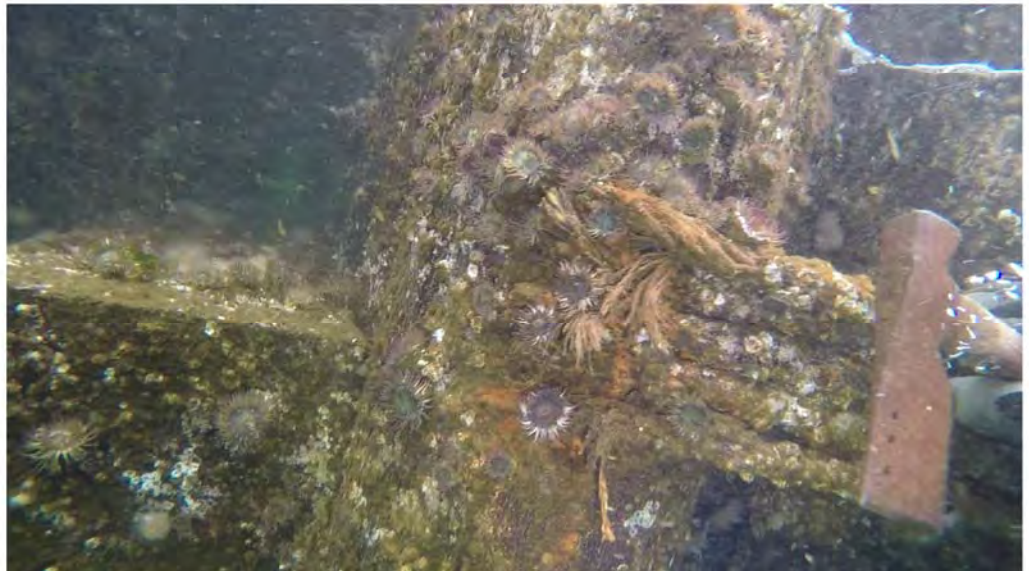
UW-7

In general, the timber wingwalls are in good condition underwater. The offshore end 5-pile groups on each wingwall have broken lower wraps (photos #UW-6 and -7). The right wingwall has one pile with MBE's noted near mudline (photos #UW-8 and -9). See attached Layout drawing and Pile Data Sheets for more information.

RWW end dolphin lower wraps broken

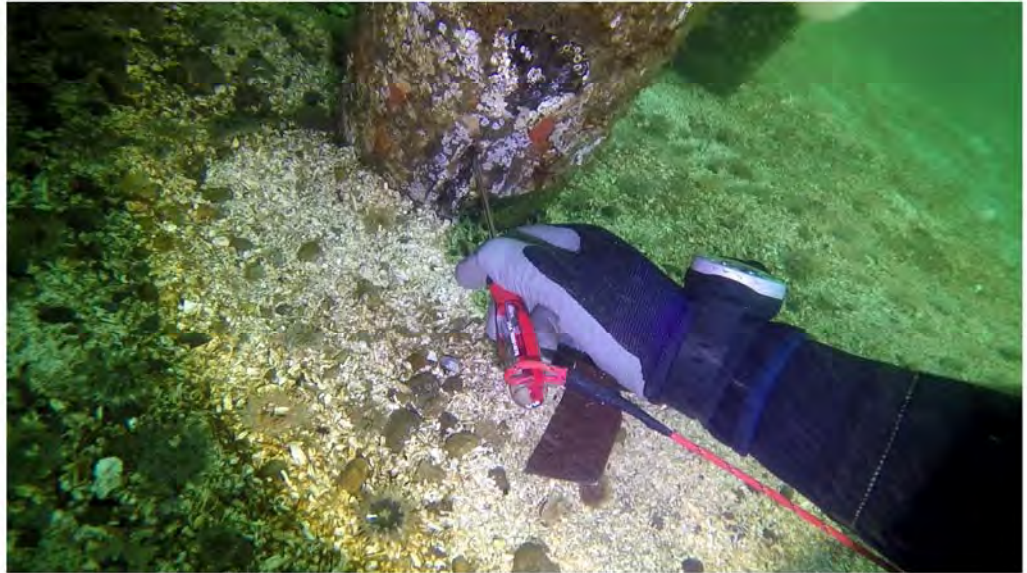
UW-8

8450 Timber Wingwalls
Photo Type: (none)
Orientation:
Date: 4/25/2017
Repairs:
RWW Pile 3I lower MBE defects

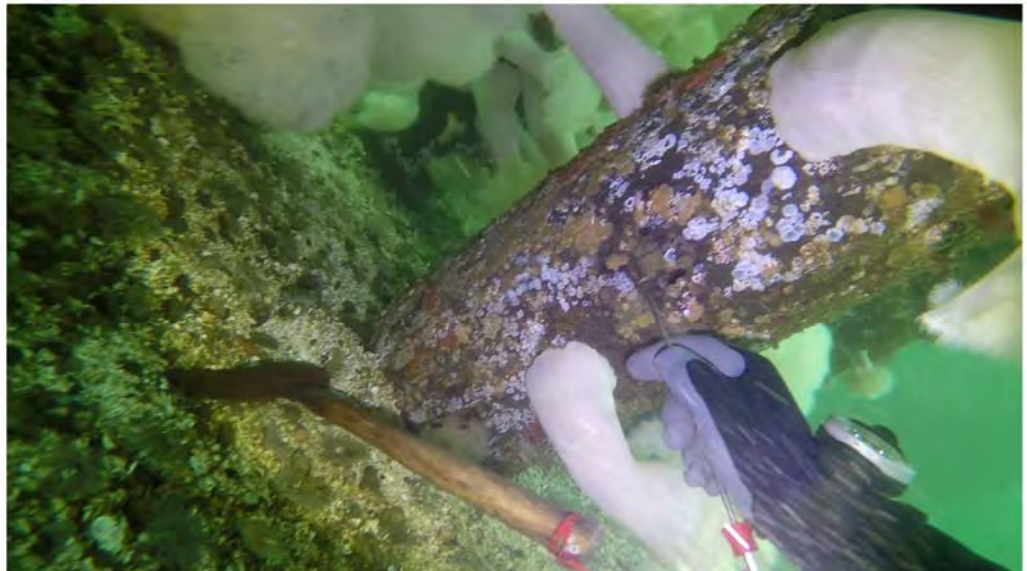
UW-9

8450 Timber Wingwalls
Photo Type: (none)
Orientation:
Date: 4/25/2017
Repairs:
RWW Pile 3I upper MBE defects

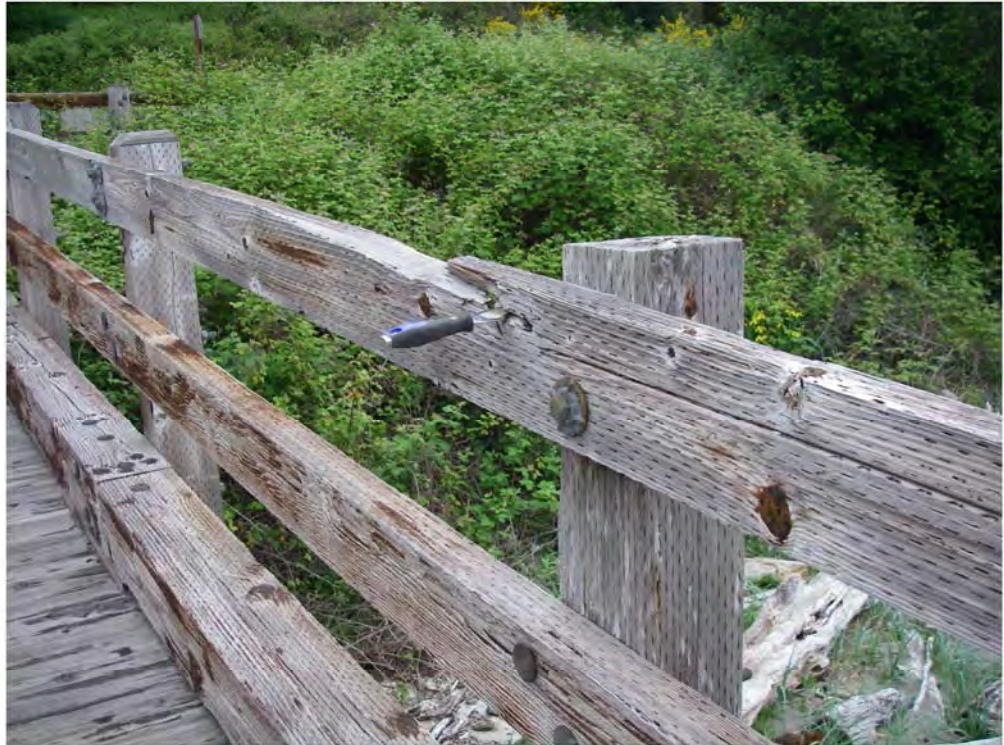
Left Timber rail is split and splintered (photo #30). REPAIR #10003.

Left Timber rail is split and splintered.
Treated timber 2-1/2" x 7" x 32'-0" long.

10003	2	B	Left Timber rail is split and splintered. Replace treated timber 2-1/2" x 7" x 32'-0" long.	8812	5/20/2013		
10004	2	B	Many of the timber deck hold down bolts are loose. Tighten bolts.	8221	5/20/2013		
10005	2	B	Girder hold down brackets are rusty. Girder 4D at Pier 4 hold down plate has holed through. Clean, paint, or replace as needed.	8114	5/20/2013		
10006	1	B	The left timber wingwall UHMW protection is missing or in poor shape in the lower half. The right timber wingwall is missing several UHMW sheets missing. Repair wingwalls, replace any rotten timbers and missing or unattached UHMW protection.	8450	5/20/2013		
10007	1	B	Boat tie up connections are heavily pitted. Replace loops.	8348	4/21/2015		
10008	2	B	The perforated metal plates near the top of the approach are loose, and slip under heavy traffic. Add, replace, and/or tighten hold down bolts.	8221	4/25/2017		
10009	3	B	Install a thimble on the apron counterweight cable, where it connects to the apron.	8348	4/25/2017

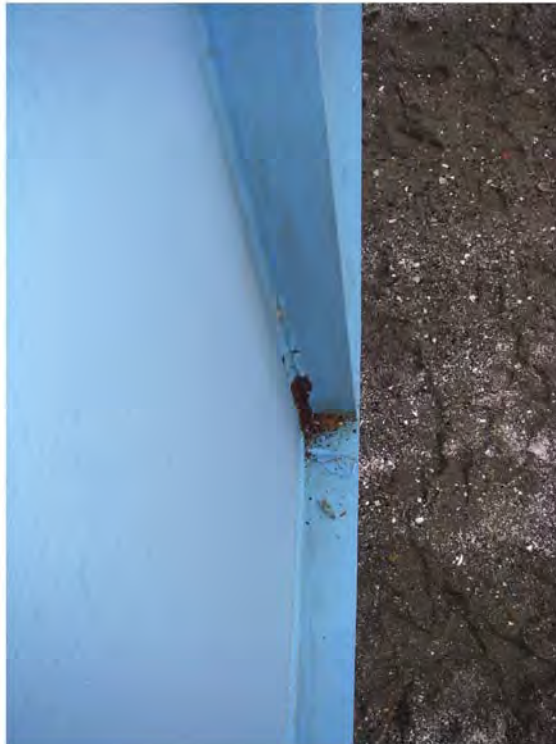
SI-8

The paint in the bottom laterals, stringers, bearings, lift beam, steel headframe, open girders, and floorbeams of transfer span have some rust blooms (photos #8, #9, #34, #39, and #51- #56). REPAIR #10000.

The right side girder at Floorbeam 3 has
a rust bloom in the exterior face of the
web with some light rust pitting.

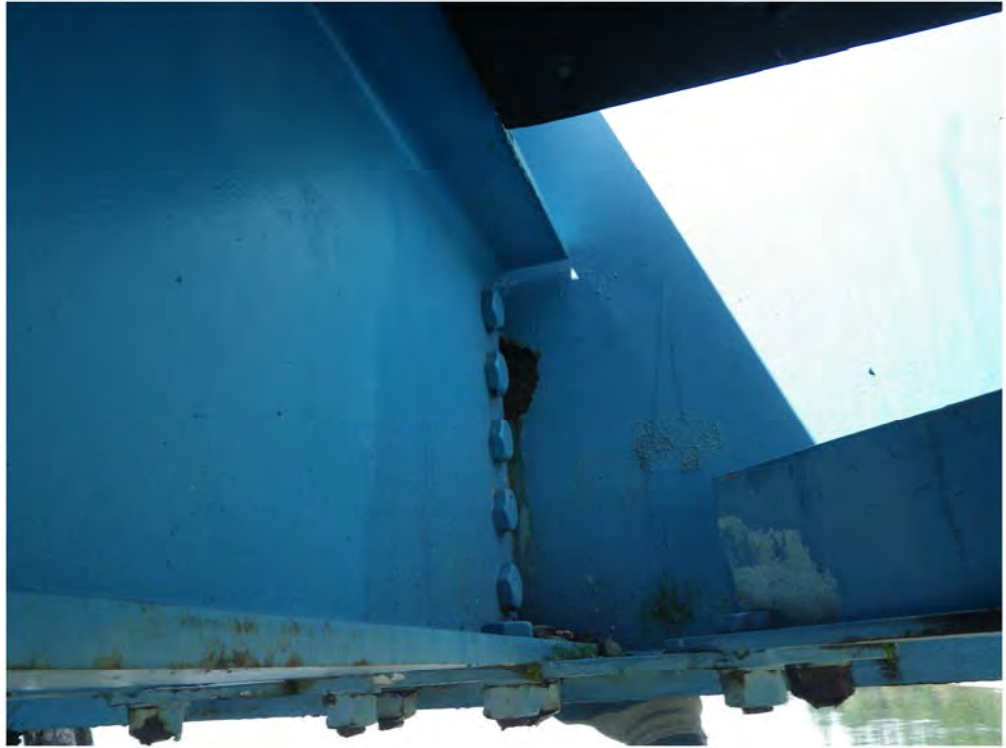
The right side girder at Floorbeam 6 has a 3" diameter rust bloom in the web with section loss 1/16" deep.

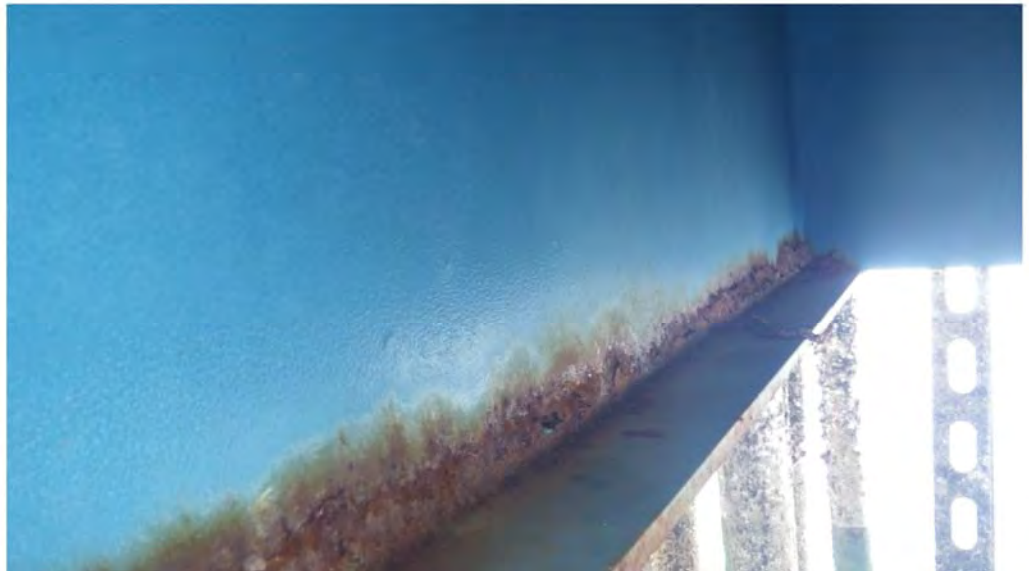
SI-34

The Lift Beam has laminar rust on the shore side girder interior web to bottom flange (element 8901 photo #34). Laminar rust is beginning to form on the bottom cover plate near the live load hangers. REPAIR #10000.

The Lift Beam has laminar rust on the shore side interior web.

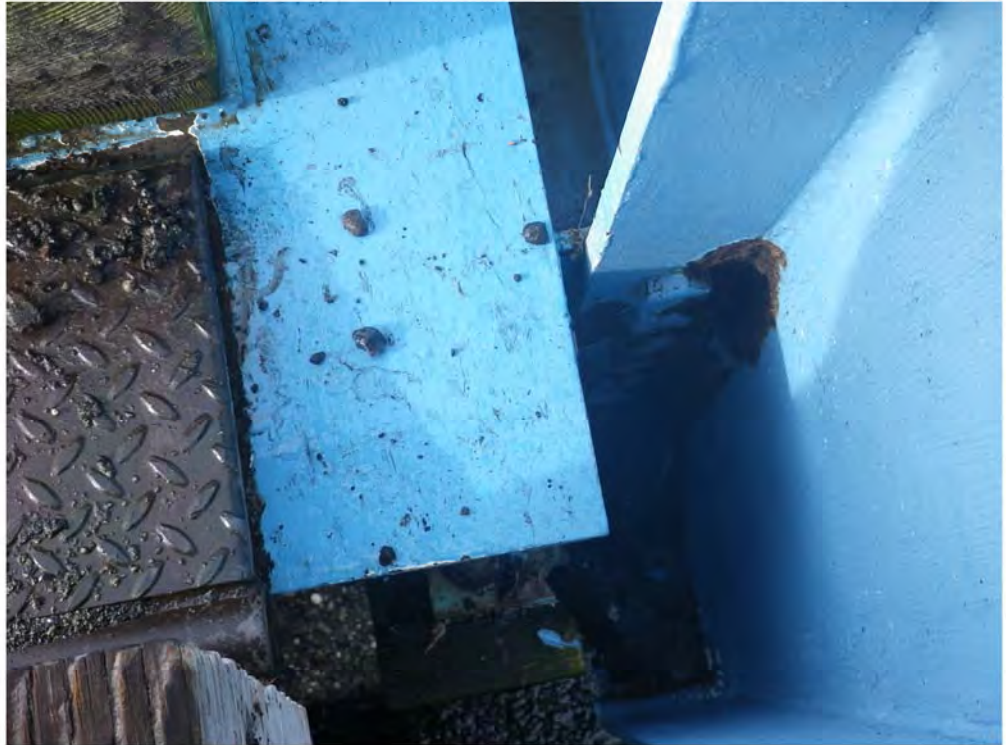
The right side girder at Floorbeam 0 has laminar rust above the bearing, at the stiffener weld.

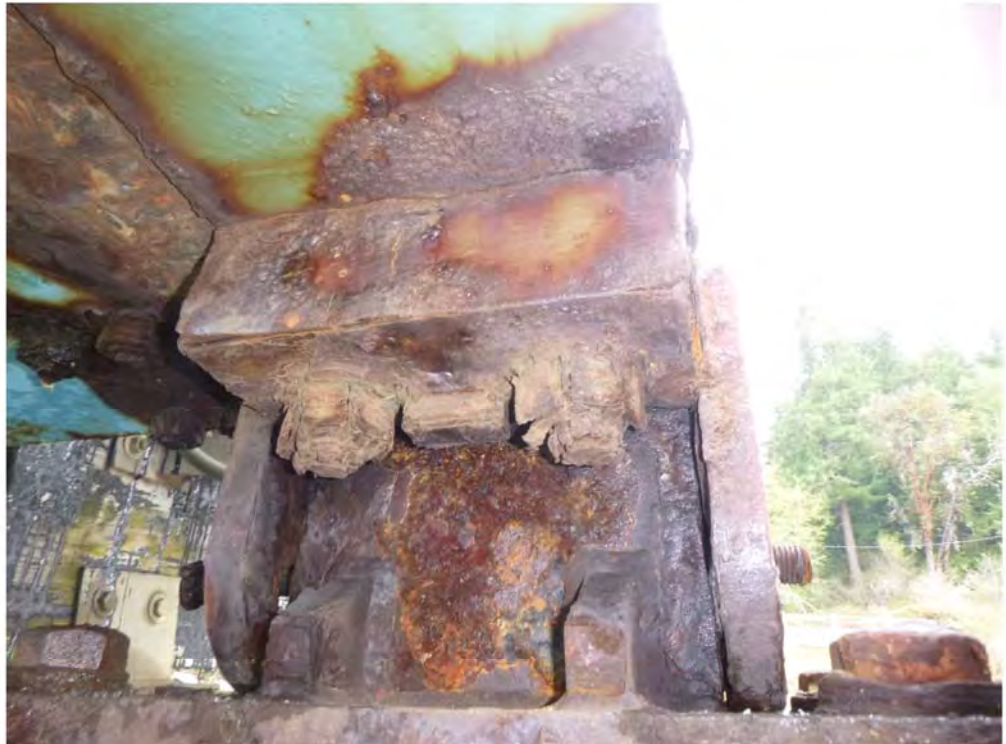
SI-51

Pier 4 transfer span right bearing paint has failed and steel is corroding.

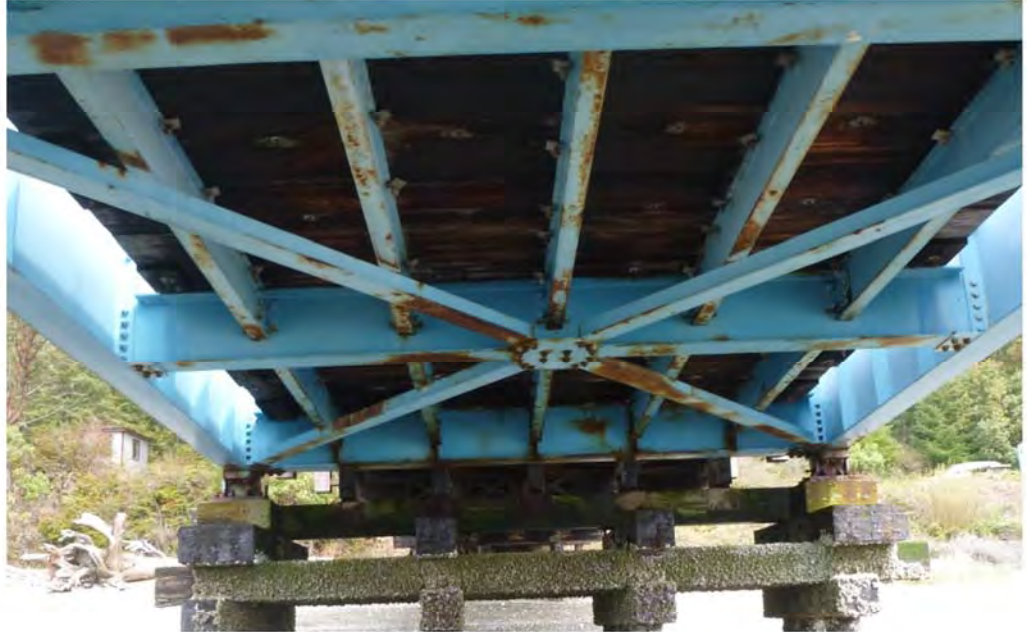
Transfer span Bay 1 and 2 paint is failing throughout.

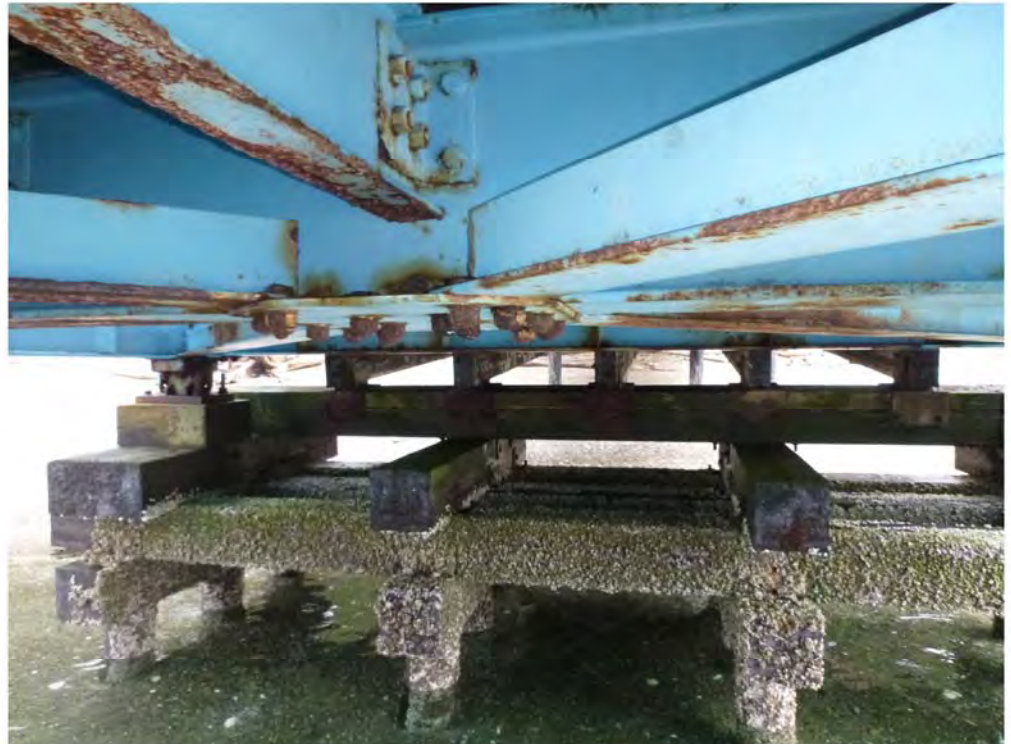
SI-53

Transfer span Bay 2 paint is failing on bottom laterals, floorbeams, and stringers.

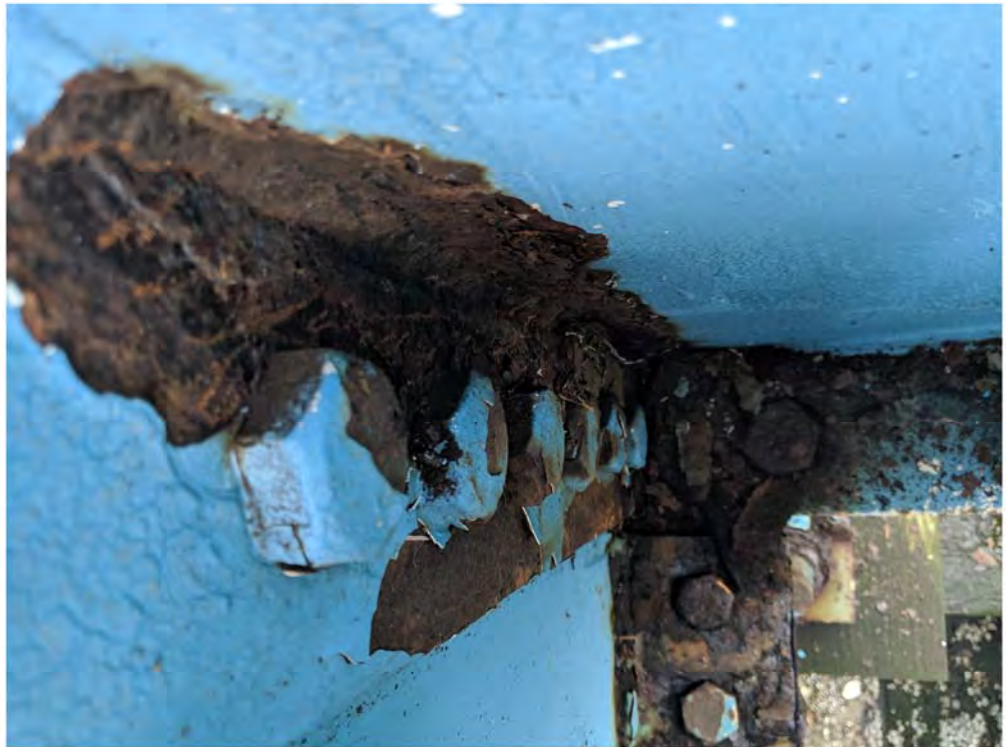
FB 0 right side connection to the right steel girder has a rust bloom with minor section loss.

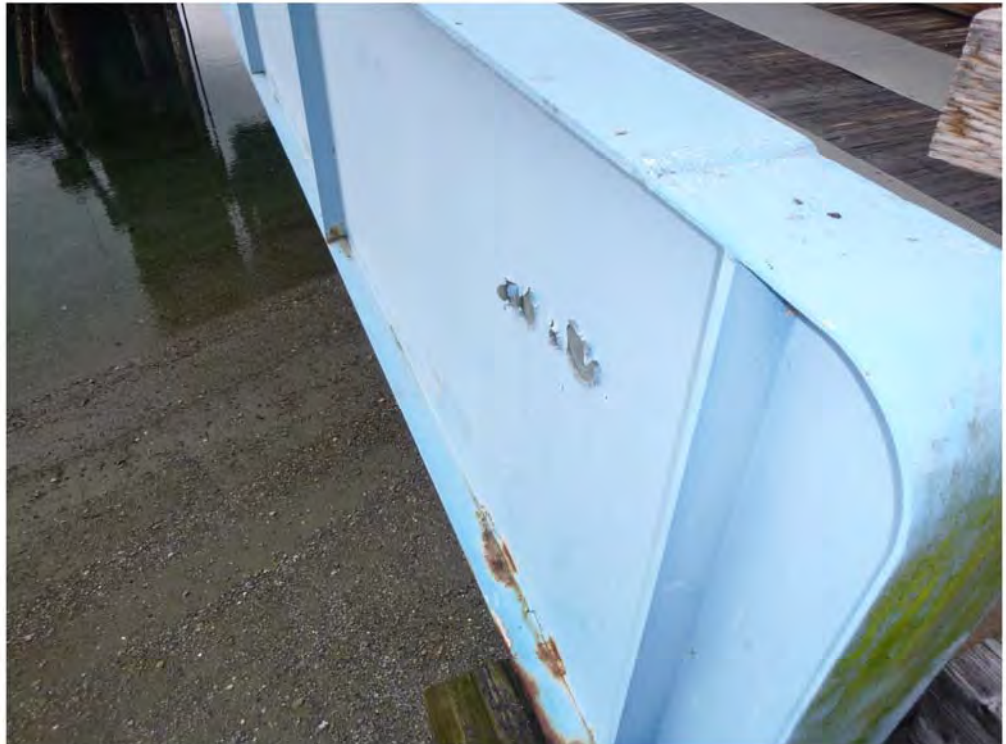
SI-55

The left open girder bottom flange has rust blooms with minor section loss near Floorbeam 0.

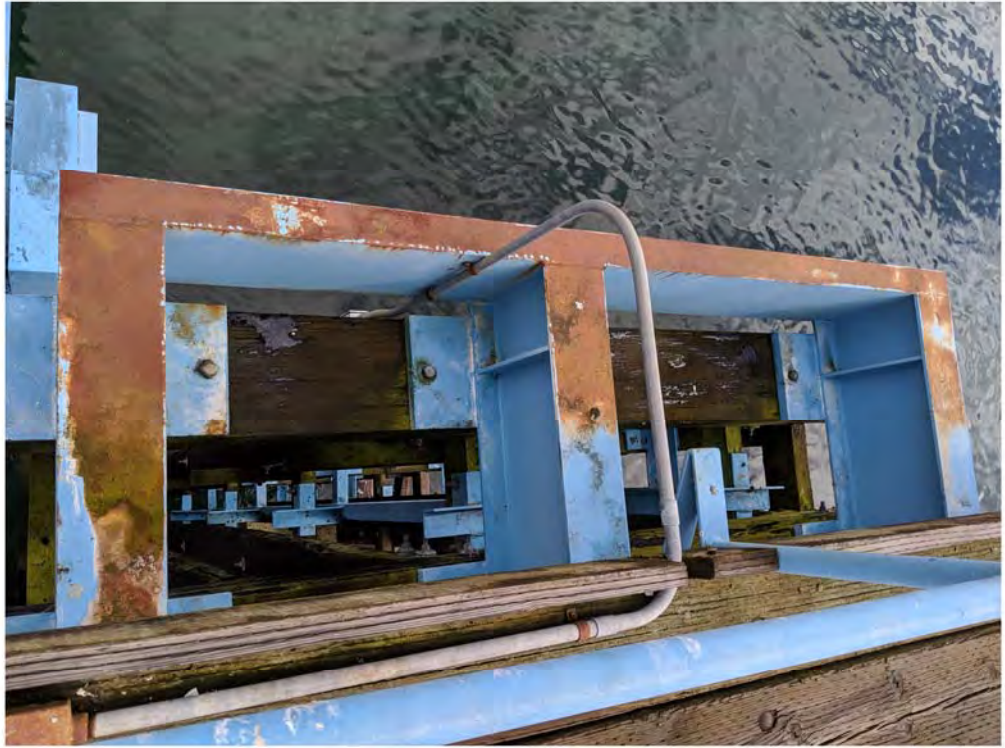
Paint failure on top of head frame above left tower.

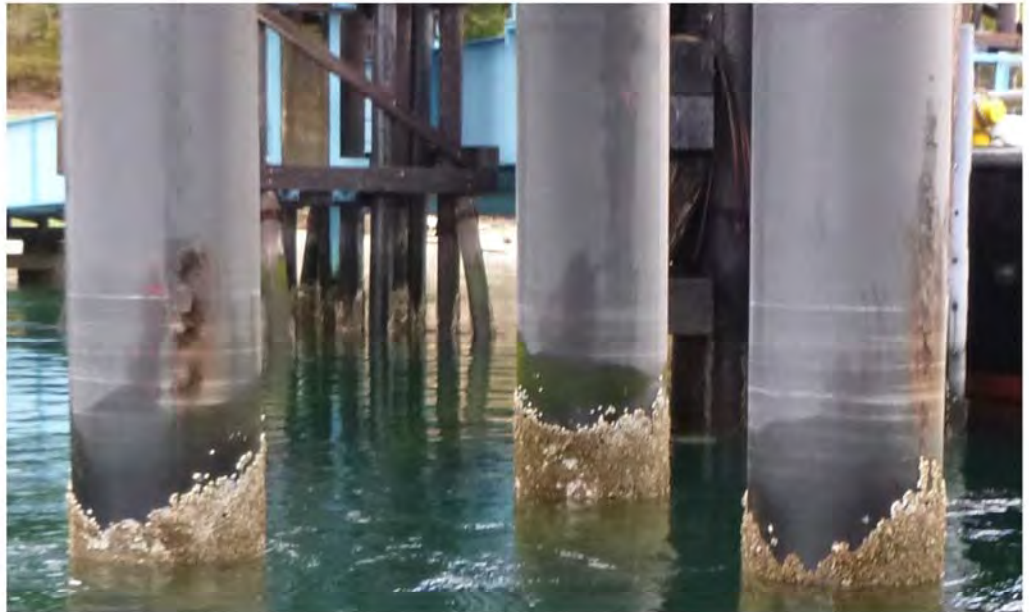
SI-45

The 2' diameter steel piles making up the Left and Right Dolphins have rust blooms starting in the intertidal zone (photo #45).

The 2' diameter steel piles making up the Left and Right Dolphins have rust blooms starting in the intertidal zone.

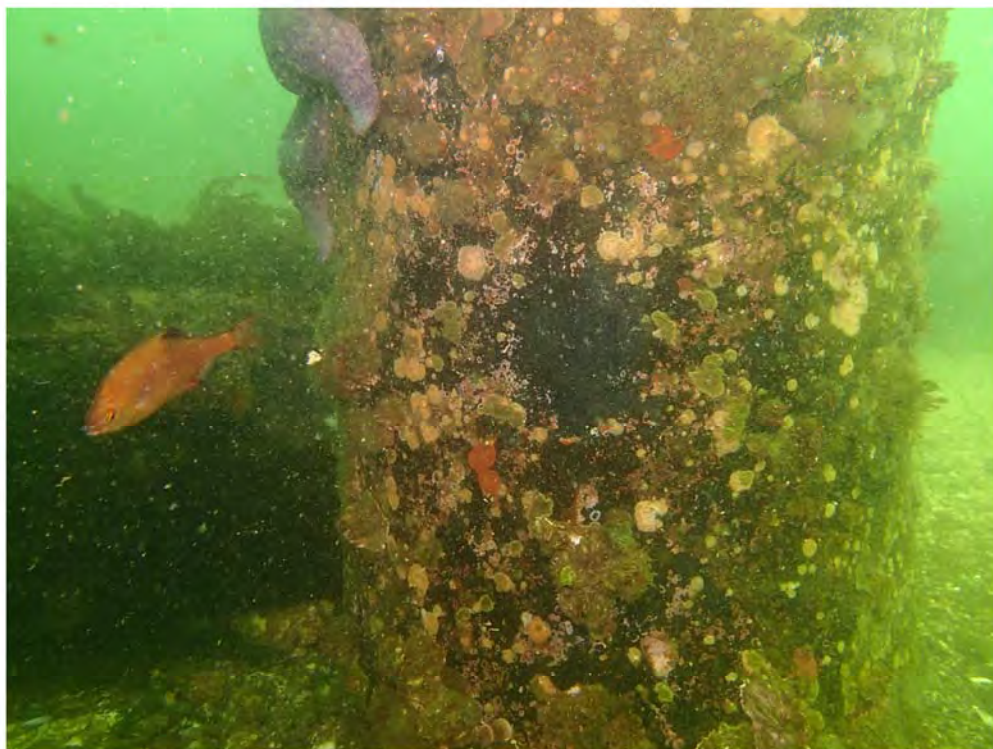
Coatings are largely intact with only minor blistering noted in small areas (photos #UW-10, -11, & -12). No corrosion observed. See Layout and Pile Data Sheets for thickness measurements.

Left Dolphin Pile 2C. Typical condition of steel dolphin piles.

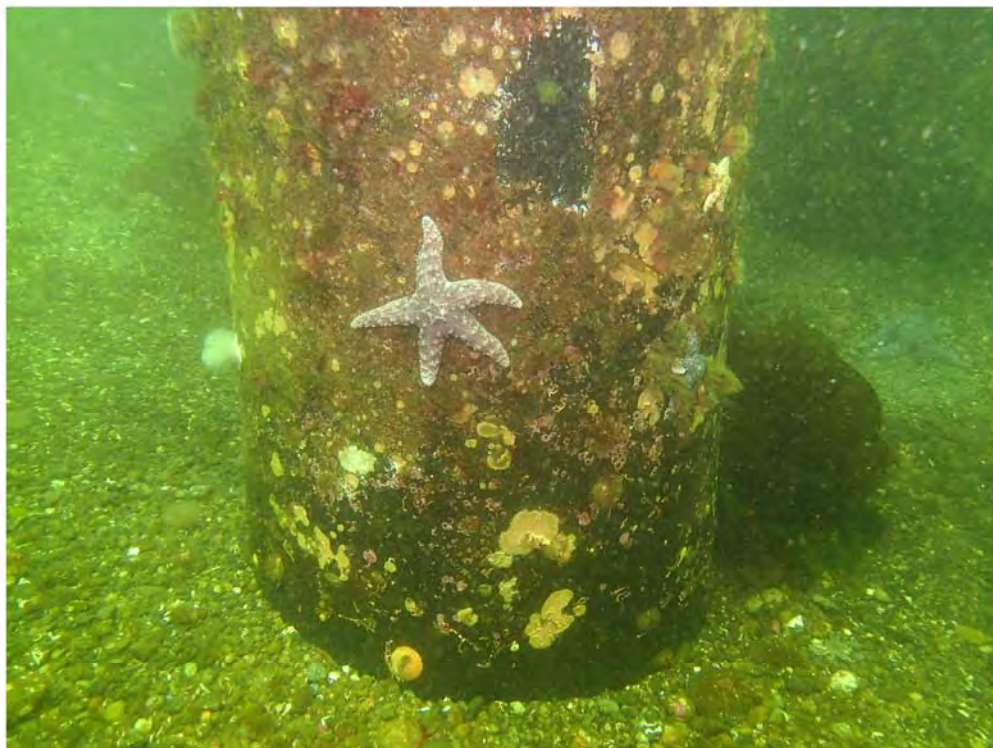
UW-11

Right dolphin Pile 4C. Coating intact.

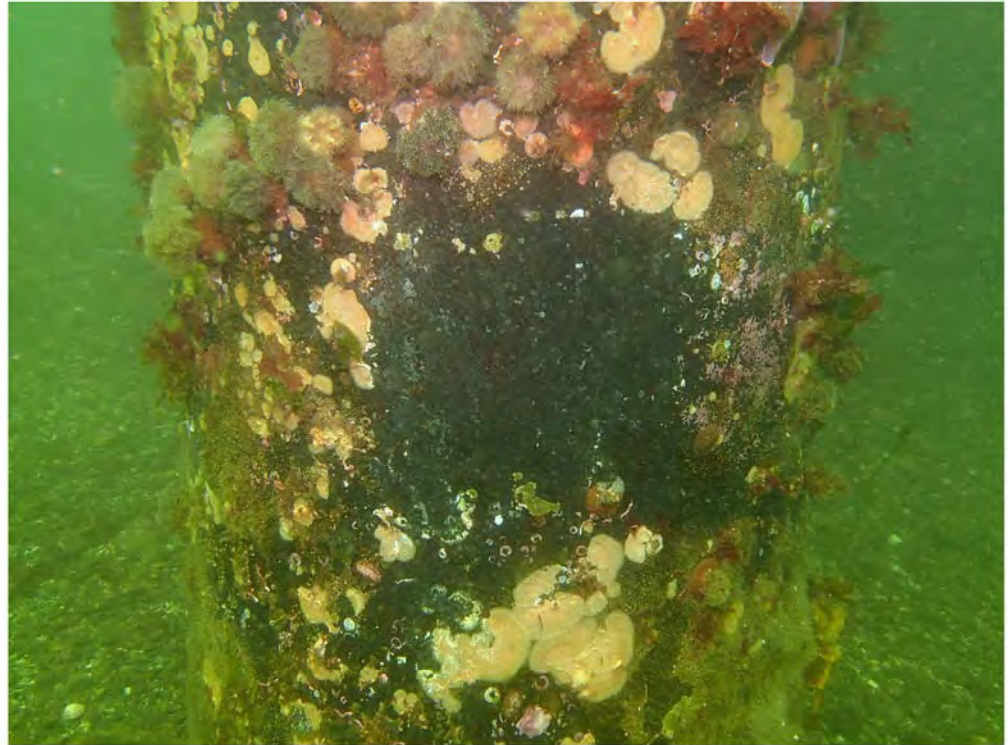
Right dolphin Pile FR9. Typical condition; coatings intact with moderate marine growth coverage.
