BRIDGE INSPECTION REPORT

Br. No. DOC-6

SID 00200441

Br. Name MCNEIL IS. STILL HARBOR DOCK

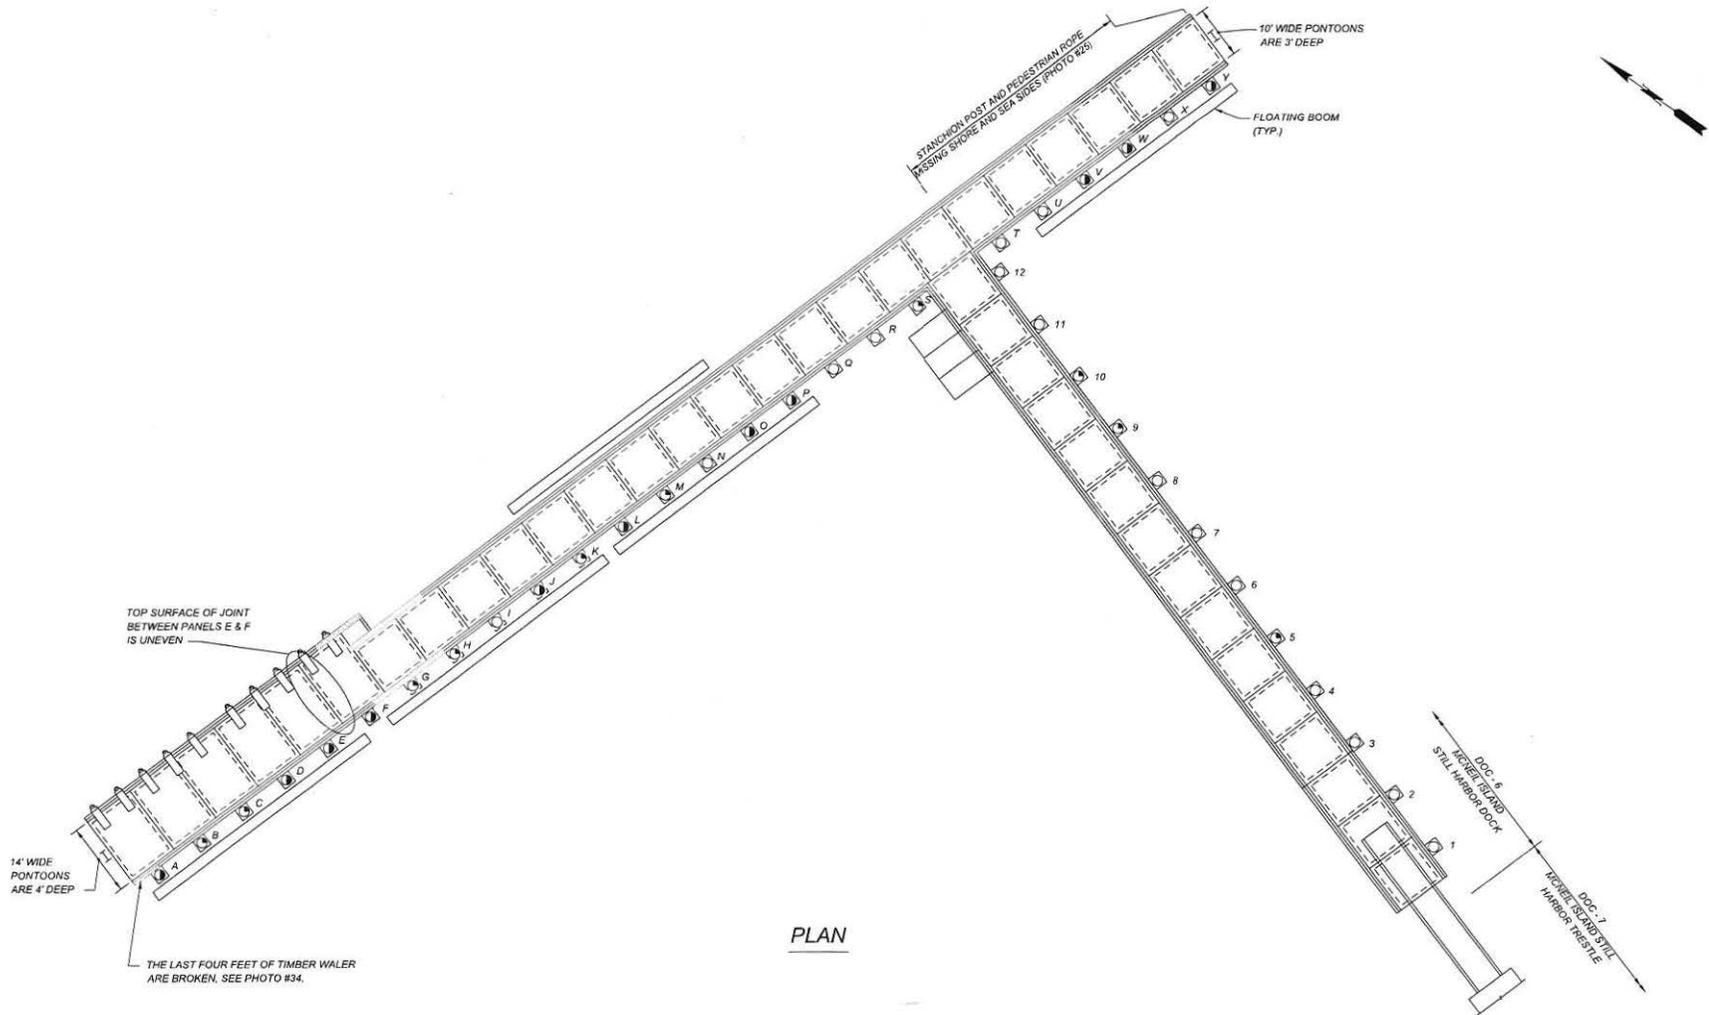
LAYOUT

The McNeil Island Still Harbor Dock includes the concrete floats, gangplank, and the steel spud piles.
 For location reference: Offshore is north, shore is south, left side is west, and right side is east. Defects on piles are called out in clock direction where 6:00 is facing onshore and 12:00 is offshore.
 See the attached Layout drawing for reference and Pile Inspection Data spreadsheet for additional findings.

There are two lines of spud/guide piles, 1 - 12 and A - Y. Assume each line is a bent or pier.

See attached Layout drawing for details.

See attached Layout drawing and Pile Data spreadsheet for detailed defect descriptions and locations.

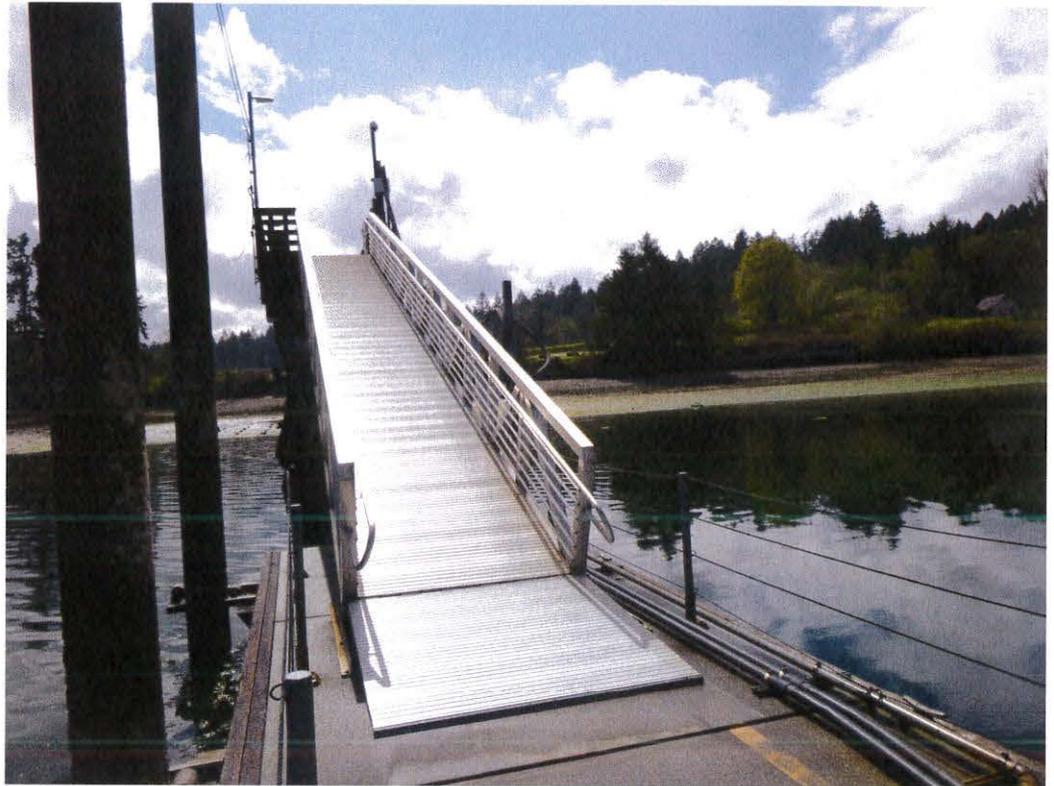
SI-31

Gangplank to floating pontoons.

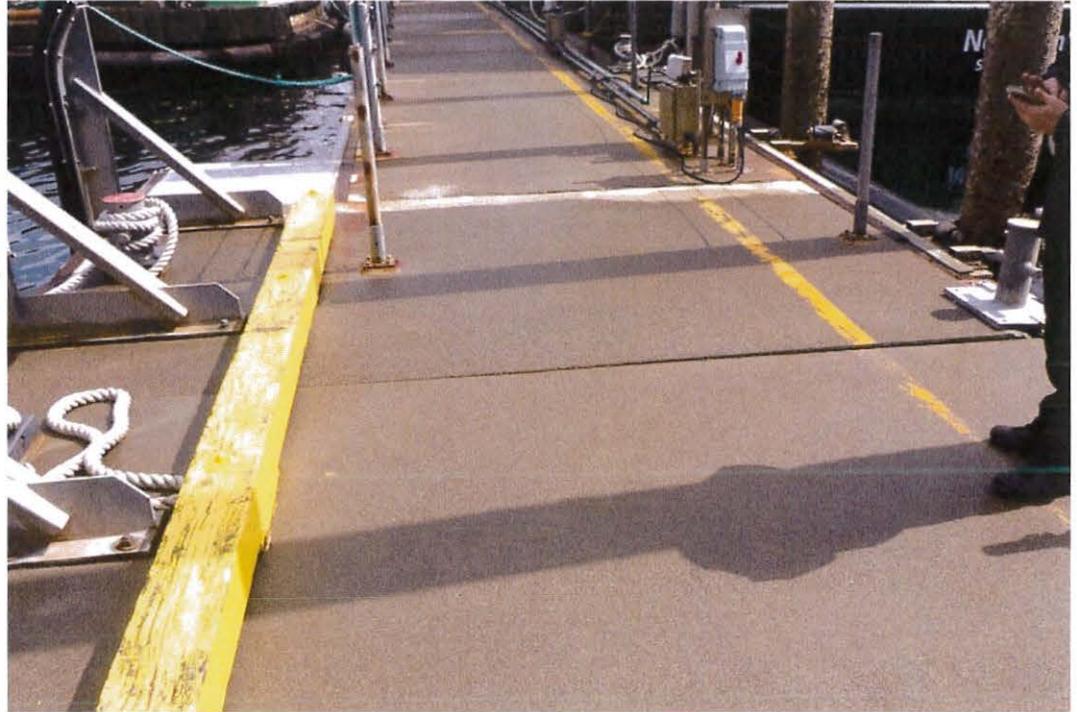
SI-28

Top surface of joint between panels E & F is uneven up to 1".

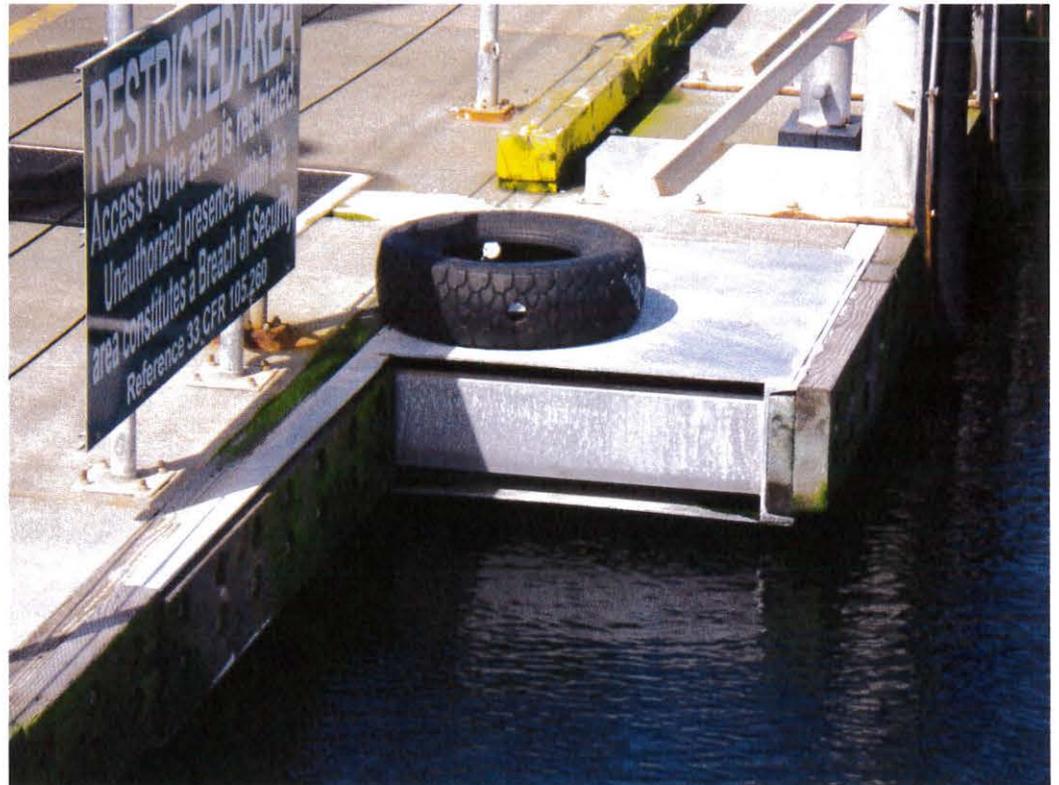
SI-26

Joint connecting pontoons F and G has been built up with stiffening plate and steel channels have been added in addition to replacing the timber walers.

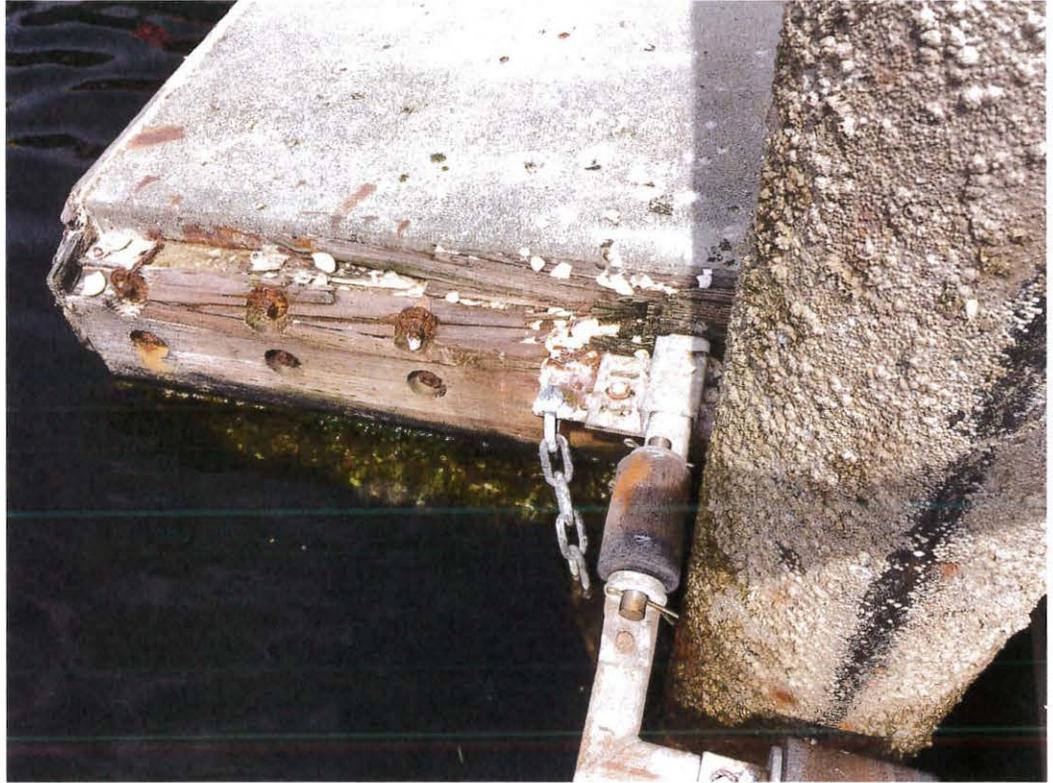
SI-34

Near Spud Pile A, the last four feet of the timber waler are broken.

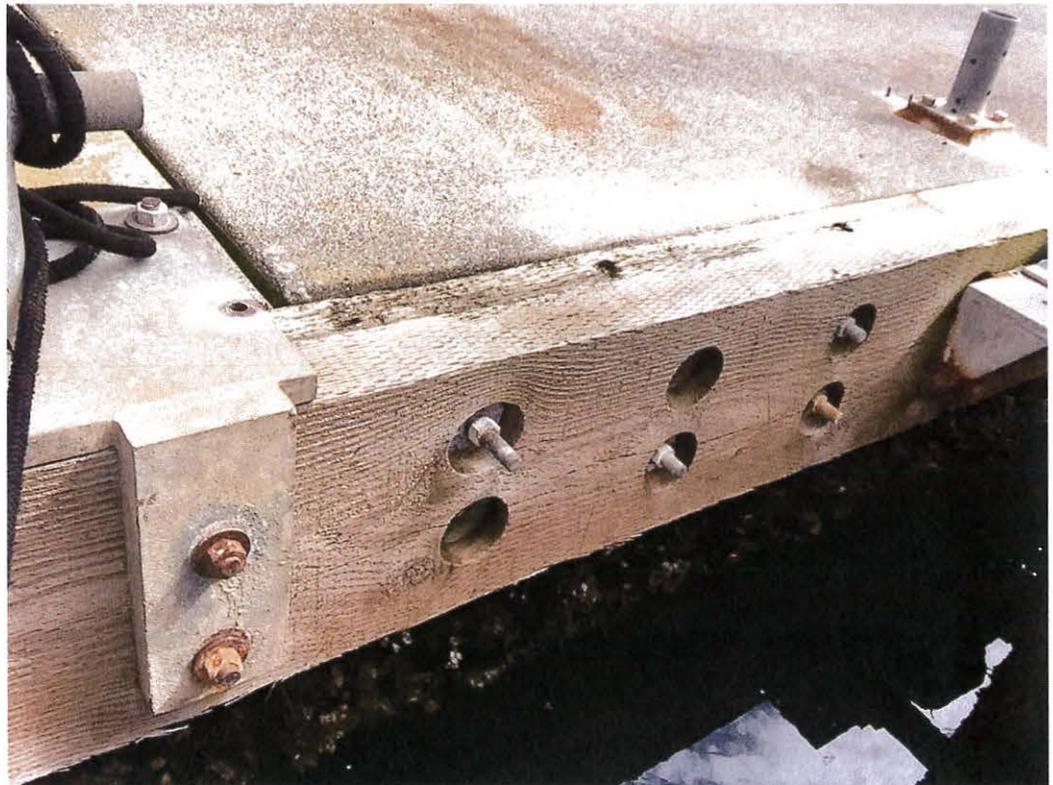
SI-33

Many of the through bolts holding the timber walers have been replaced. Some are still missing in several pontoon segments.

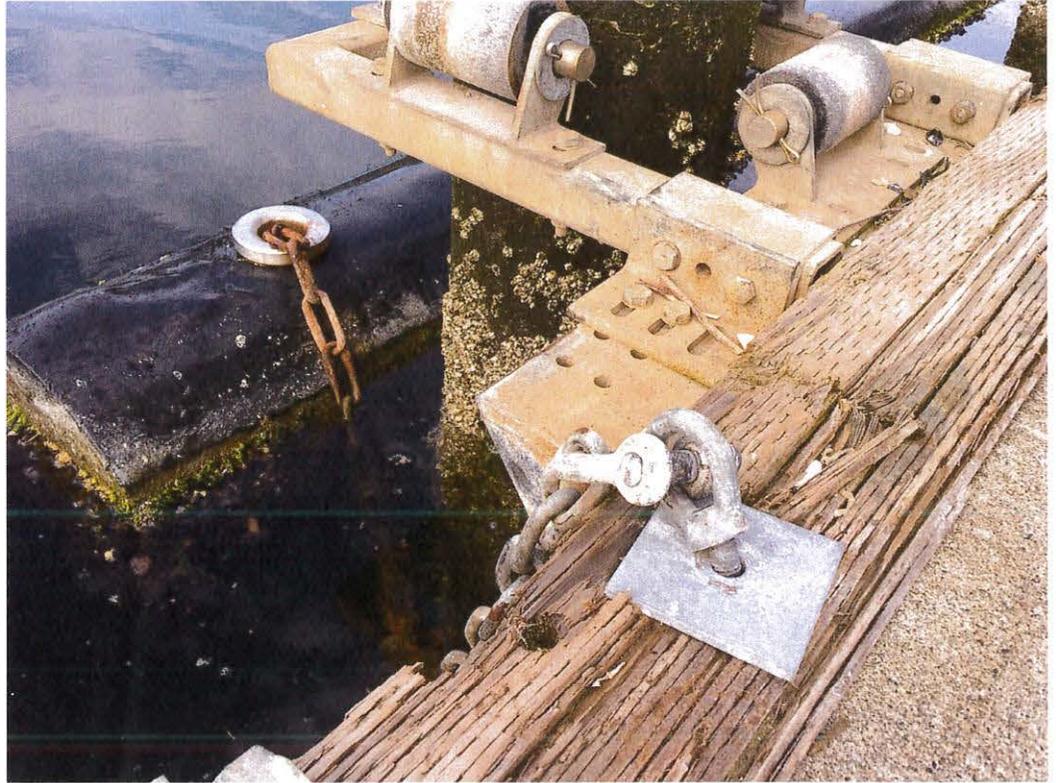
SI-35

The floating dock concrete segments are held together with timber walers side mounted and through bolted. These provide a fairly rigid connection between the docks and provide a rub face for docked vessels. Winter storms have caused breakage of the timber walers.
 Joint between panels E & F to be uneven up to 1" (photo #28).
 Joint connecting Pontoons F and G has been built up with a horizontal stiffening plate and steel channels in addition to replacing the timber walers (photo #26) (CS 2).
 The last four feet of timber waler near Spud Pile A is broken (photo #34).
 Many of the timber waler through bolts have been replaced. There are still some missing near Piles U and V (photo #33).
 Eyelets securing log fenders are distressed and bent (photo #35). REPAIR #10004.
 See the attached layout and photos for more details.

Eyebolts securing log fenders are distressed and bent.

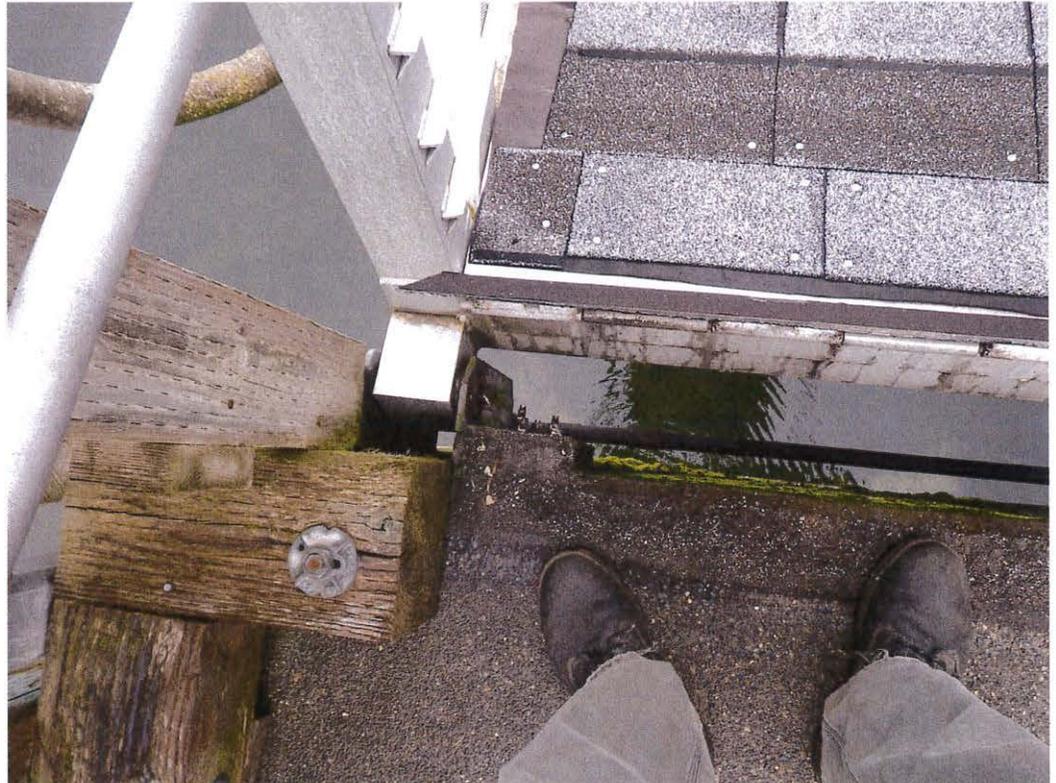
SI-10

Fixed bearings located at top gangplank connection to the concrete pier (photo #10).

Fixed bearings located at top of gangplank connection to the concrete pier.

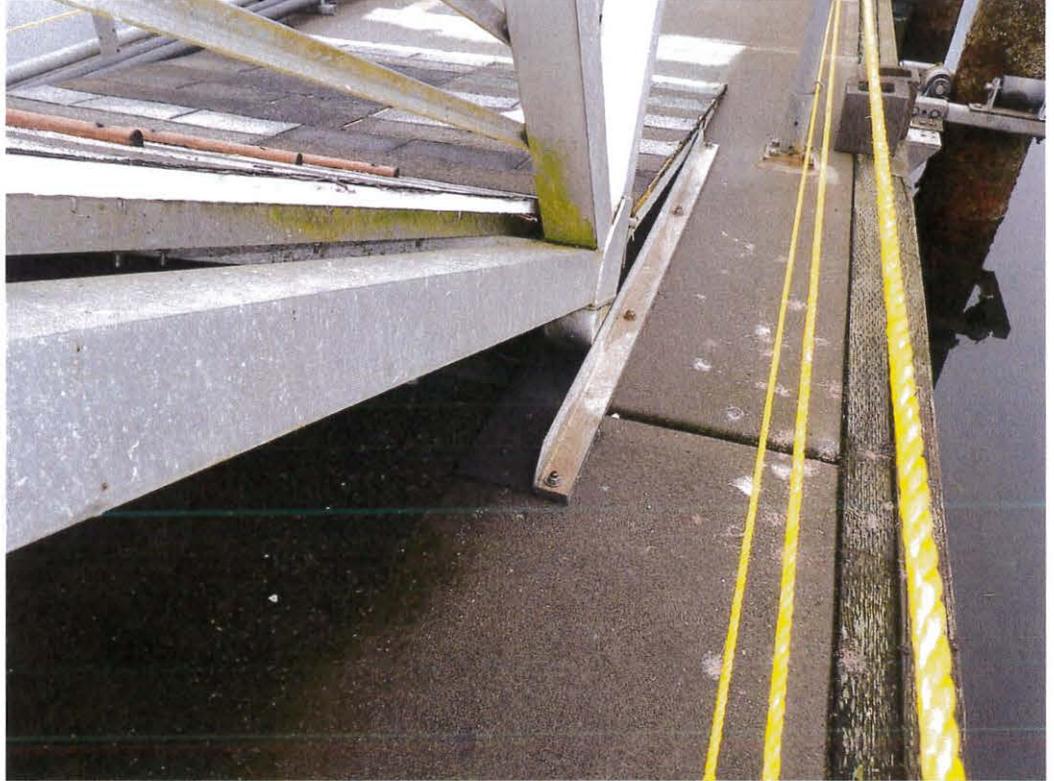
SI-11

Slider bearings located at the gangplank landing (photo #11).

Slider bearings located at the gangplank landing.

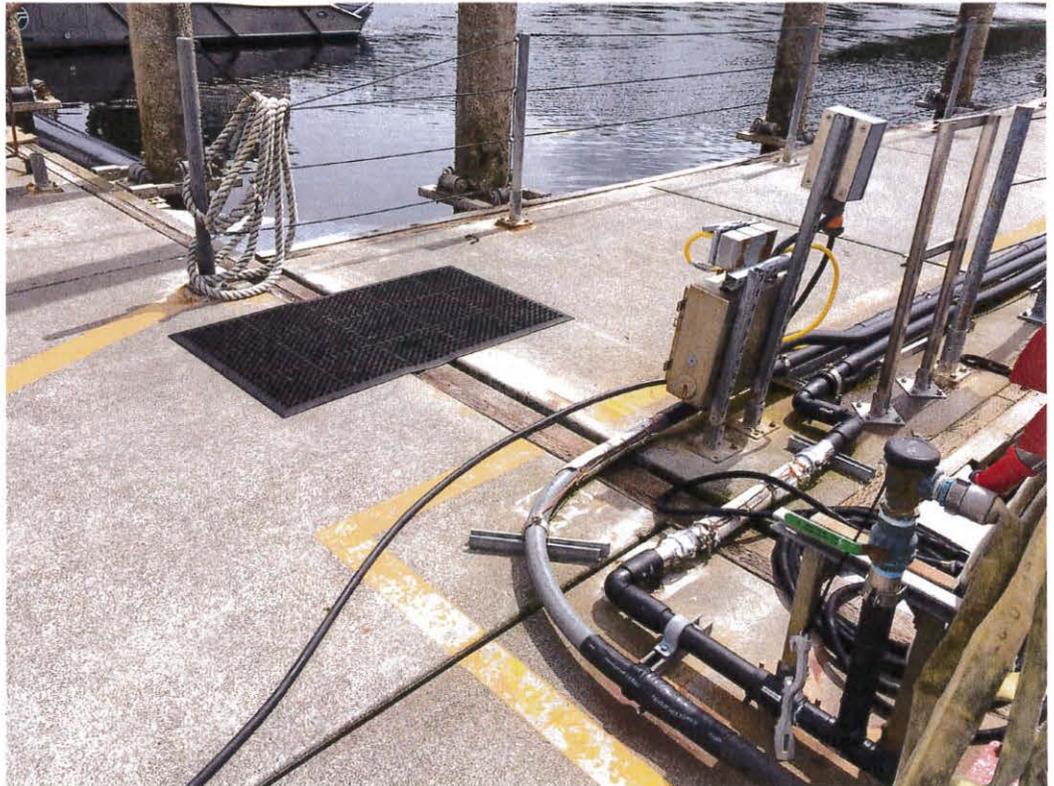
SI-36

8408 **STEEL SLIDING PLATE JOINT:**
Steel sliding joint at the top of the gangplank (element 8390, photo #10) Steel plate at the Pontoon T has been removed and no longer coded (photo #36).

Steel plate joint has been replaced with rubber mat.

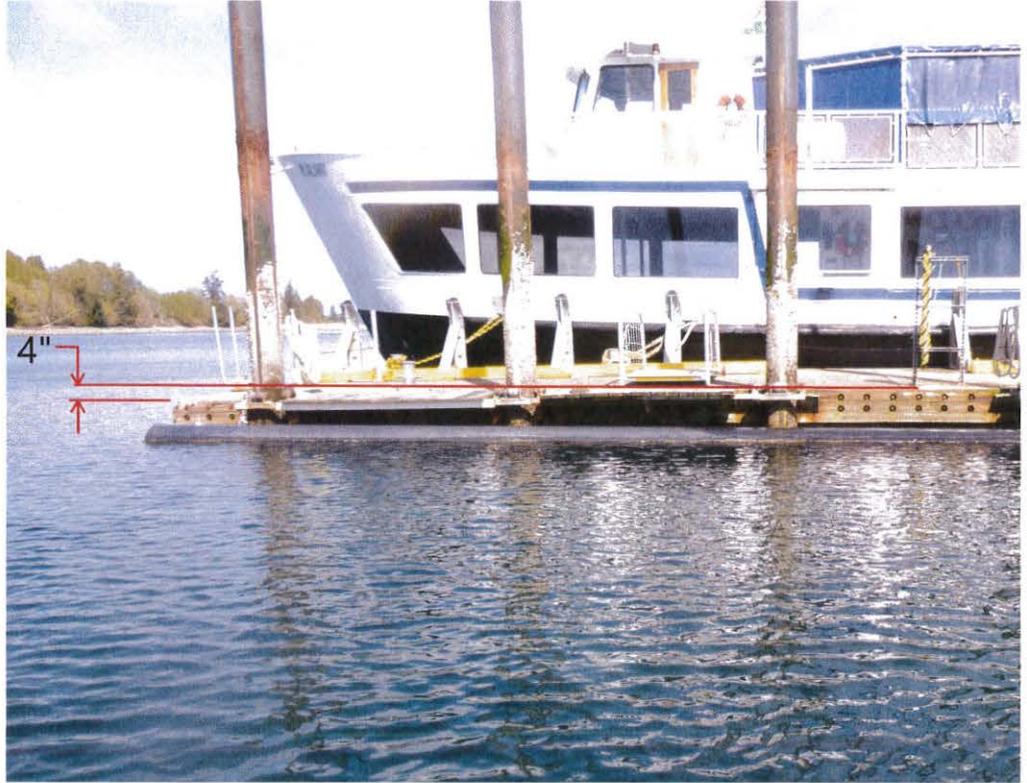
SI-29

Dock lists 4" down from Panel C to the end of Panel A.

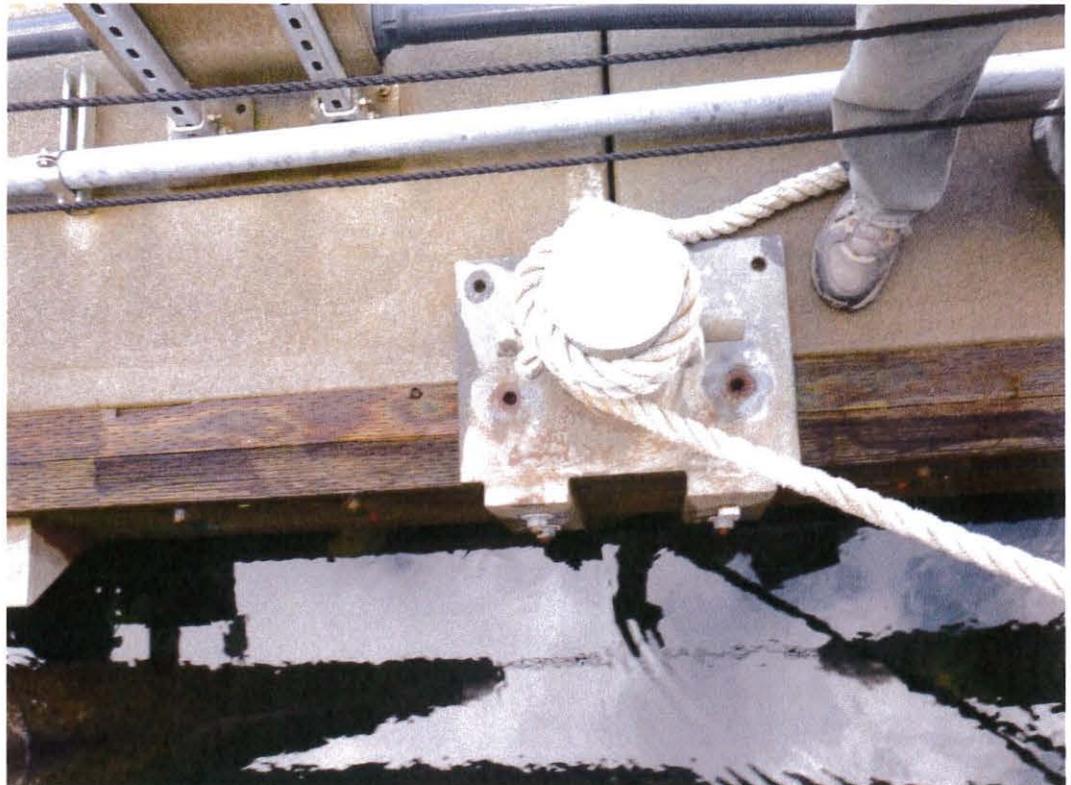
SI-30

At the M-N joint shore side, the boat tie off cleat is bolted only to the timber walers.

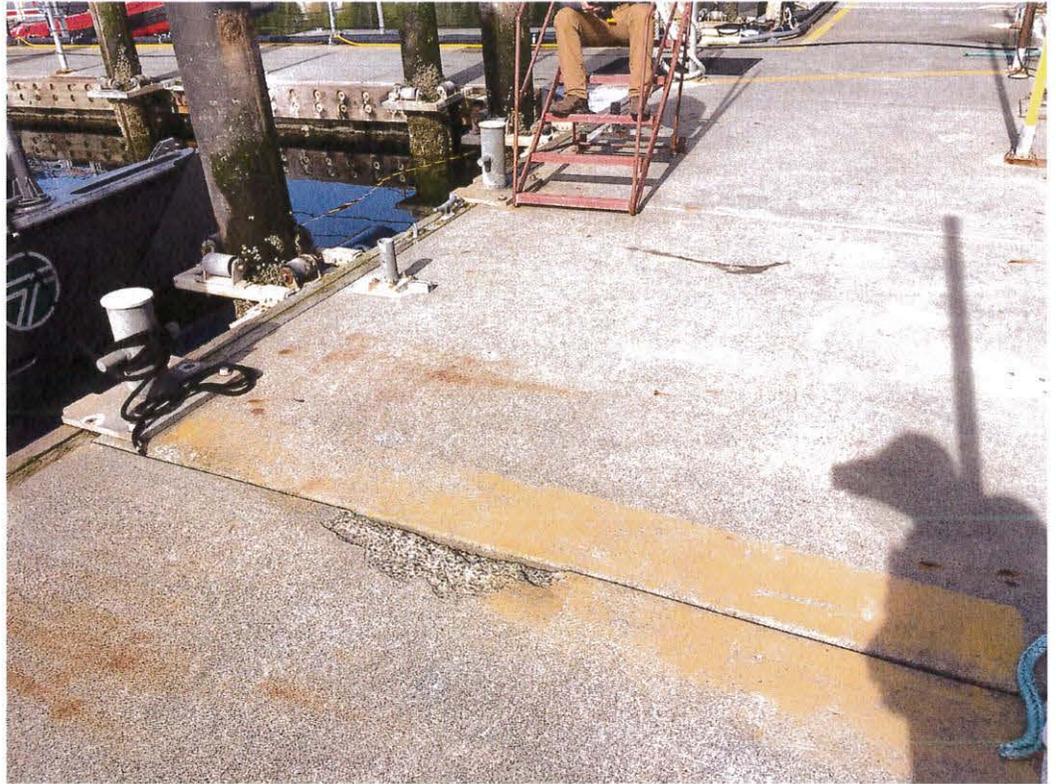
SI-32

The U-V joint has a 2.5" x 9" x 1" deep spall.

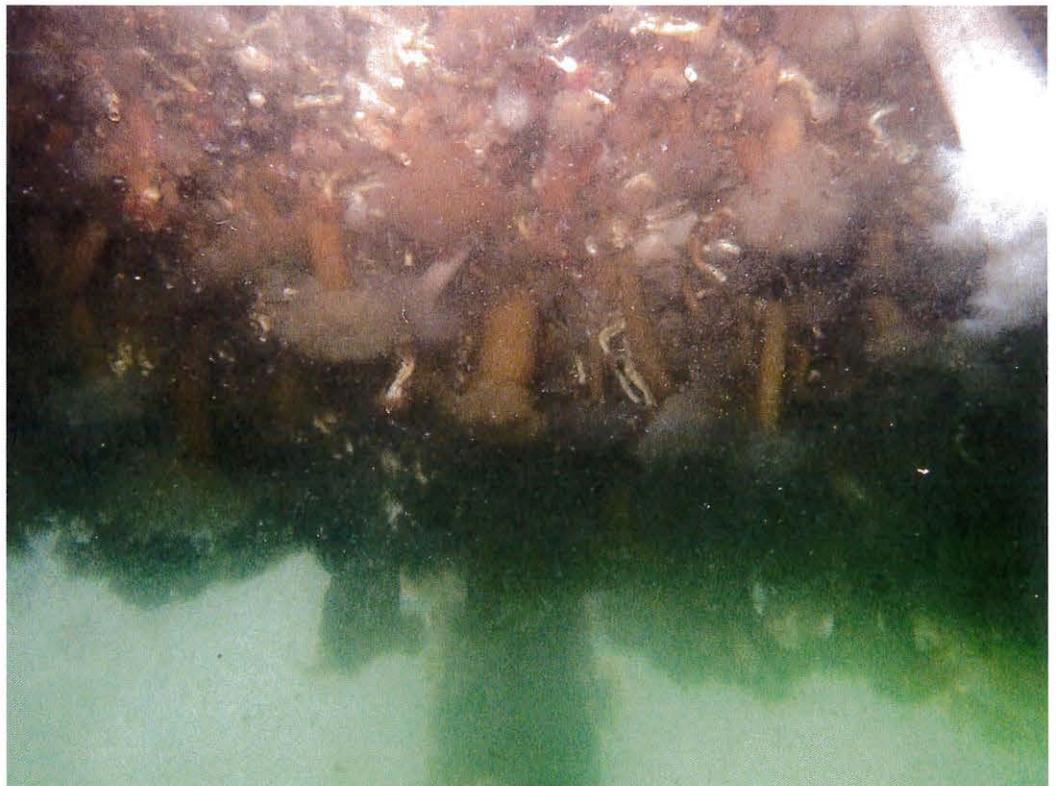
UW-1

Underwater Inspection Findings:
The submerged surfaces of the pontoons are covered in heavy marine growth, making a detailed inspection very difficult. Spot cleaning revealed no defects (Photo #UW-1).

Typical heavy marine growth on floating dock sections.

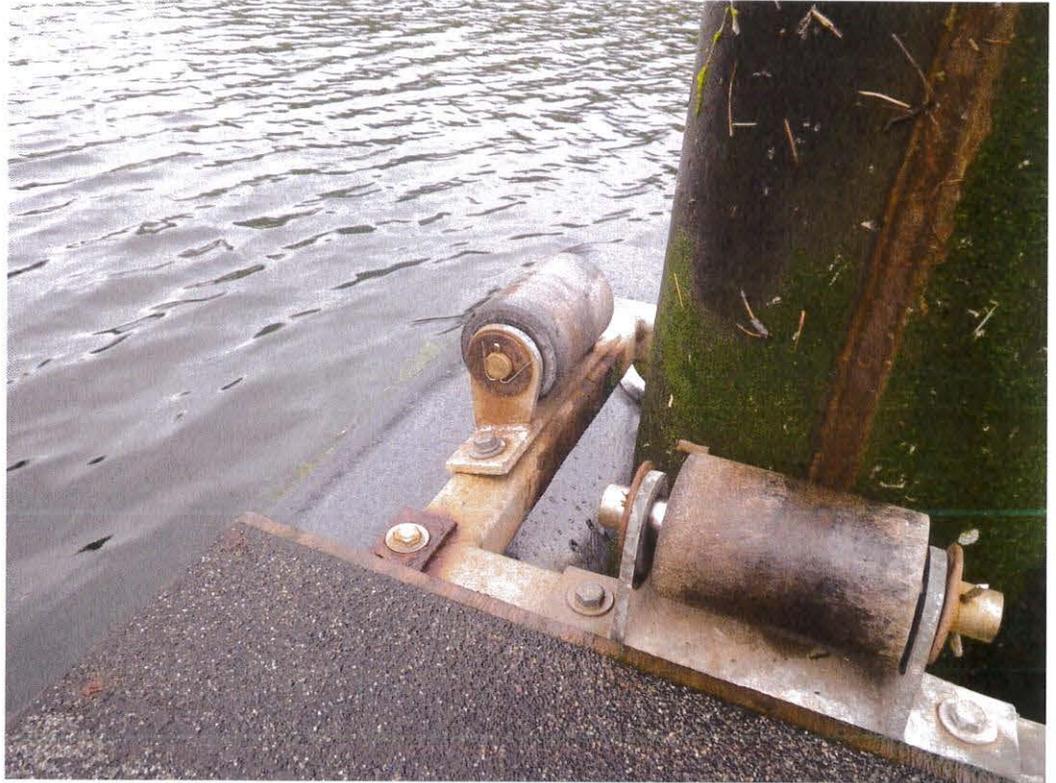
Spud pile rollers are all intact, some are bent from storm events.

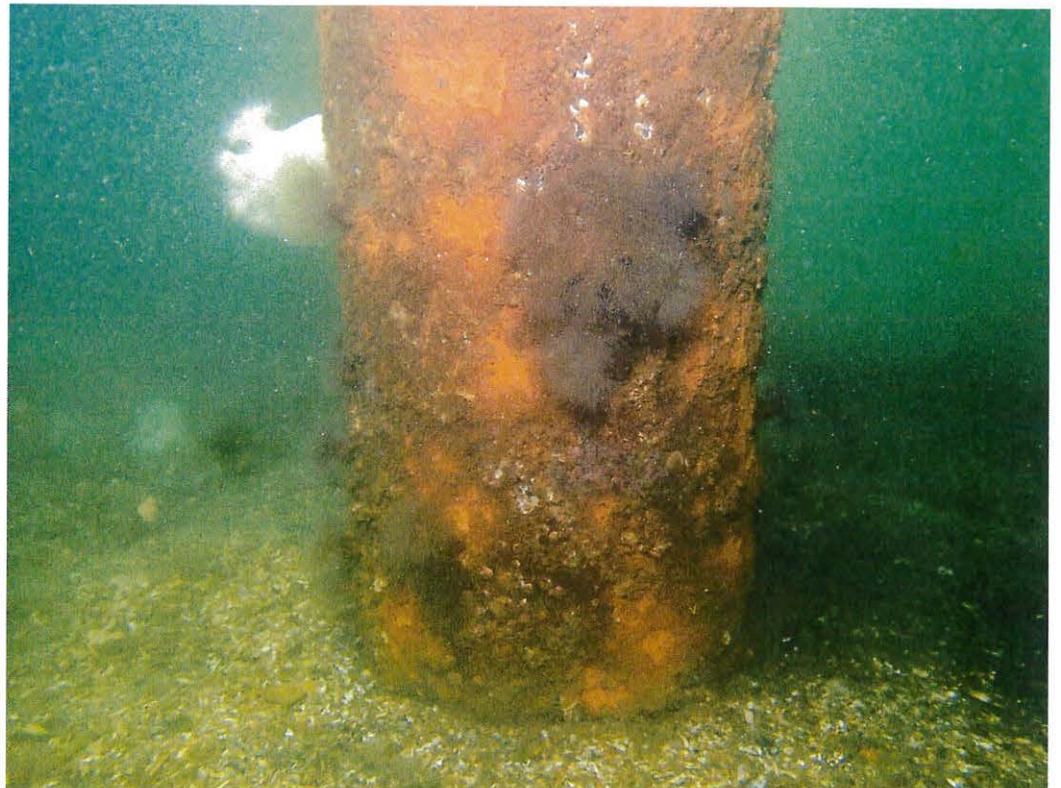
UW-2

Ten spud piles (Piles 5, 9, 10, B, C, G, H, K, M, and S) have section loss, but do not currently threaten the performance of the pontoon positioning system (Photo #UW-2).

T-dock Pile S; general coating failure and rusting with section loss. Typical of T-dock piles.

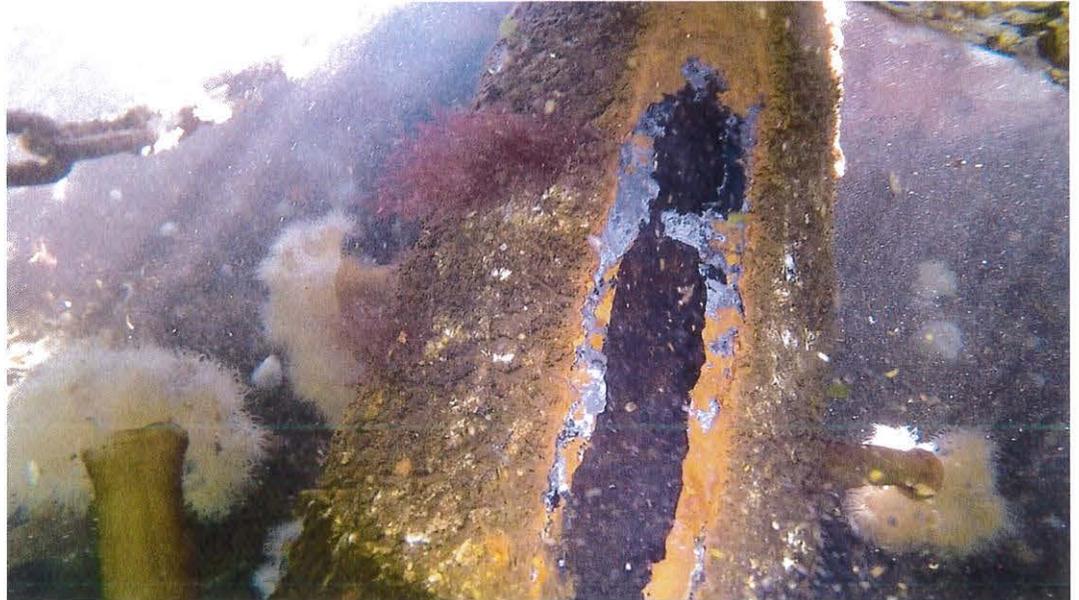
T-dock, Pile A: 18" H x 4" W hole from mechanical damage.

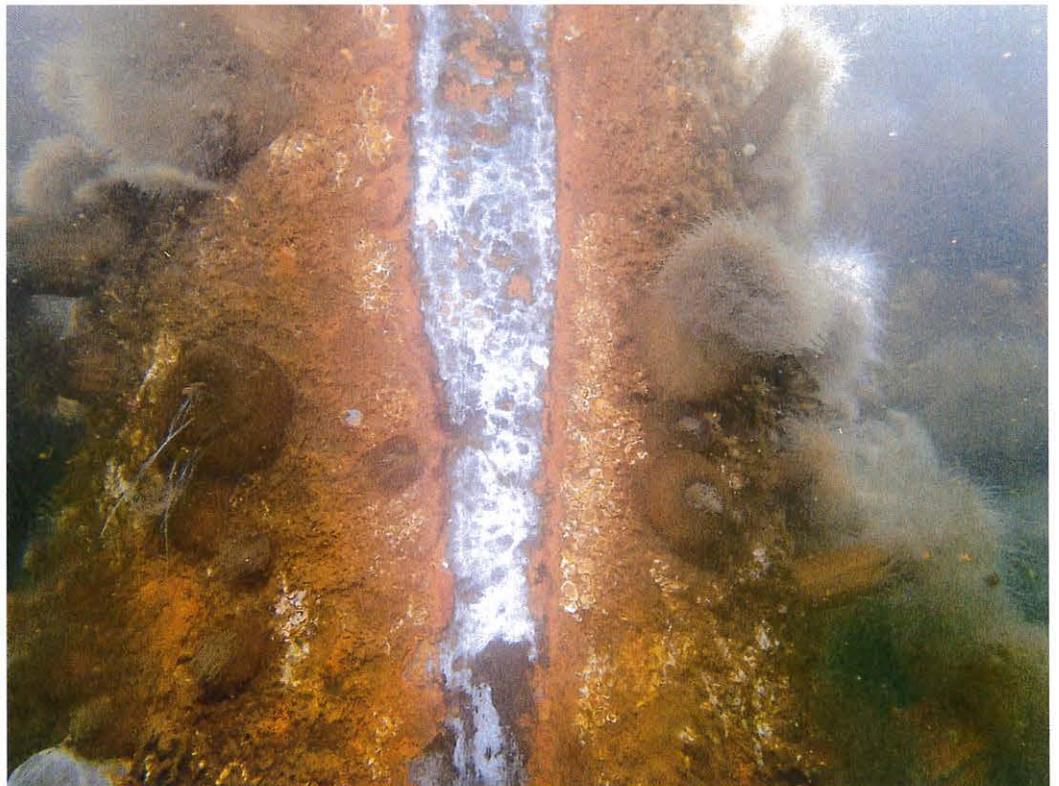
UW-4

T-dock Pile J; 4" wide mechanical damage (flat spot). 2013 photo; compare to UW-5 for 2017 photo and UW-18 for 2021 photo to see progression.

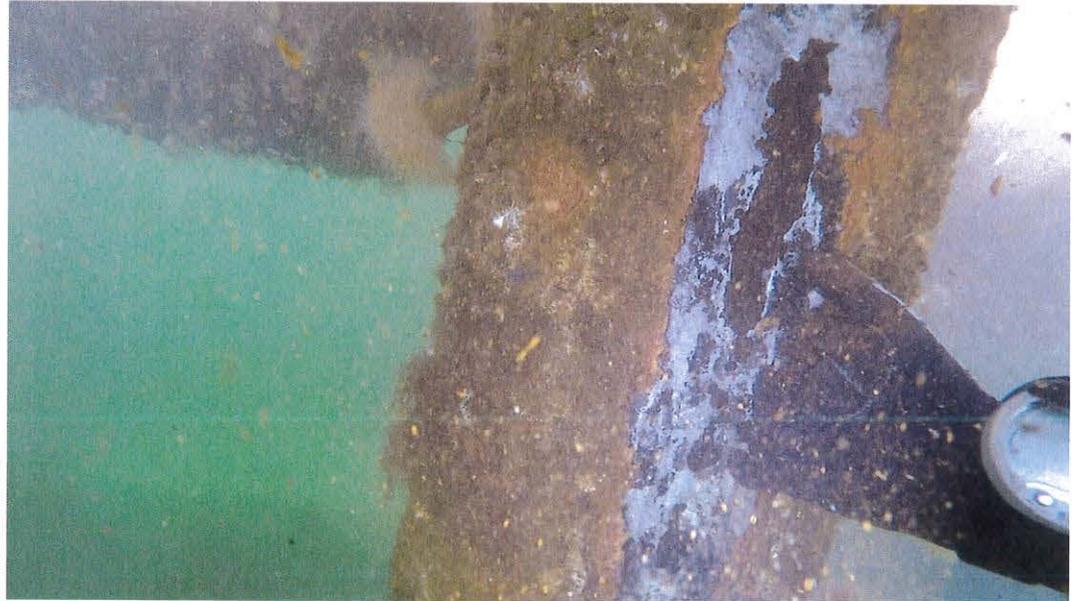
T-dock Pile J: 12" H x 2.5" W hole (was just a flat spot in 2013, see UW-4).

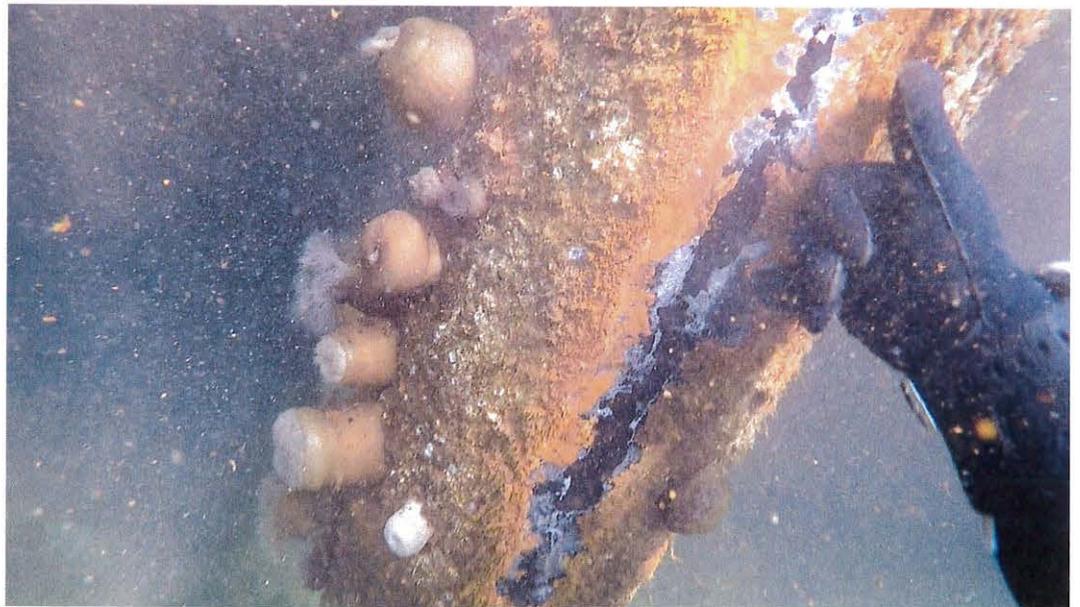
UW-6

T-dock Pile O: 18" H x 4" W (up to) hole from mechanical damage.

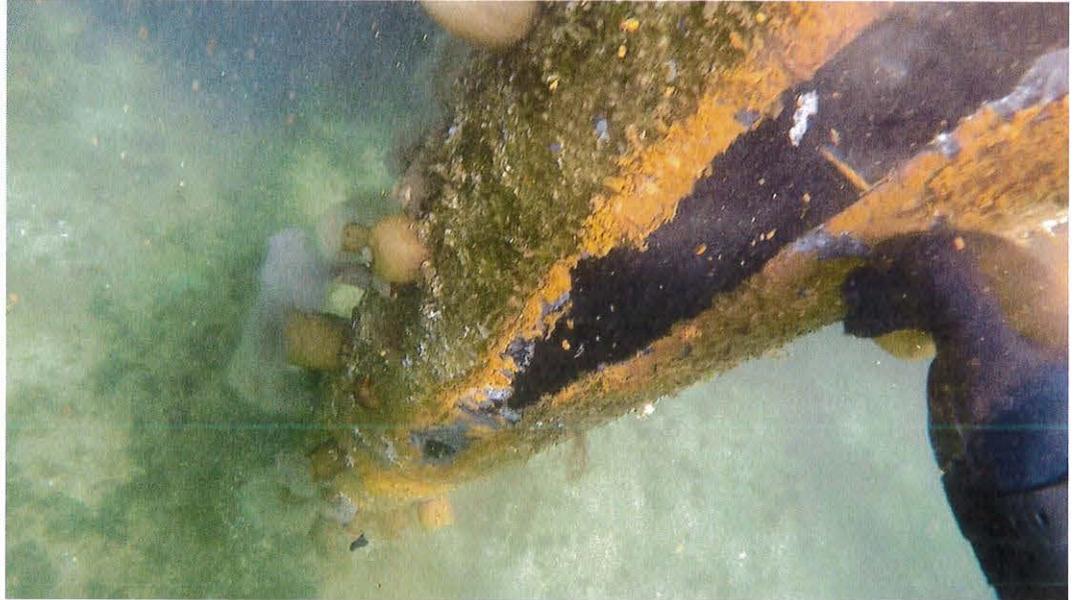
UW-7

8703 Spud Piling & Wells
Photo Type: I - In Depth
Orientation:
Date: 4/27/2017
Repairs:
T-dock Pile P: Large 3-ft. vertical hole from mechanical damage.

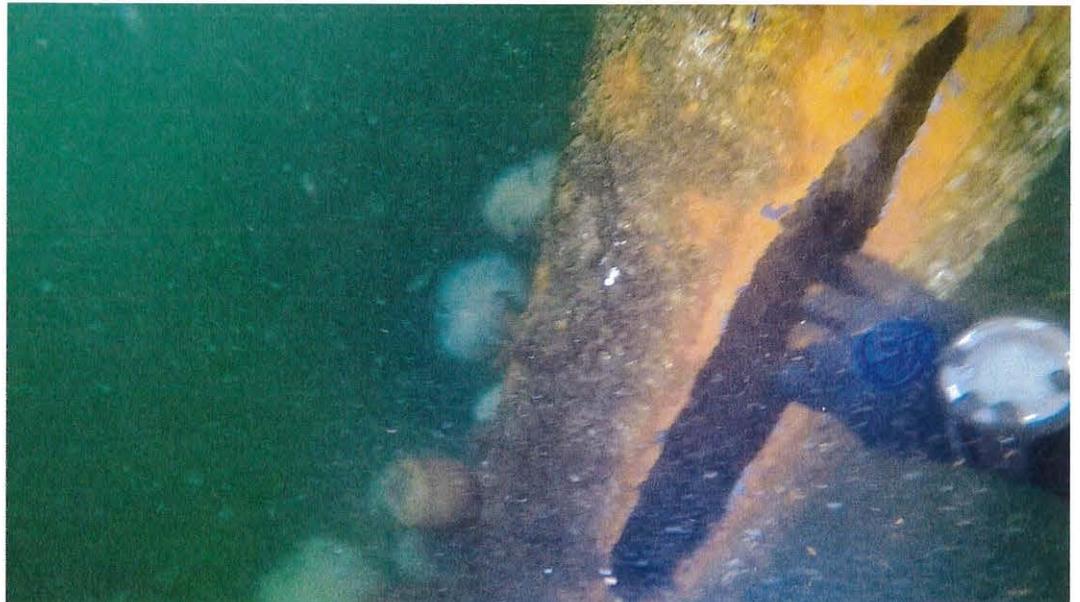
UW-10

Eleven spud piles (Piles A, D, E, F, J, L, O, P, V, W, and Y) have section loss that threatens performance during an extreme event such as high winds and heavy wave action.
(Photos #UW-10 through #UW-24)(CS4). REPAIR #10003.

8703 Spud Piling & Wells
Photo Type: R - Repair
Orientation: Sea
Date: 4/27/2021
Repairs: 10003
Pile A has a 3"(W) x 36"(H) hole from mechanical abrasion of UHMW log boom.

Repair or replace steel spud/guide piles that are rated as Condition State 4 with multiple and large holes. REPAIR #10003.

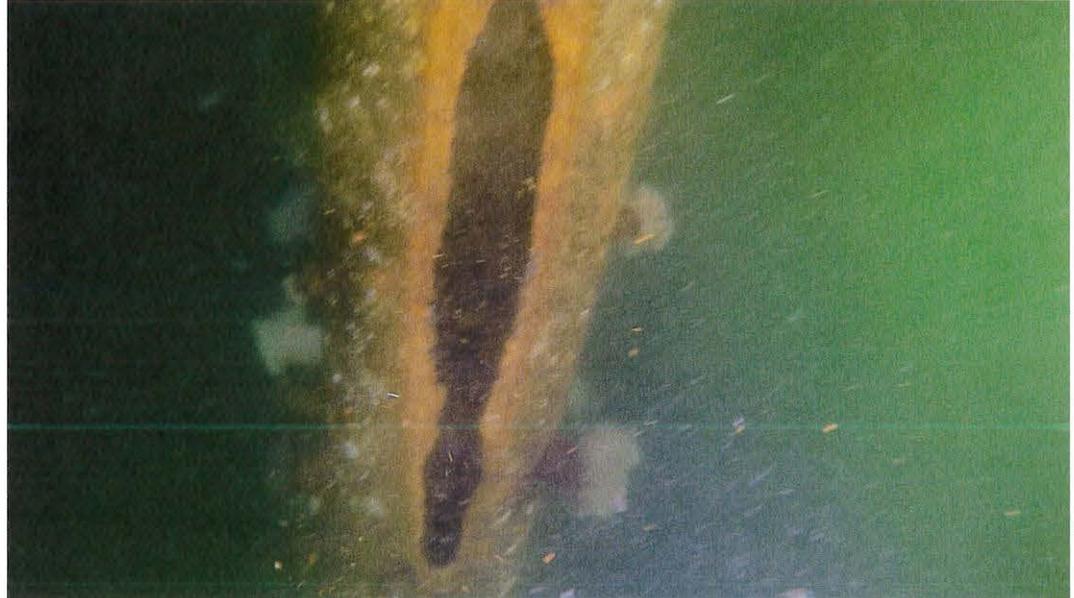
Pile D has a 4"(W) x 36"(H) hole from mechanical abrasion of UHMW log boom.

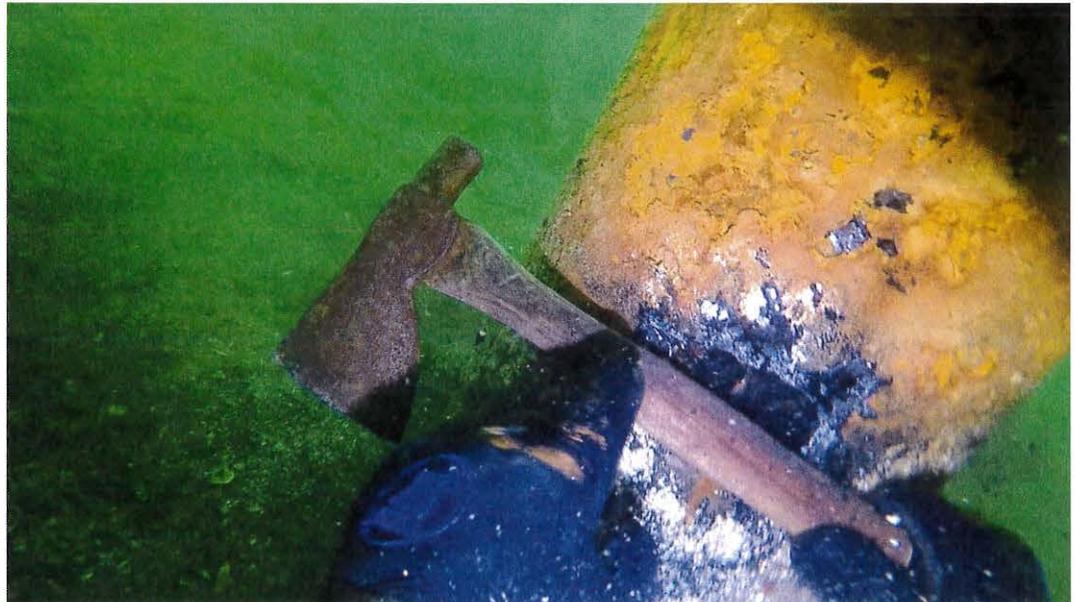
UW-12

Pile D has a 5"(W) x 2"(H) hole.

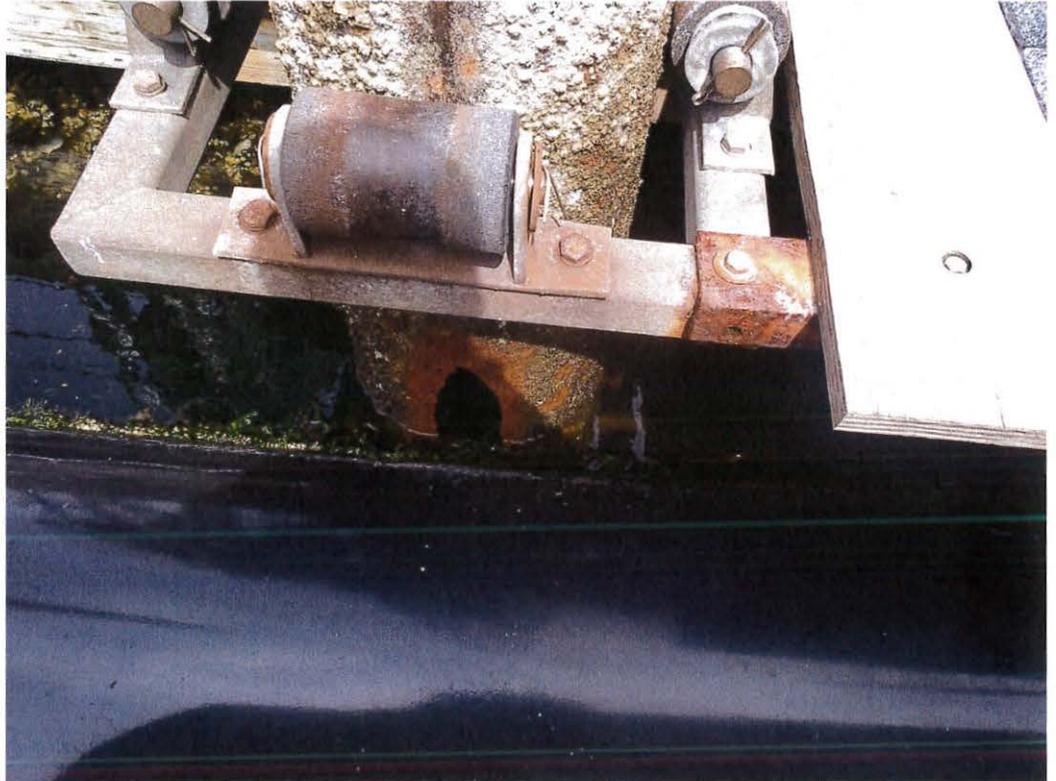
Pile E has a 2"(W) x 18"(H) hole from mechanical abrasion of log boom. Looking offshore during low tide.

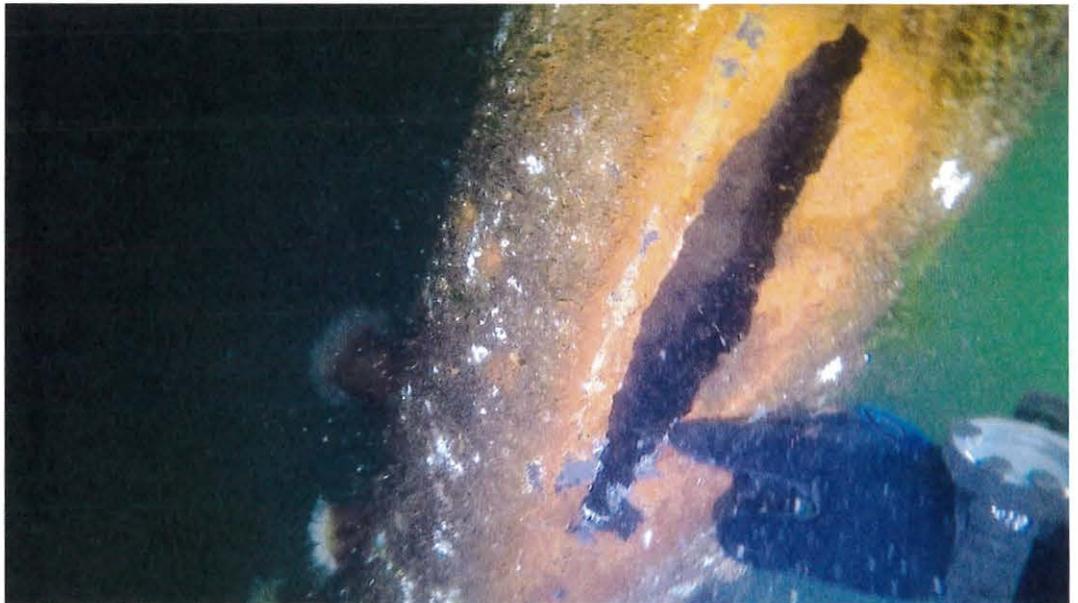
UW-14

Pile E has a 2"(W) x 18"(H) hole from mechanical abrasion of log boom looking offshore.

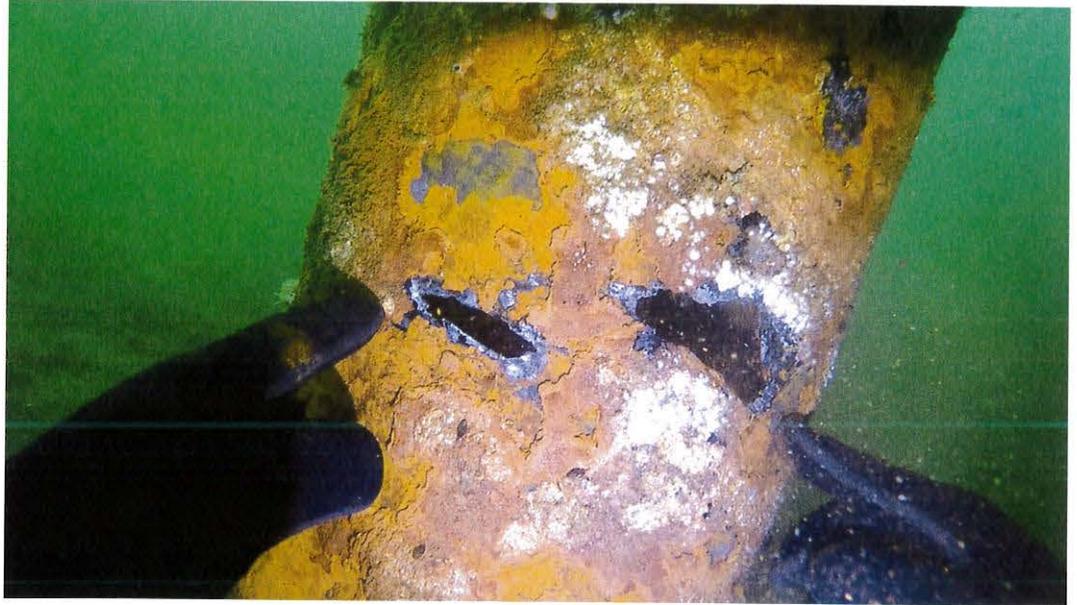
Pile E has 4-1/2"(W) x 1-1/2"(H) and 3-1/2"(W) x 3/4"(H) side-by-side holes looking inshore left.
