BRIDGE INSPECTION REPORT

Br. No. DOC-6

SID 00200441

Br. Name MCNEIL IS. STILL HARBOR DOCK

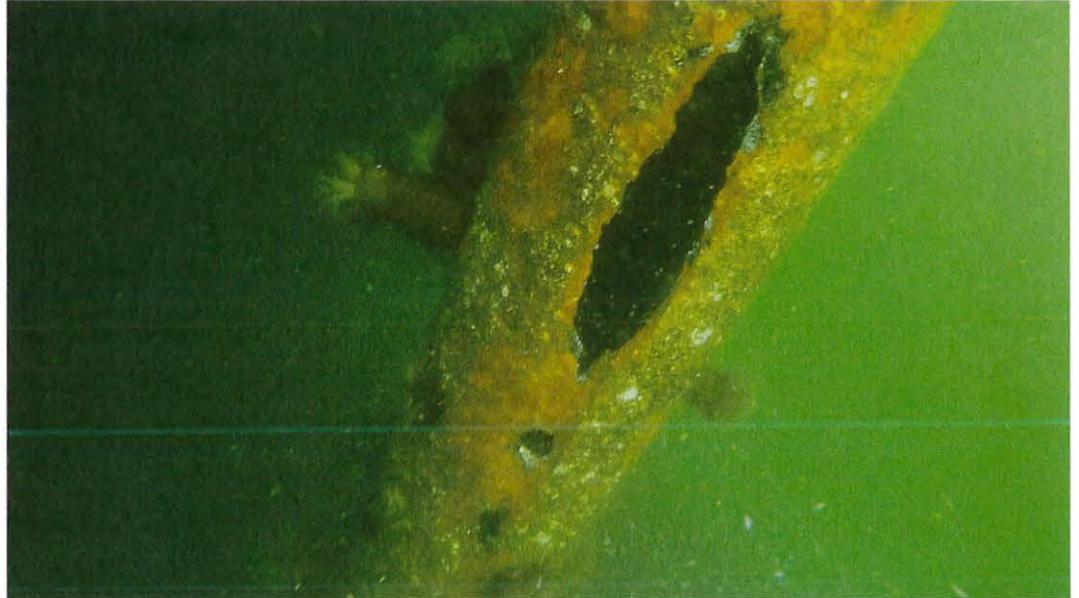
Eleven spud piles (Piles A, D, E, F, J, L, O, P, V, W, and Y) have section loss that threatens performance during an extreme event such as high winds and heavy wave action.
(Photos #UW-10 through #UW-24)(CS4). REPAIR #10003.

Pile F has 3-1/2"(W) x 18"(H), 2"(W) x 2-1/2"(H), and 1-1/2"(W) x 3"(H) holes from mechanical abrasion of log boom.

Repair or replace steel spud/guide piles that are rated as Condition State 4 with multiple and large holes. REPAIR #10003.

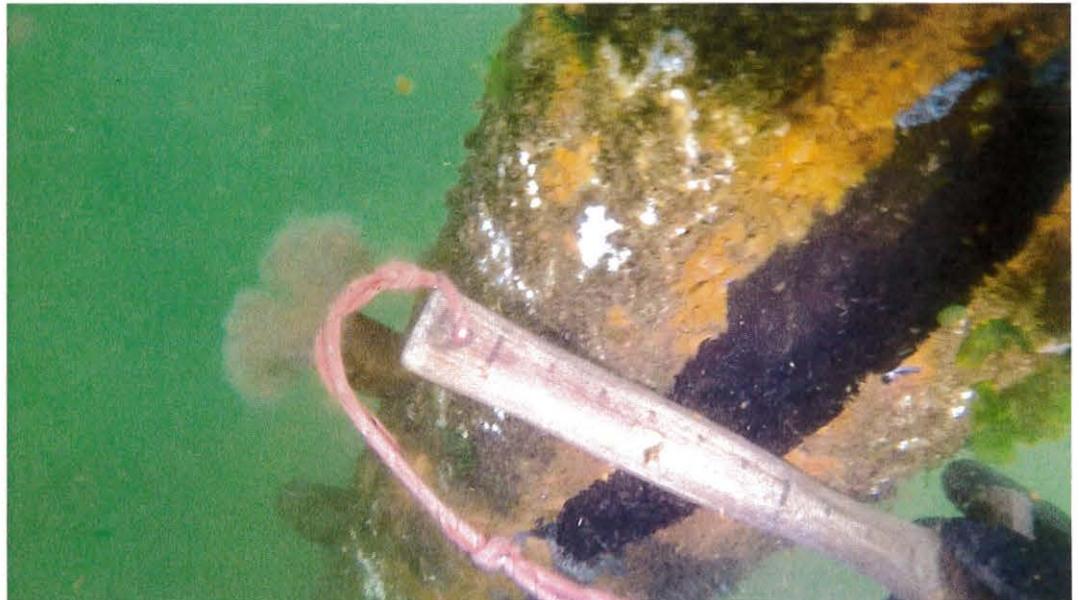
UW-18

Pile J has a 3"(W) x 18"(H) hole from mechanical abrasion of log boom.

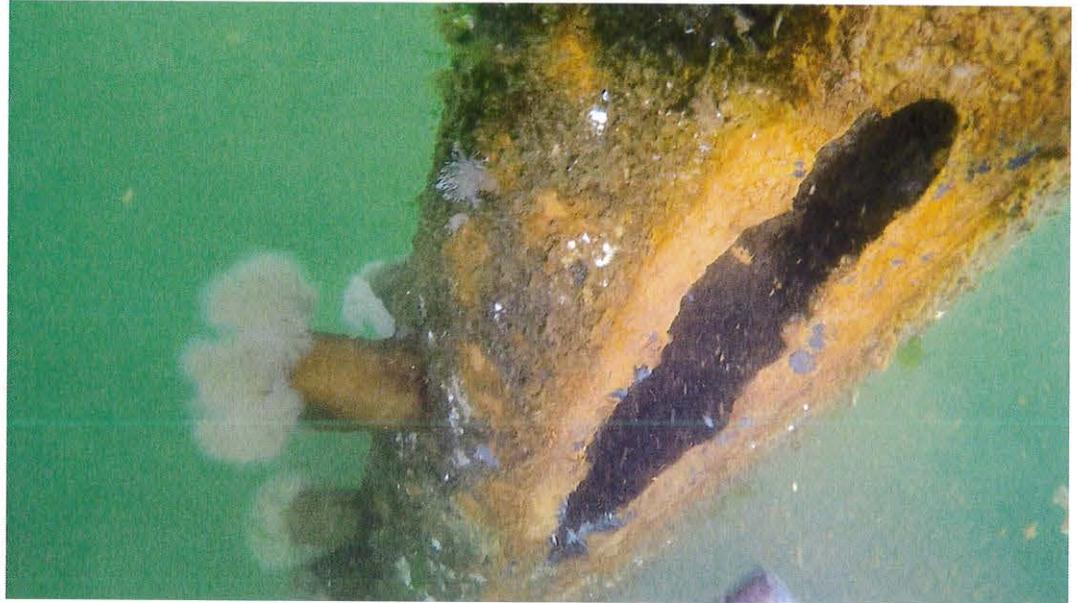
Pile L has a 3"(W) x 24"(H) hole from mech abrasion of log boom.

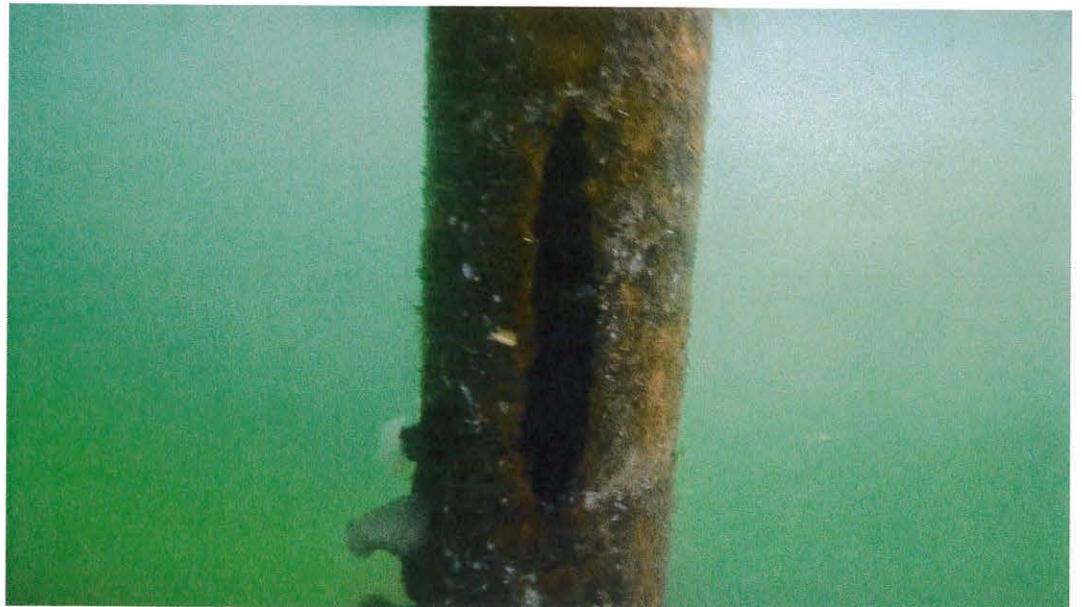
UW-20

Pile O has a 4"(W) x 24"(H) hole from mechanical abrasion of log boom.

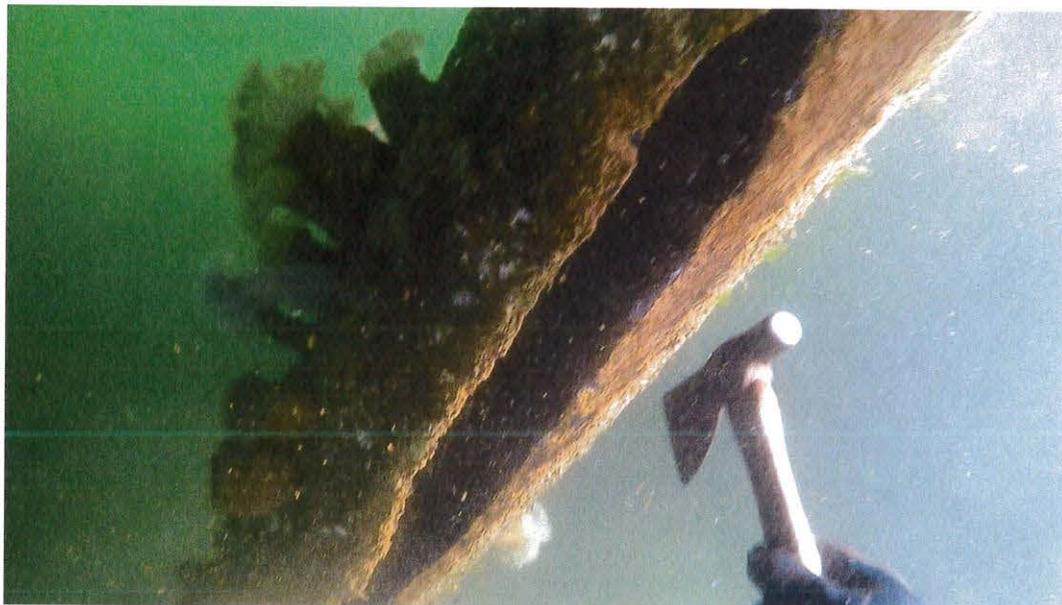
Pile P has a 5"(W) x 54"(H) large hole from mechanical abrasion of log boom.

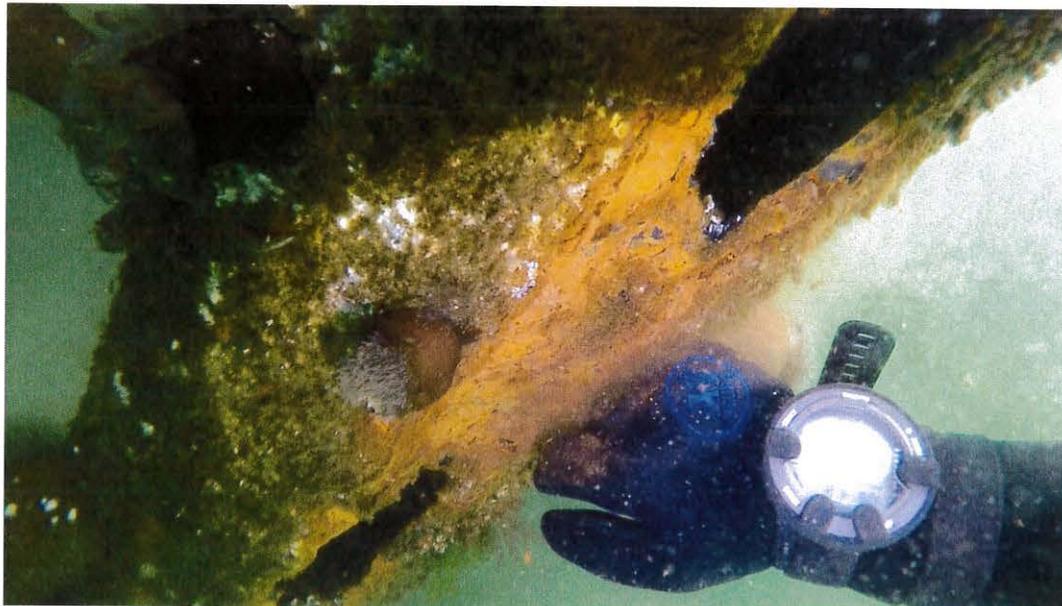
UW-22

Pile V has 4" (W) x 24"(H) and 3"(W) x 14"(H) holes from mechanical abrasion of log boom.

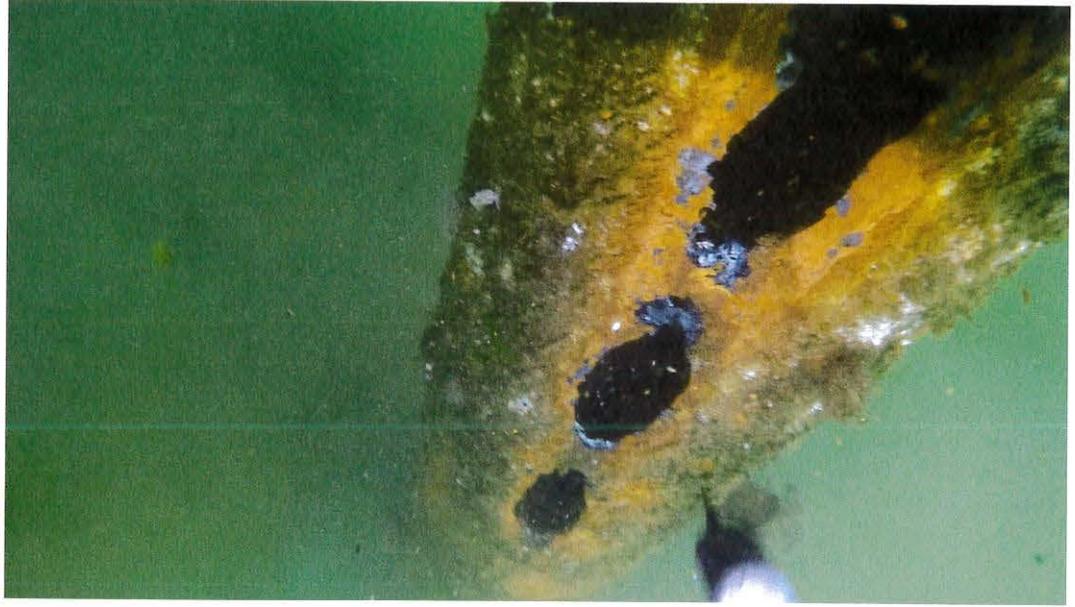
Pile W has 4-1/2"(W) x 18"(H), 2-1/2"(W) x 7"(H), and 3"(W) x 8"(H) holes from mechanical abrasion of log boom.

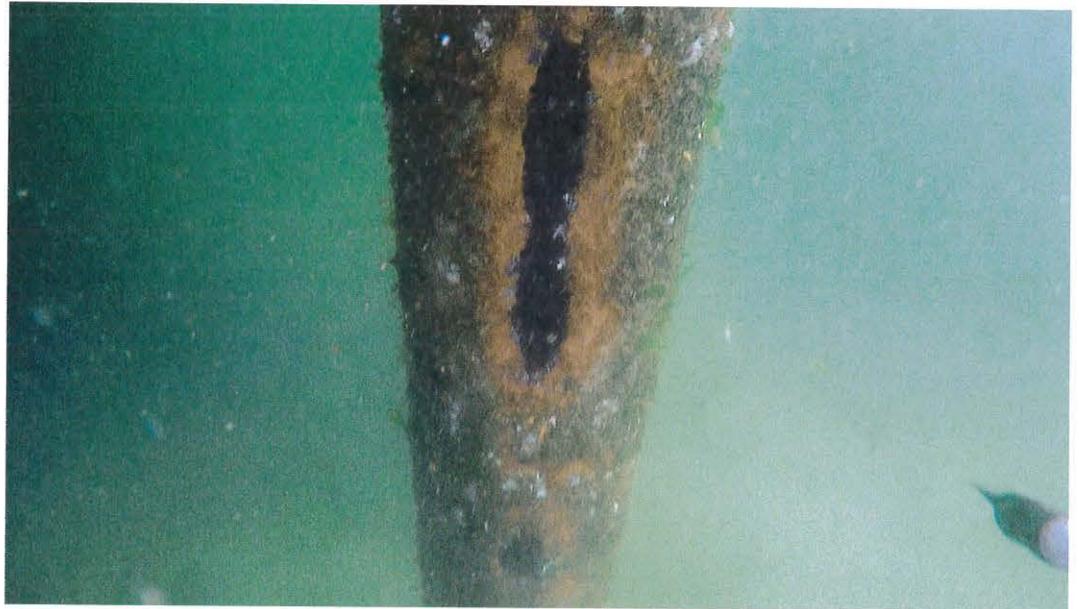
UW-24

Pile Y has a 3"(W) x 18"(H) hole and a 3"(W) x 6"(H) hole from mechanical abrasion of log boom.

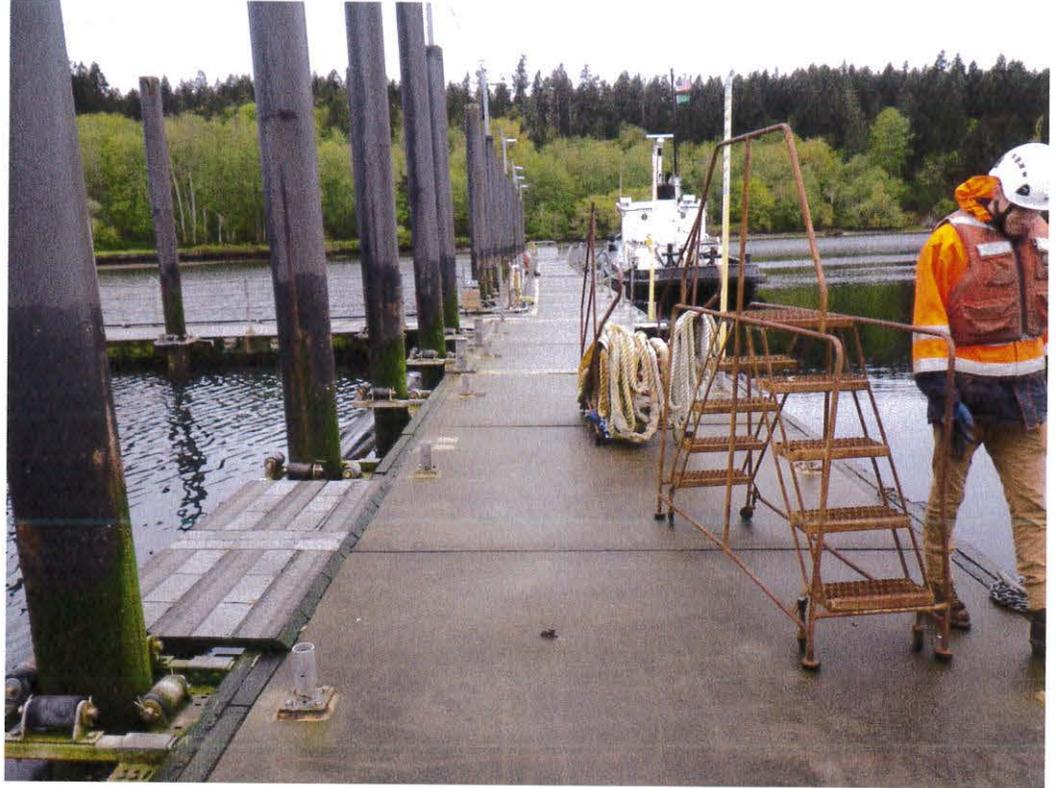
8818 **OTHER PEDESTRIAN RAILING:**
The steel post stanchions and rope rail have been removed from floats T thru Y prior to the 2017 inspection (photo #25).

The steel post stanchions and rope rail have been removed from floats T thru Y.

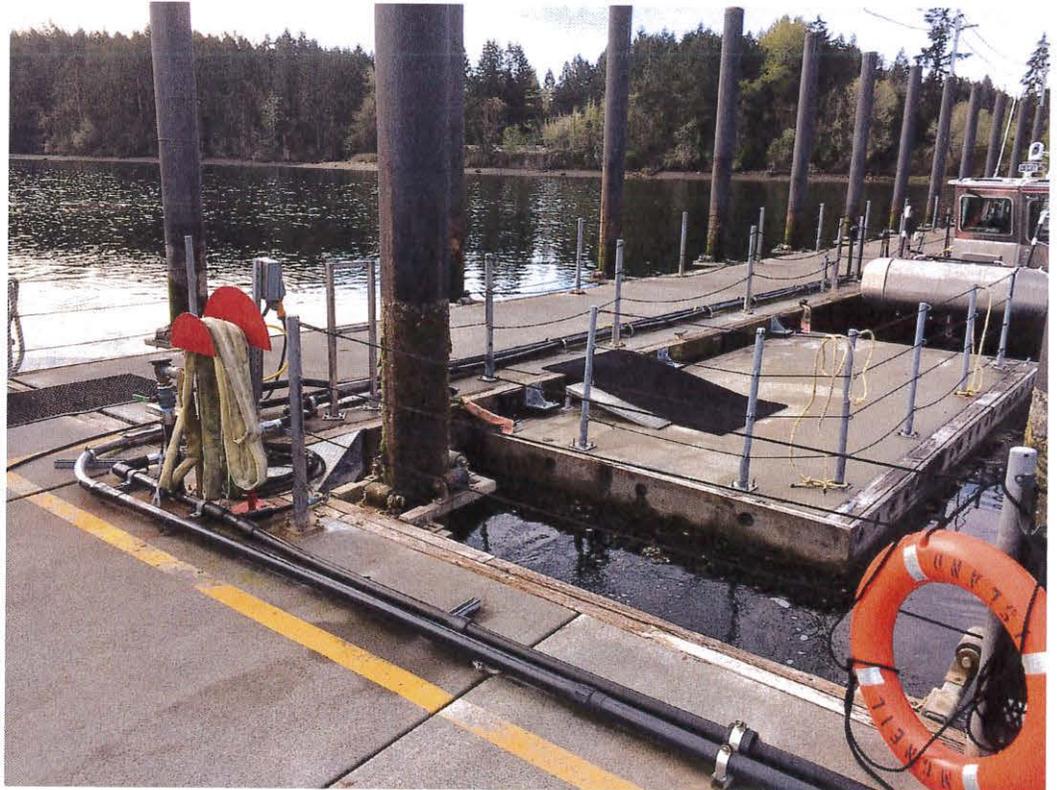
SI-37

8902 **INORGANIC ZINC VINYL PAINT:**
Many of the spud piles have rust blisters and seam rust (photo #37).

Typical shot of spud piles. Seam rust on welds are breaking through the paint.

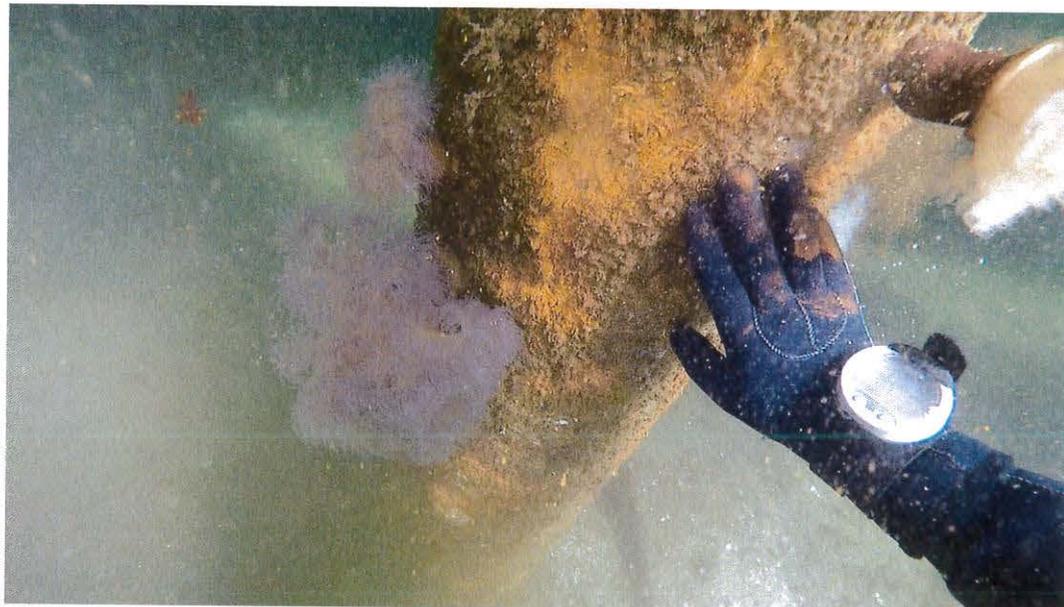
Underwater Inspection Findings:
Much of the spud pile coating has failed underwater. Pile metal substrate is exposed between 10% and 50% of the pile surface area underwater, see Element 8703 Photos #UW-2 and #UW-8 for typical underwater coating condition.

Typical pile condition underwater. Coating has failed over 25%-50% of the surface area on the piles below water. Example of ~25% exposed metal shown.

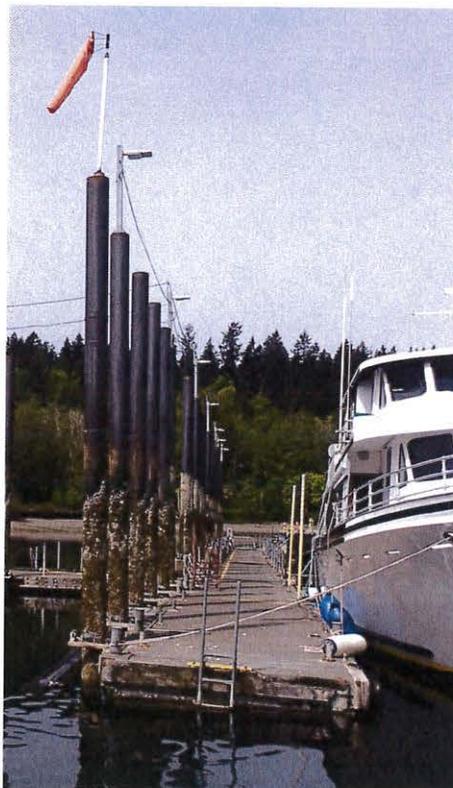
UW-25

There is a ladder attached to each end of the t-dock.
