Washington State  
Department of Transportation  
Bridge Preservation Dive Team

UNDERWATER INSPECTION REPORT FOR  
MCNEIL IS. STILL HARBOR DOCK

BRIDGE NO. DOC-6

Inspection Date April 27, 2021

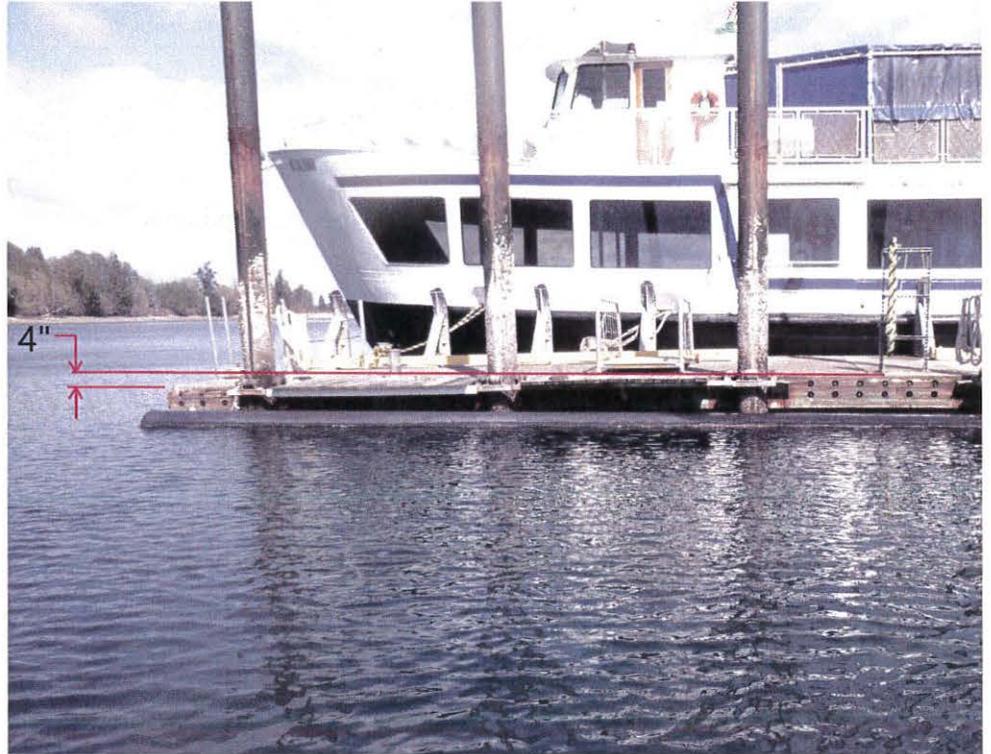
**SI-29**

Dock lists 4" down from Panel C to the end of Panel A.

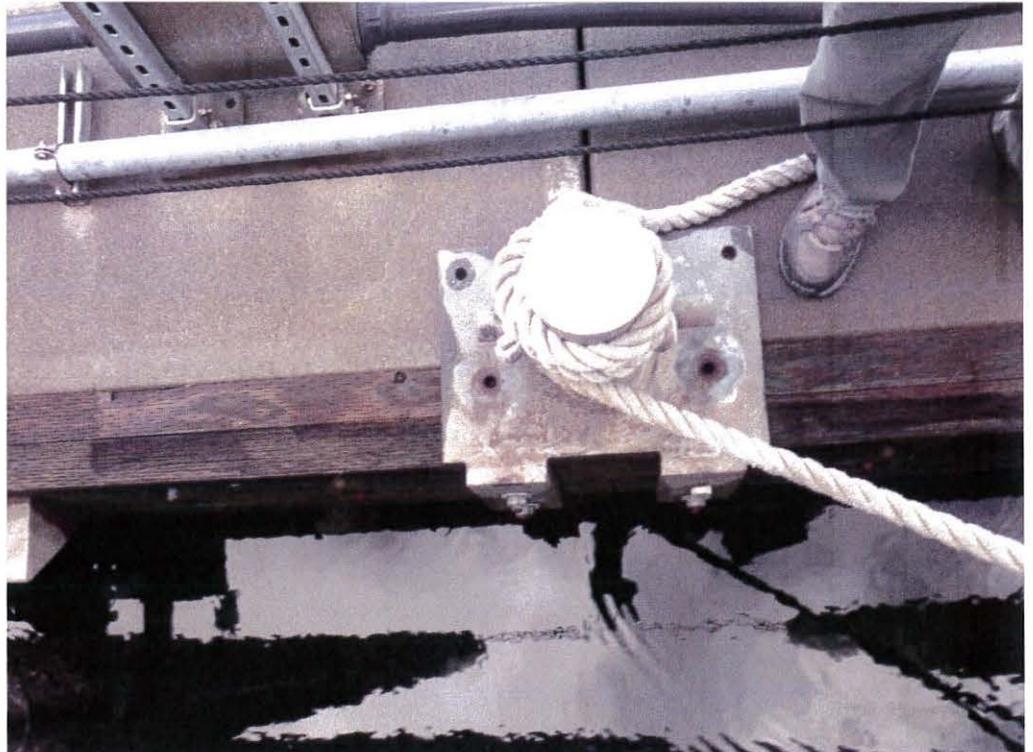
**SI-30**

At the M-N joint shore side, the boat tie off cleat is bolted only to the timber walers.

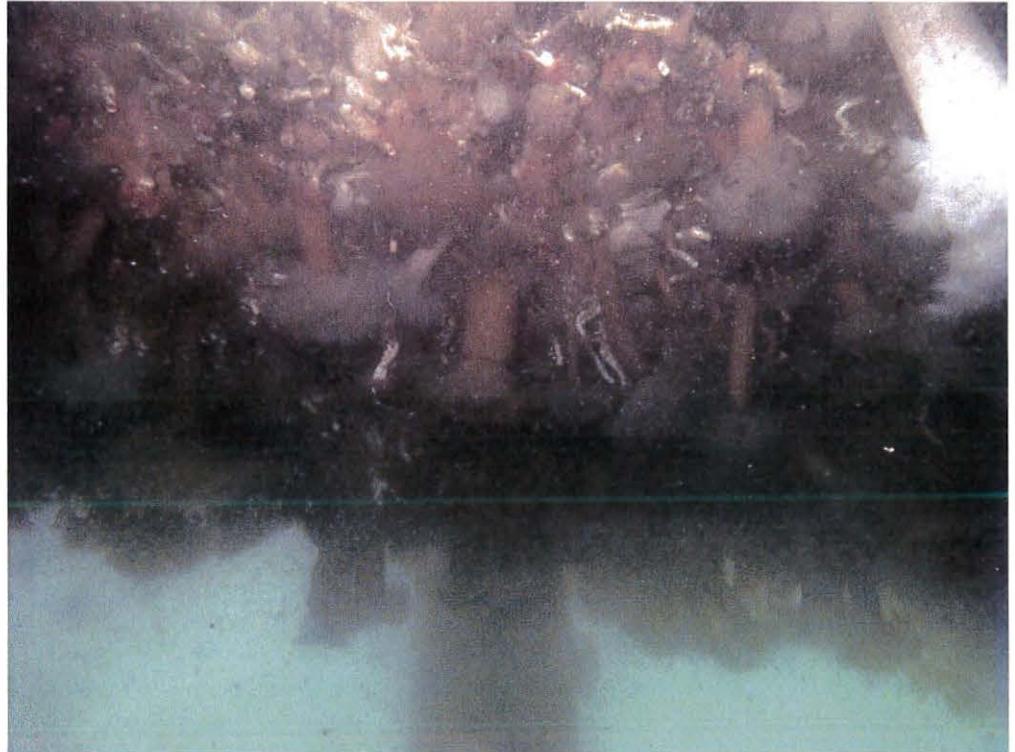
UW-1

Underwater Inspection Findings:  
 The submerged surfaces of the pontoons are covered in heavy marine growth, making a detailed inspection very difficult. Spot cleaning revealed no defects (Photo #UW-1).

Typical heavy marine growth on floating dock sections.

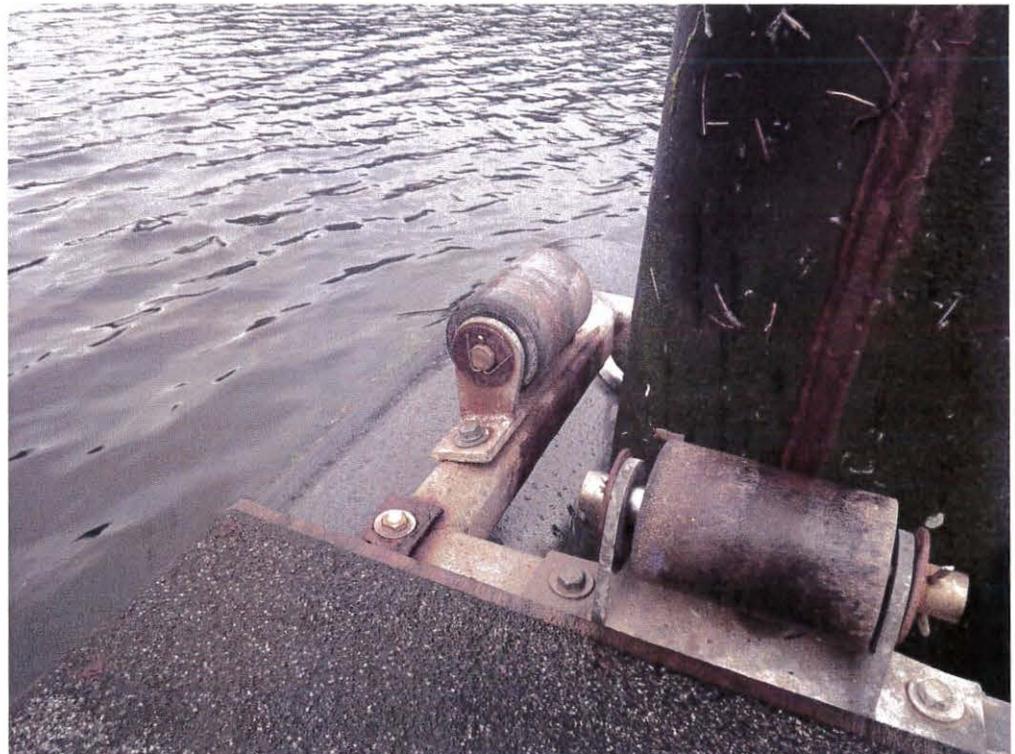
SI-27

Spud pile rollers are all intact, some are bent from storm events.

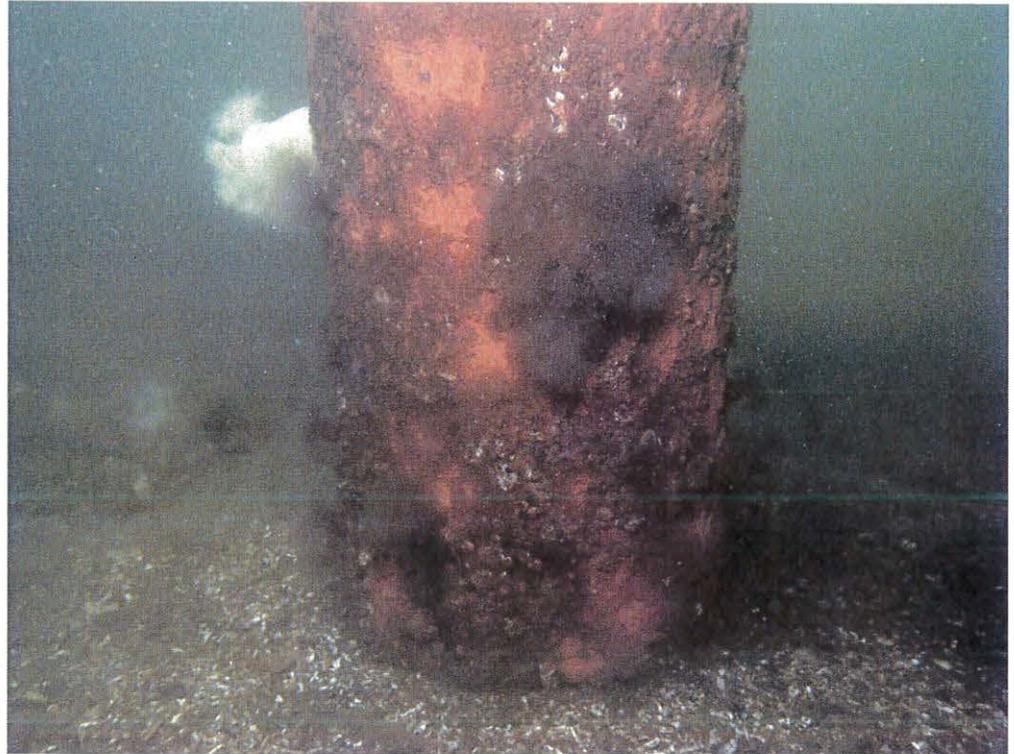
## UW-2

Underwater Inspection Findings:  
 Much of the spud pile coating has failed underwater. Pile metal substrate is exposed between 10% and 50% of the pile surface area underwater, see Element 8703 Photos #UW-2 and #UW-8 for typical underwater coating condition.

T-dock Pile S; general coating failure and rusting with section loss. Typical of T-dock piles.

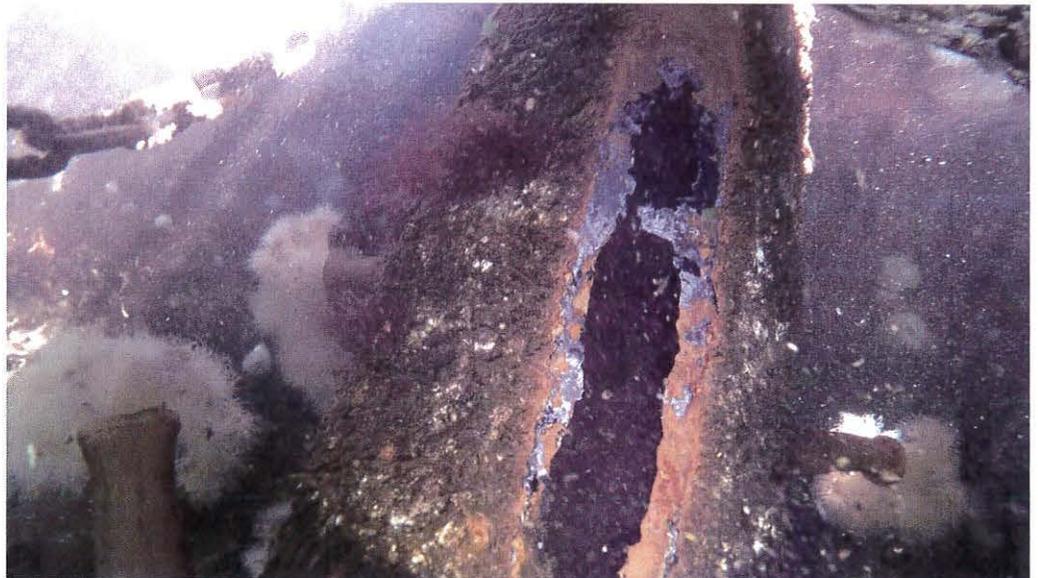
## UW-3

T-dock, Pile A: 18" H x 4" W hole from mechanical damage.

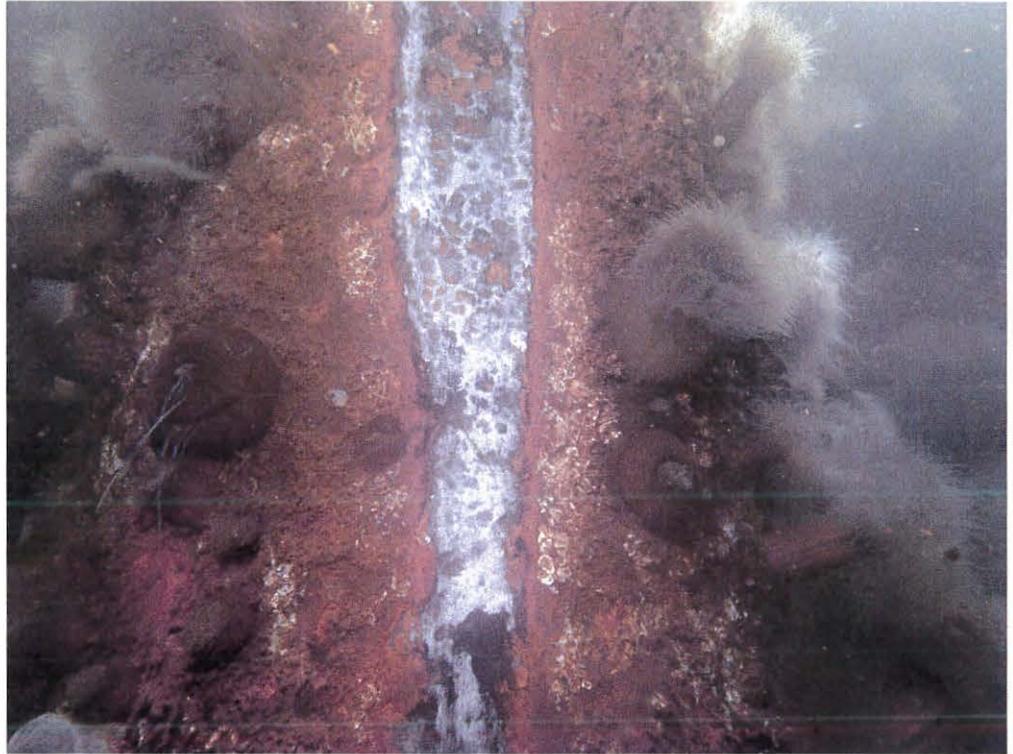
T-dock Pile J; 4" wide mechanical damage (flat spot). 2013 photo; compare to UW-5 for 2017 photo and UW-18 for 2021 photo to see progression.

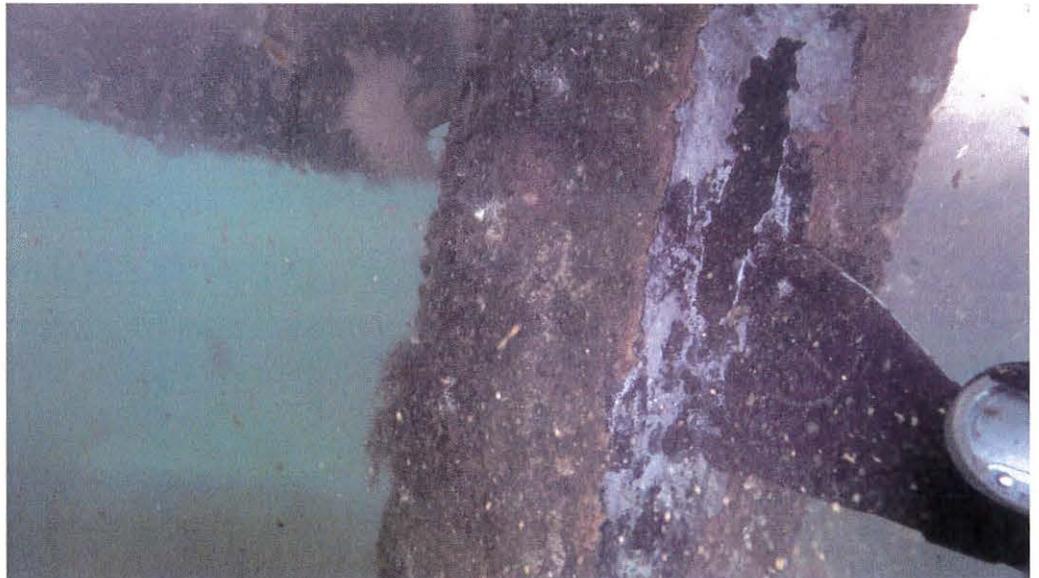
**UW-5**

T-dock Pile J: 12" H x 2.5" W hole (was just a flat spot in 2013, see UW-4).

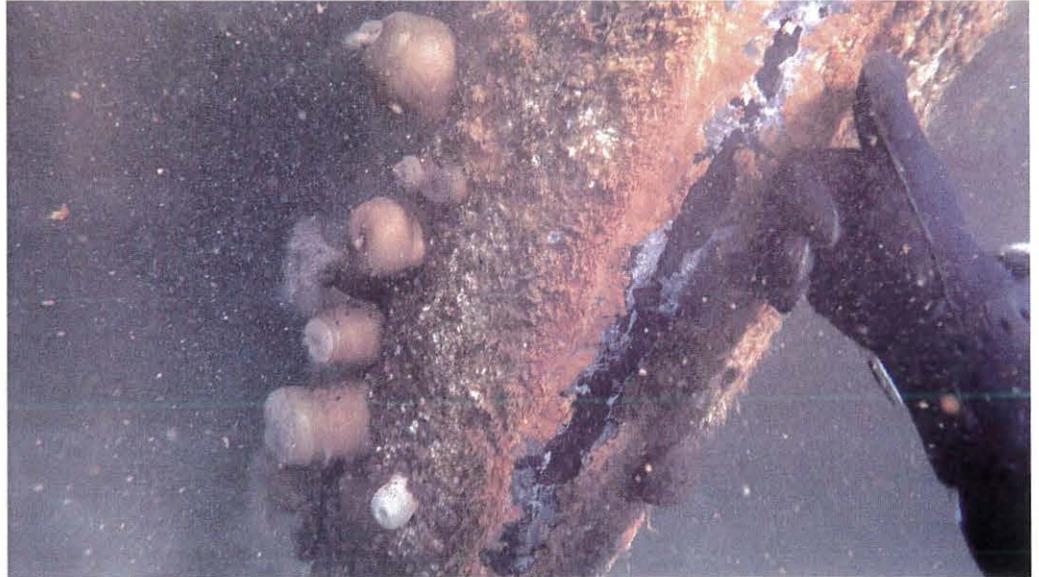
T-dock Pile O: 18" H x 4" W (up to) hole from mechanical damage.

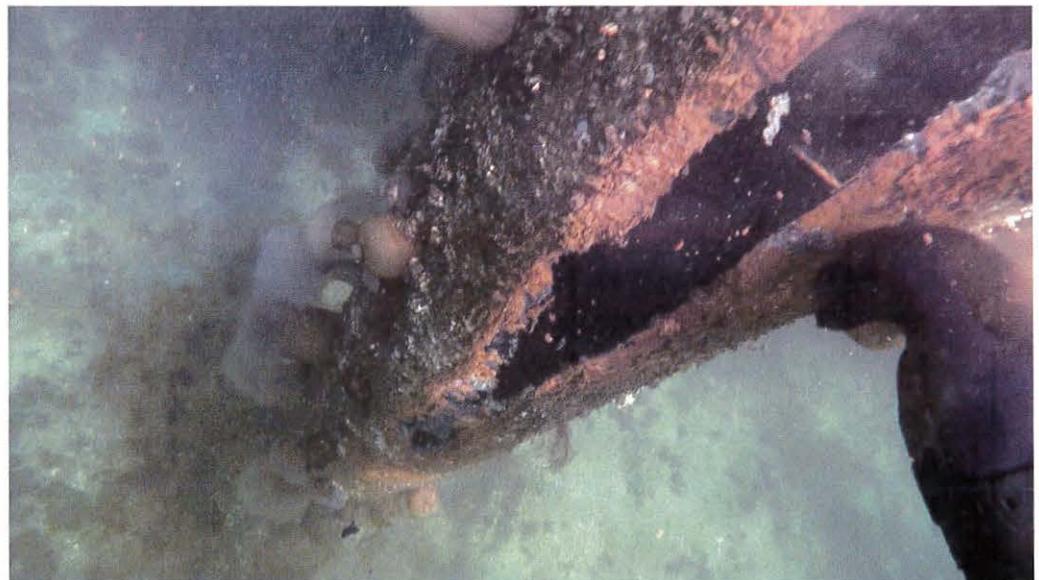
**UW-7**

T-dock Pile P: Large 3-ft. vertical hole from mechanical damage.

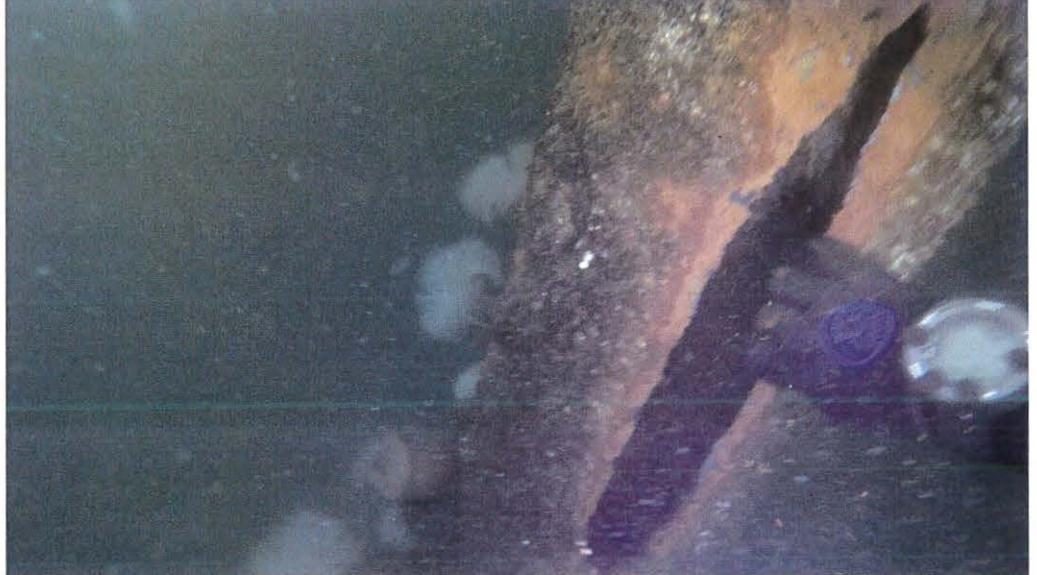
Pile A has a 3"(W) x 36"(H) hole from mechanical abrasion of UHMW log boom.

Repair No	Pr	R	Repair Description	BMS	Noted	Maint	Verified
10003	1	B	Repair or replace steel spud/guide Piles A, D, E, F, J, L, O, P, V, W, and Y. These piles have multiple and/or larger holes that may be detrimental to performance during an extreme weather event.	8703	4/27/2021

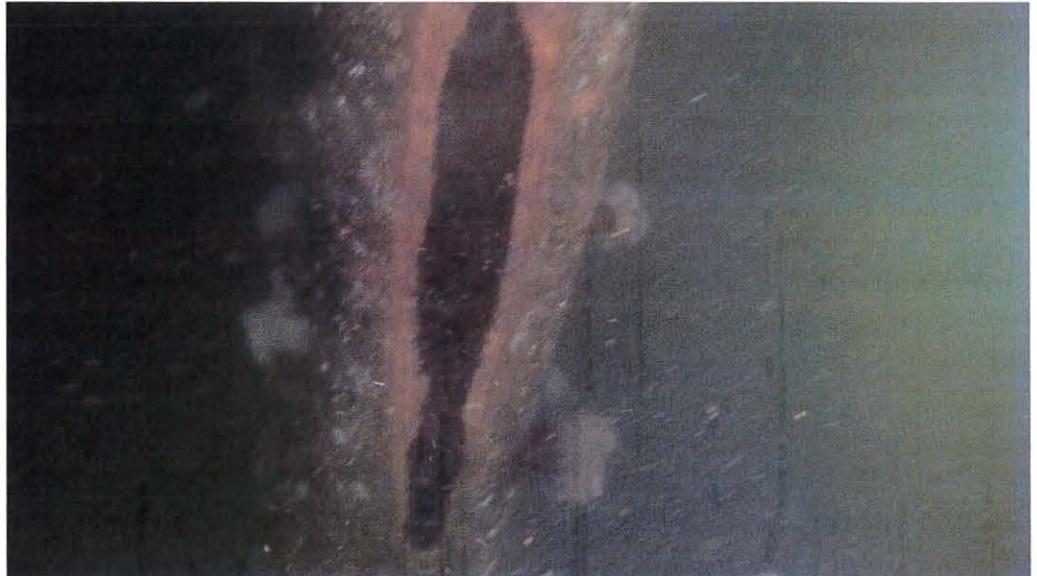
**UW-11**

Pile D has a 4"(W) x 36"(H) hole from mechanical abrasion of UHMW log boom.

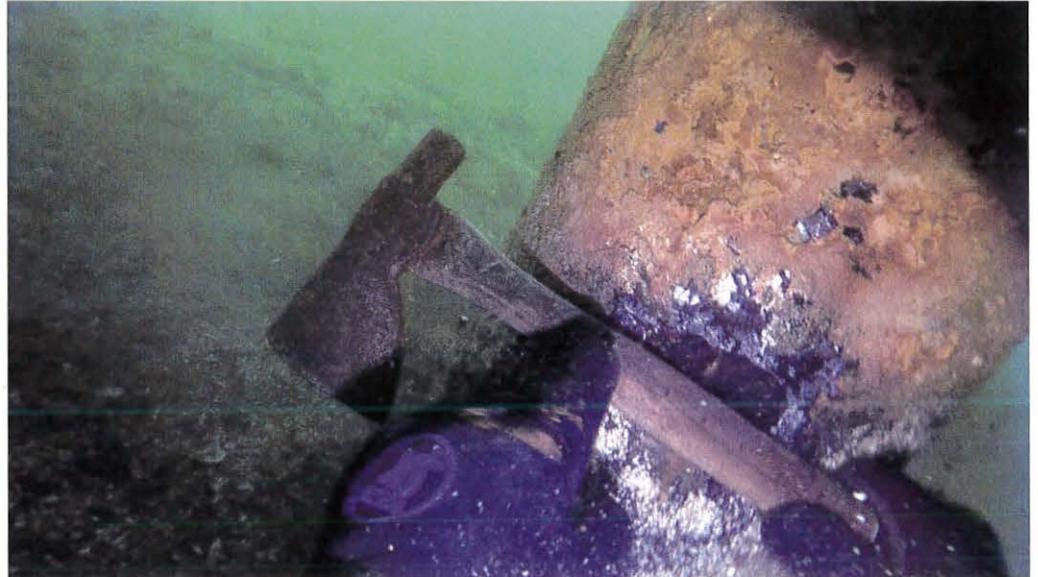
Pile D has a 5"(W) x 2"(H) hole.

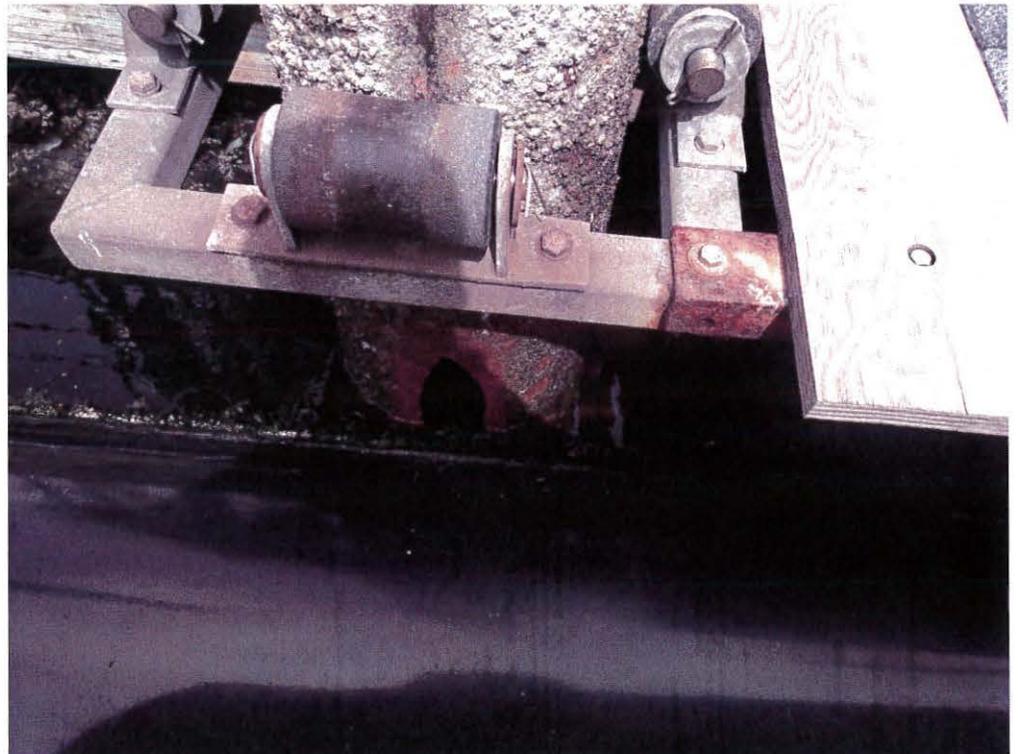
## UW-13

Pile E has a 2"(W) x 18"(H) hole from mechanical abrasion of log boom. Looking offshore during low tide.

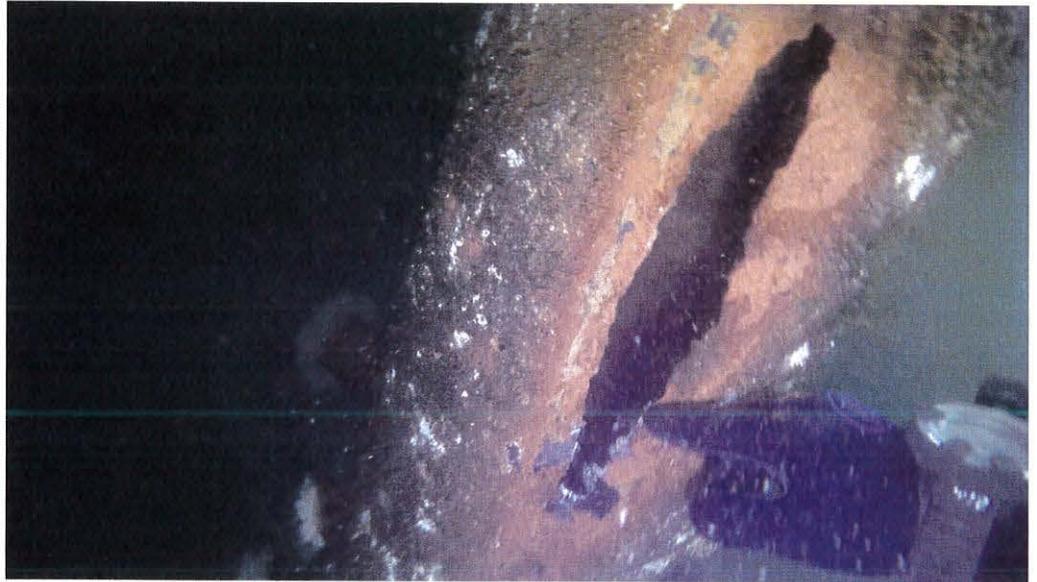
Pile E has a 2"(W) x 18"(H) hole from mechanical abrasion of log boom looking offshore.

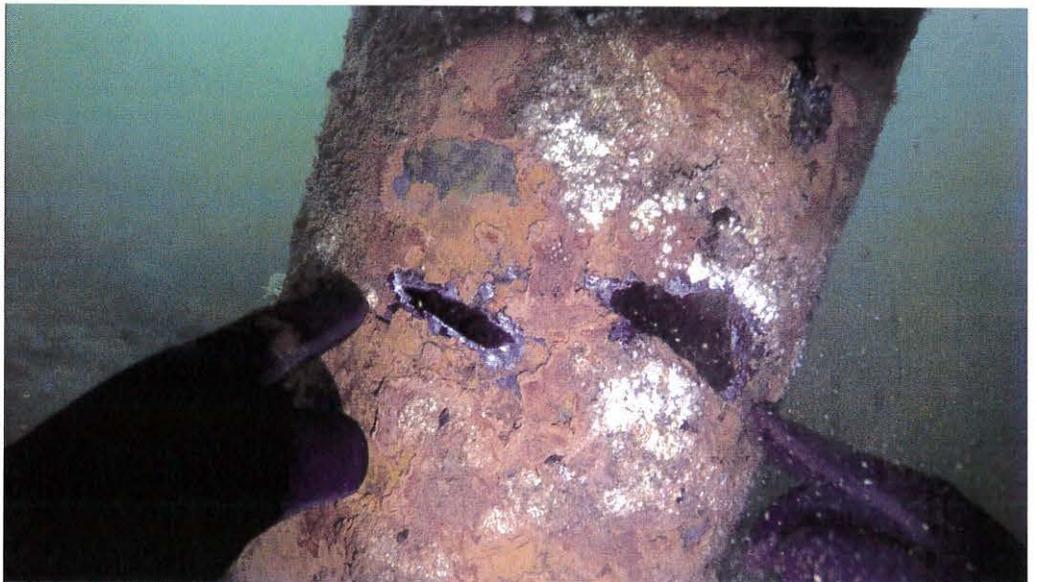
UW-15

Pile E has 4-1/2"(W) x 1-1/2"(H) and 3-1/2"(W) x 3/4"(H) side-by-side holes looking inshore left.

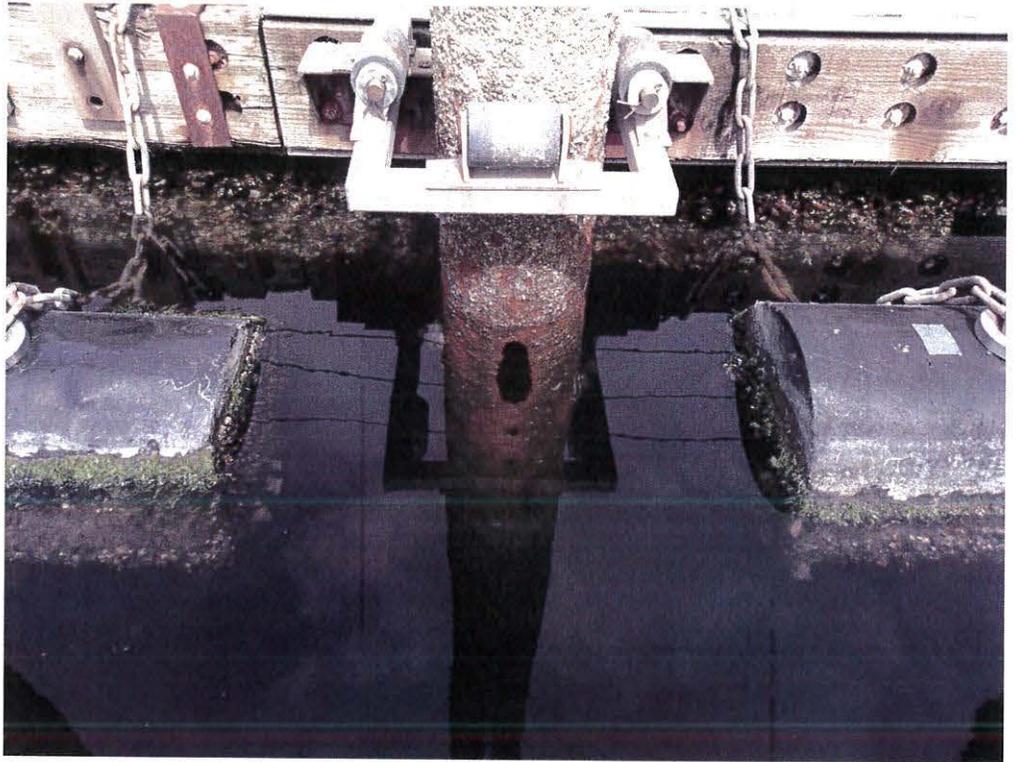
Pile F has 3-1/2"(W) x 18"(H), 2"(W) x 2-1/2"(H), and 1-1/2"(W) x 3"(H) holes from mechanical abrasion of log boom at low tide.

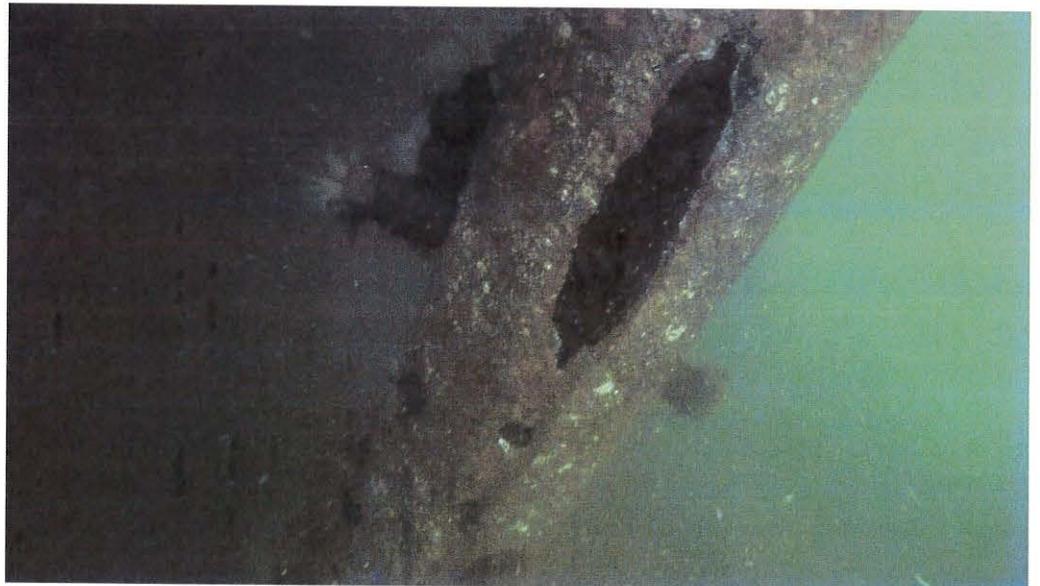
UW-17

Pile F has 3-1/2"(W) x 18"(H), 2"(W) x 2-1/2"(H), and 1-1/2"(W) x 3"(H) holes from mechanical abrasion of log boom.

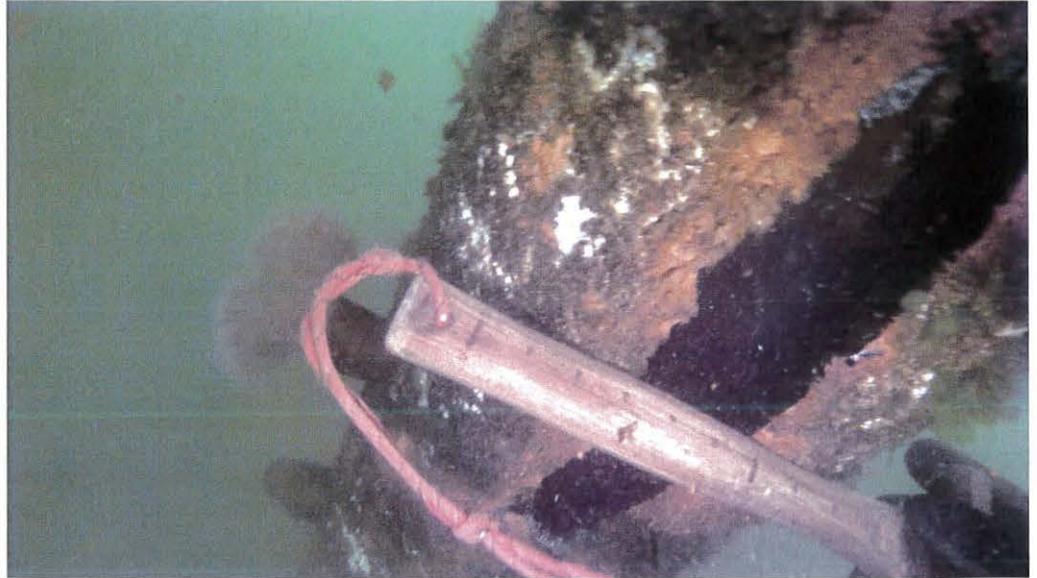
Pile J has a 3"(W) x 18"(H) hole from mechanical abrasion of log boom.

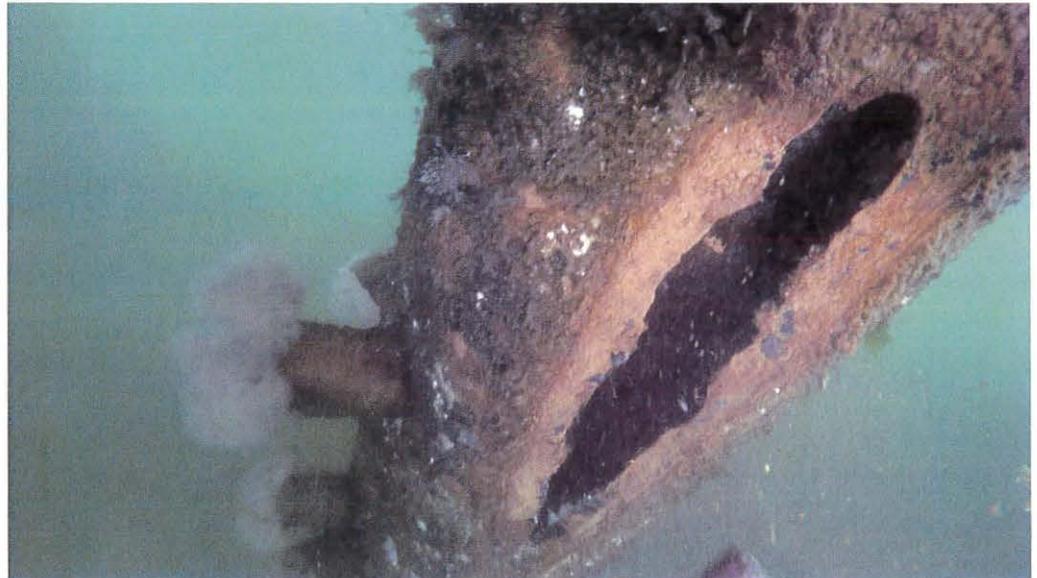
**UW-19**

Pile L has a 3"(W) x 24"(H) hole from mech abrasion of log boom.

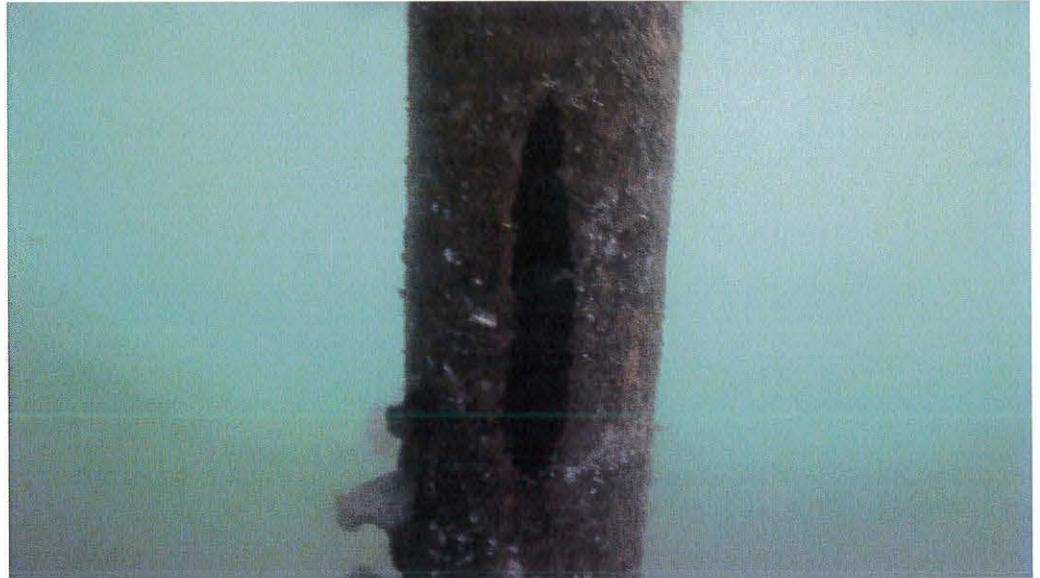
Pile O has a 4"(W) x 24"(H) hole from mechanical abrasion of log boom.

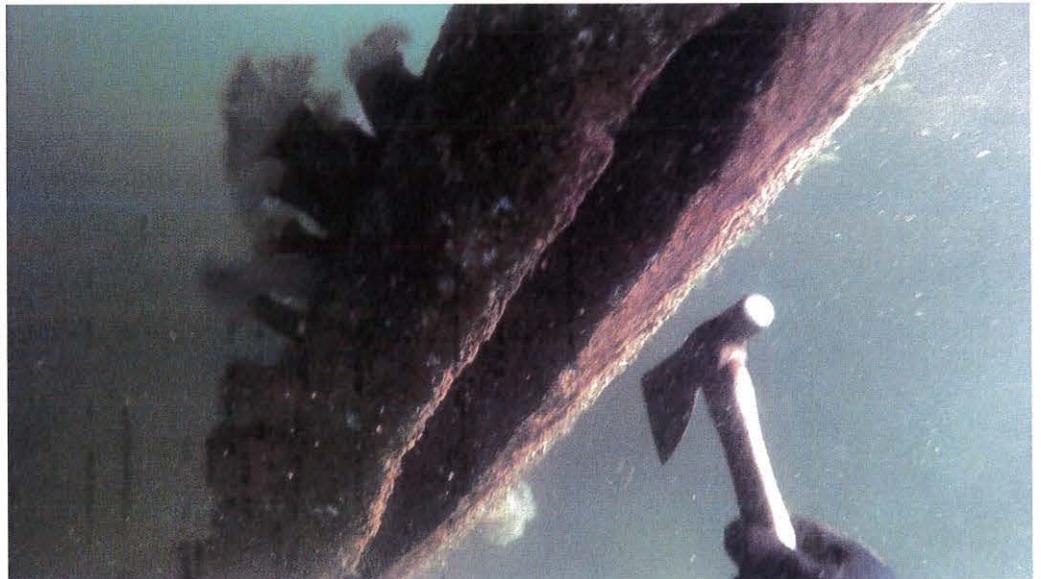
**UW-21**

Pile P has a 5"(W) x 54"(H) large hole from mechanical abrasion of log boom.

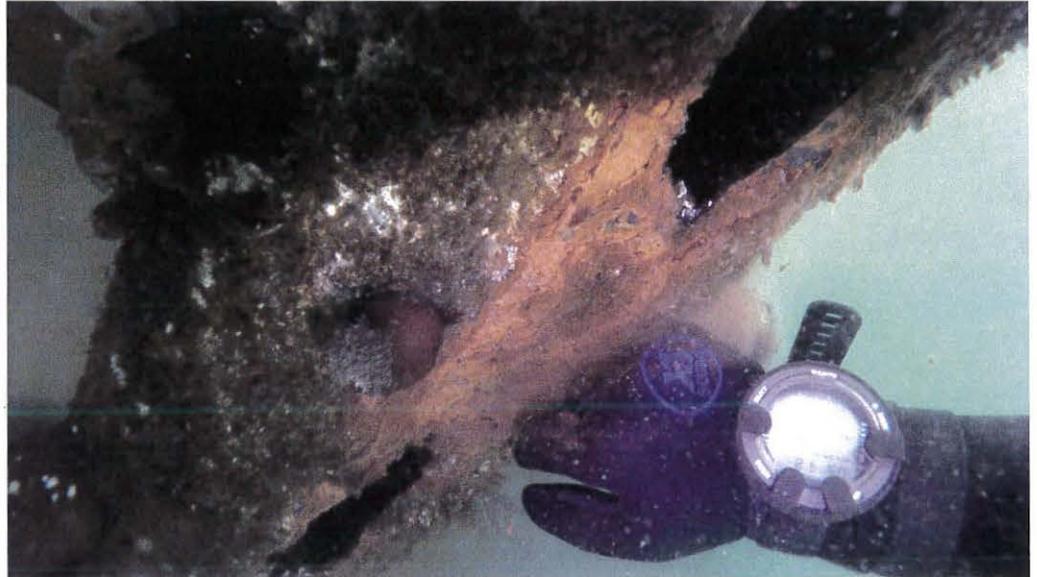
Pile V has 4" (W) x 24"(H) and 3"(W) x 14"(H) holes from mechanical abrasion of log boom.

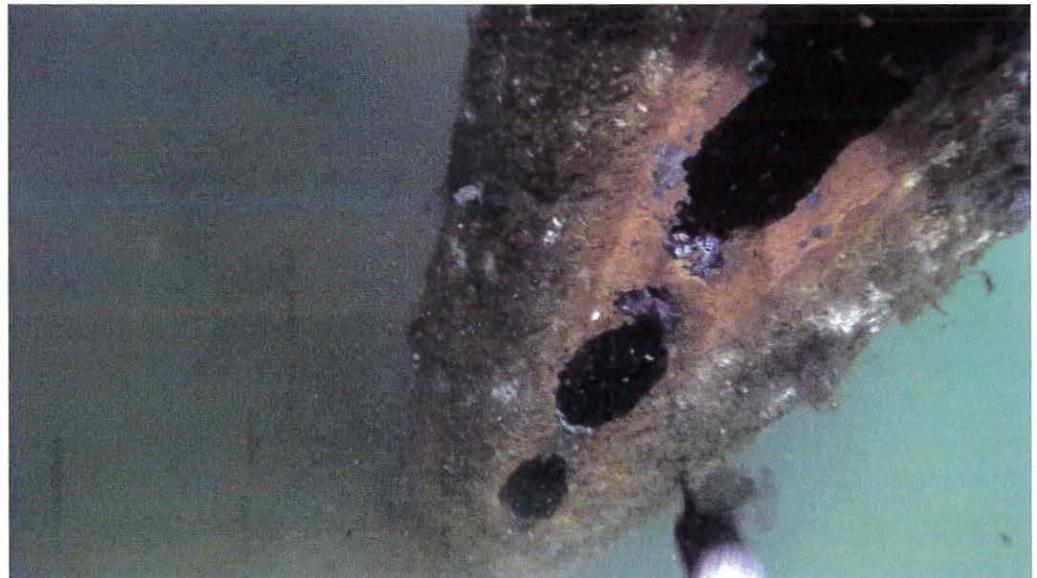
UW-23

Pile W has 4-1/2"(W) x 18"(H), 2-1/2"(W) x 7"(H), and 3"(W) x 8"(H) holes from mechanical abrasion of log boom.

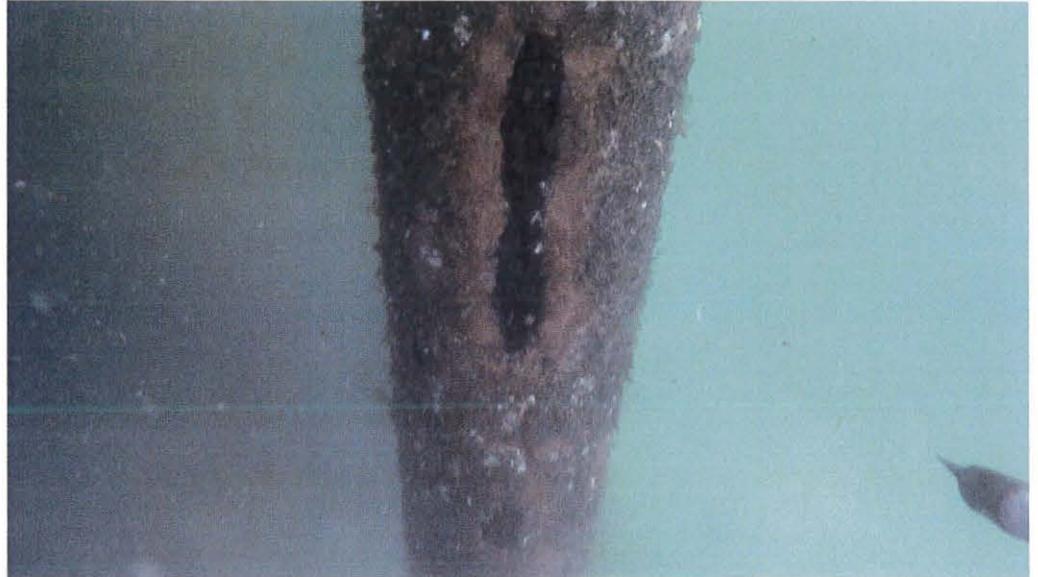
Pile Y has a 3"(W) x 18"(H) hole and a 3" (W) x 6"(H) hole from mechanical abrasion of log boom.

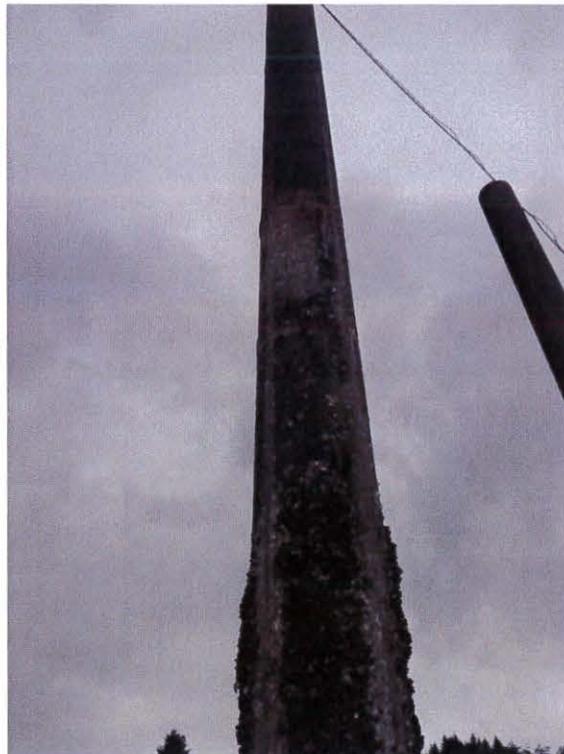
**SI-3**

8902 INORGANIC ZINC VINYL PAINT:  
 Many of the spud piles have rust blisters and seam rust (photo #3).

Typical shot of spud piles. Seam rust on welds are breaking through the paint.

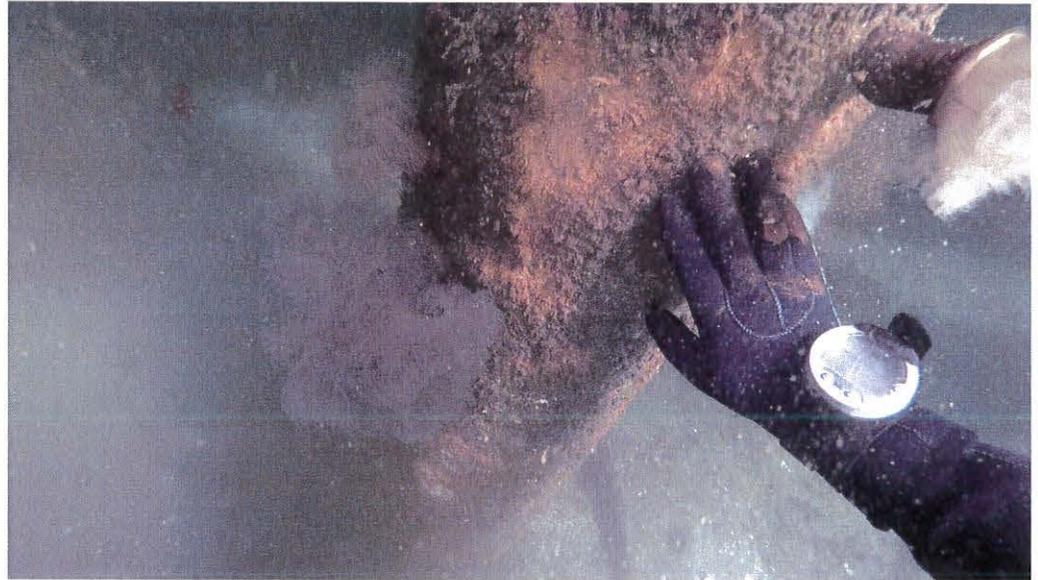
Typical pile condition underwater.  
Coating has failed over 25%-50% of the  
surface area on the piles below water.  
Example of ~25% exposed metal shown.

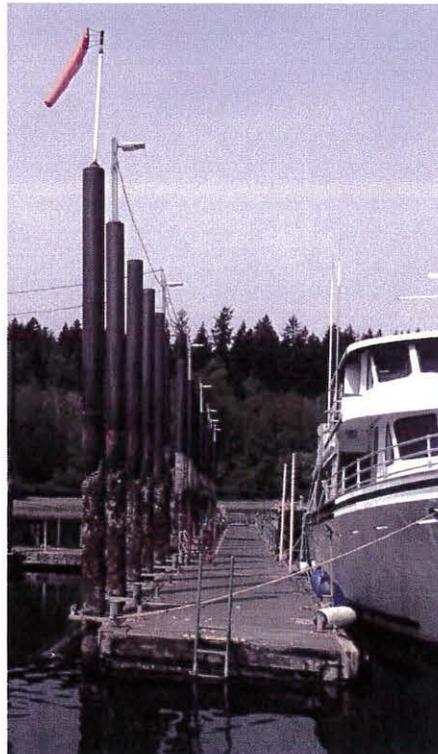
## UW-25

8910 SAFETY ACCESS LADDERS:  
 There is a ladder attached to each end of the t-dock (Photo UW-25).

There is a ladder attached to each end of  
the t-dock.
