BRIDGE INSPECTION REPORT

Br. No. DOC-7

Br. Name MCNEIL IS. STILL HARBOR TRESTLE

Report Type	Inspection Type	Date	Freq	Hours	Inspector	Cert No	Co-Insp.
Routine		4/27/2021	24	1.0	ABK	G1220	LAW

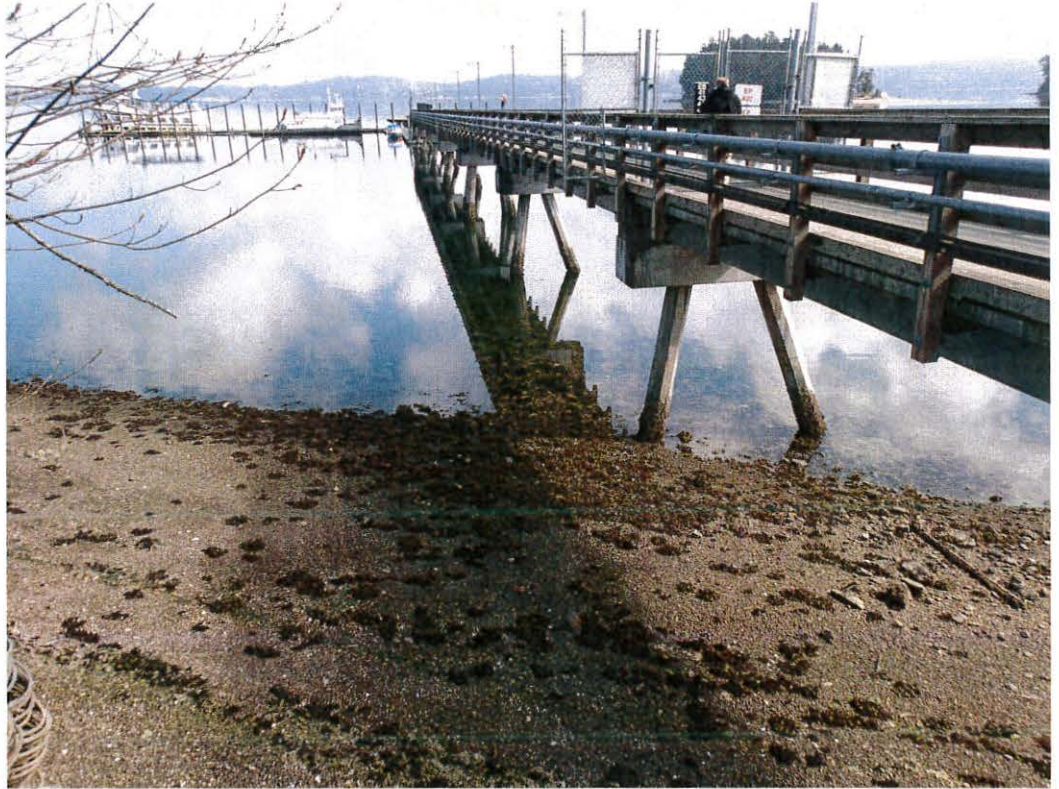
SI-1

Still Harbor Trestle looking NE.

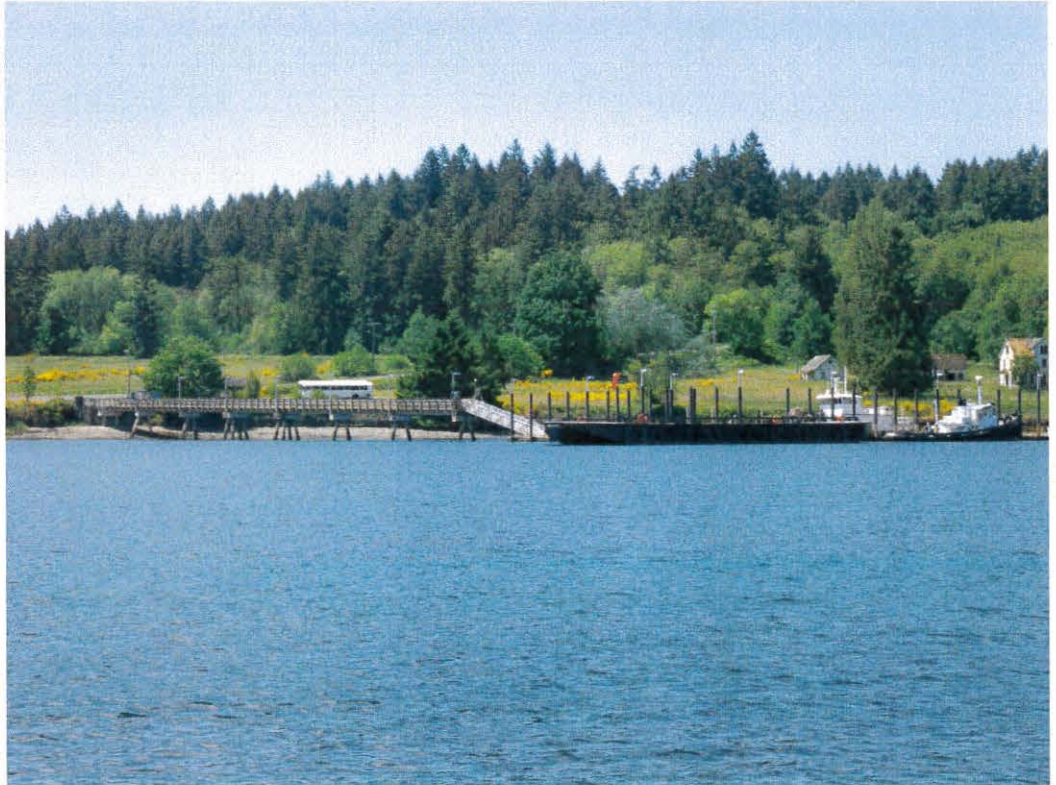
SI-2

Trestle elevation looking SW.

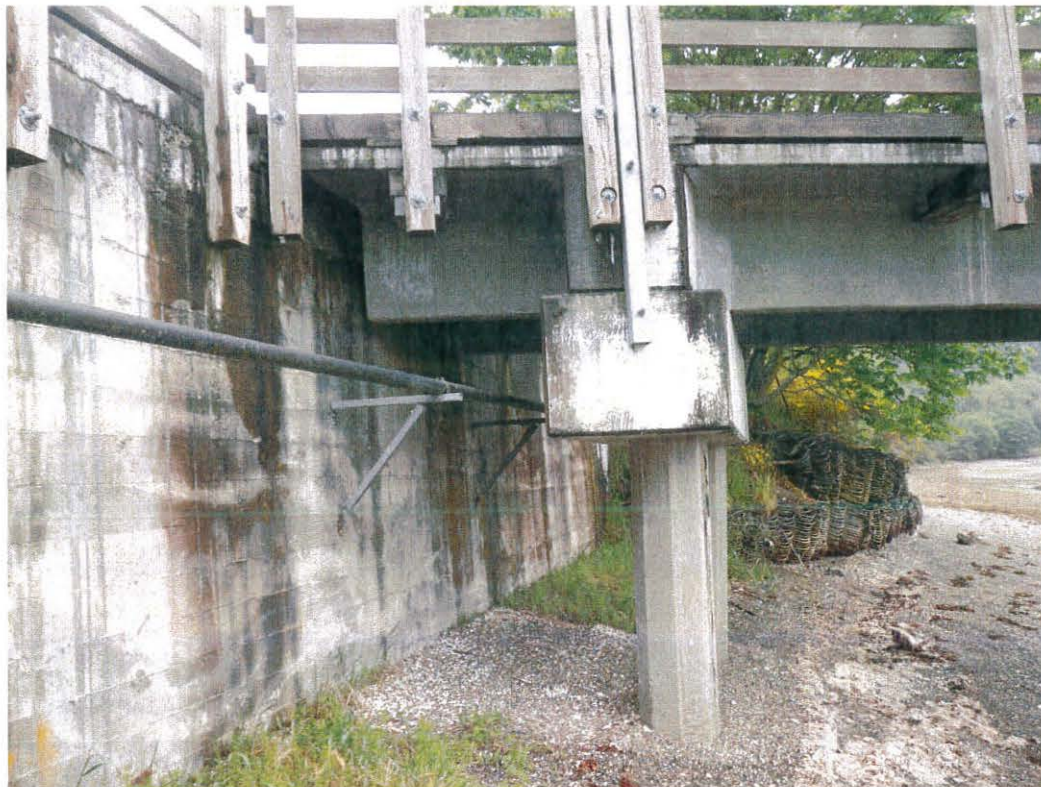
SI-3

This abutment consists of a precast deck cantilevered 5' from Pier 1 (photo #3). The retaining wall was previously used as the abutment of the old dock in Still Harbor.

Pier 1 supports 5 ft. of cantilevered precast deck.

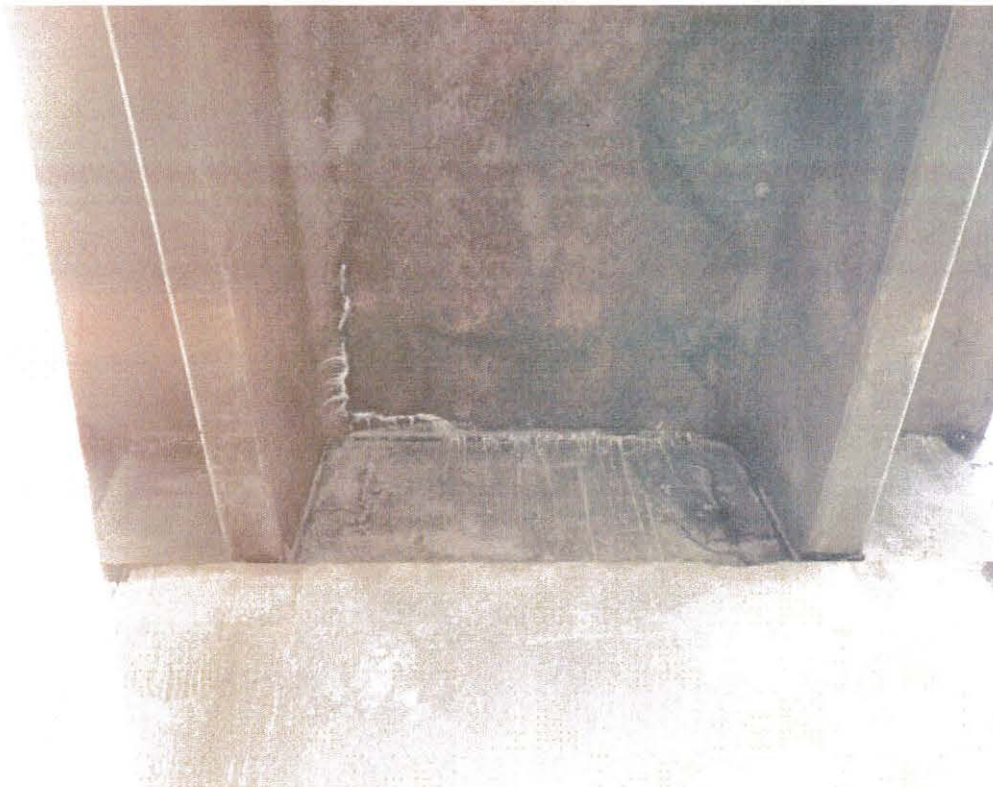
SI-4

8109 PRESTRESSED CONCRETE MUTIPLE WEB GIRDER:
 About half of the girders have very light leaching cracks, typically near the piers.
 Span 1 has a leaching crack at Pier 2, 5 lf. (photo #4).
 Pier 2 end diaphragm has a delamination on the right web of Span 1 (photo #5).
 Pier 5 end diaphragm has delamintions adjacent to the interface with the bottom of the P/S girders.
 Pier 7 end diaphragm has a delamination at the left web of Span 7 (photo #6).

Span 1 has a leaching crack at Pier 2.

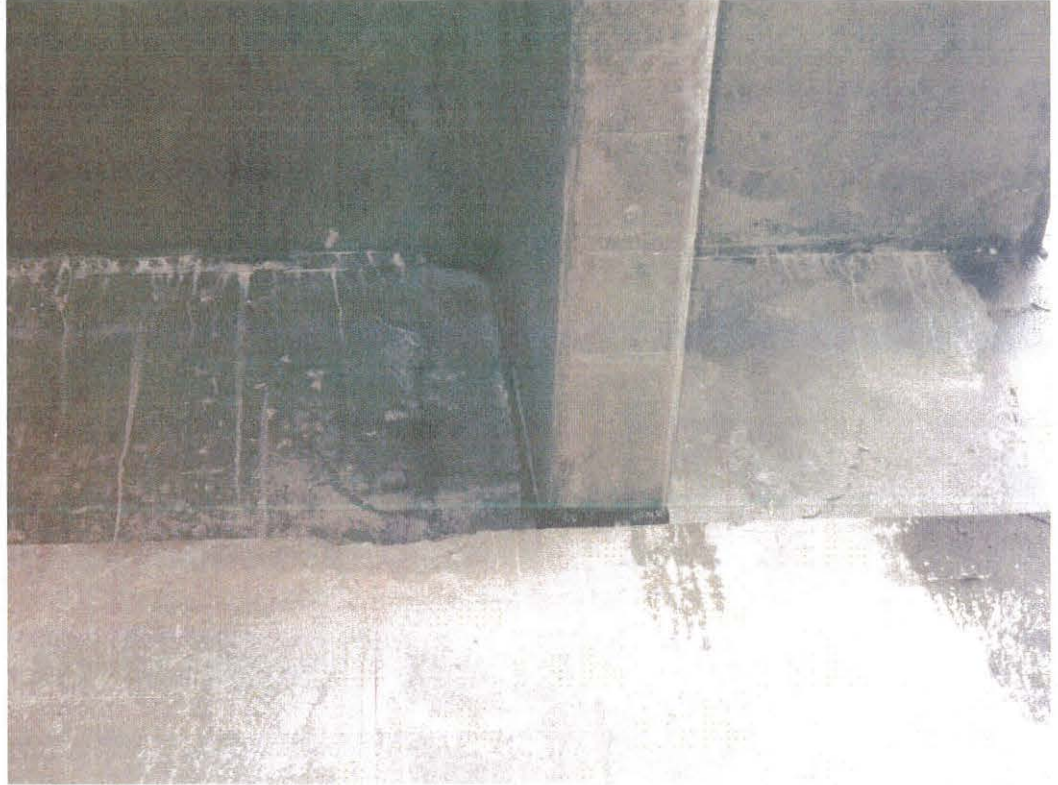
SI-5

Pier 2 end diaphragm has a delamination on the right web of Span 1.

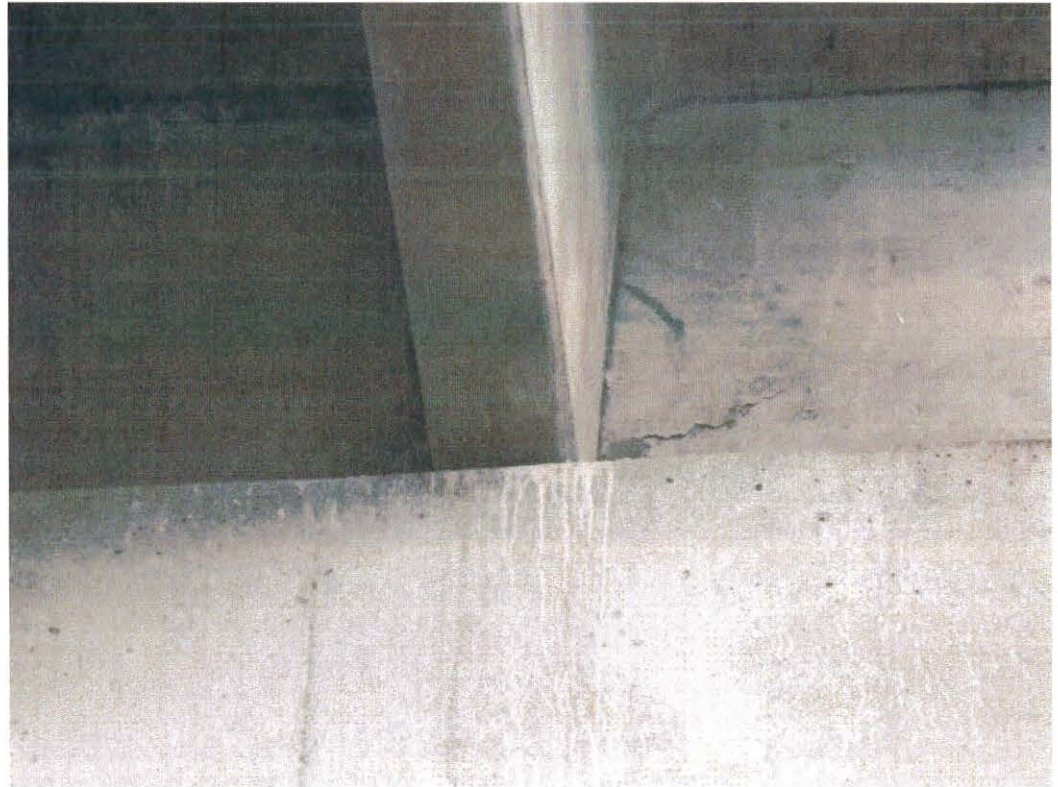
SI-6

Pier 7 end diaphragm has a delamination at the left web of Span 7.

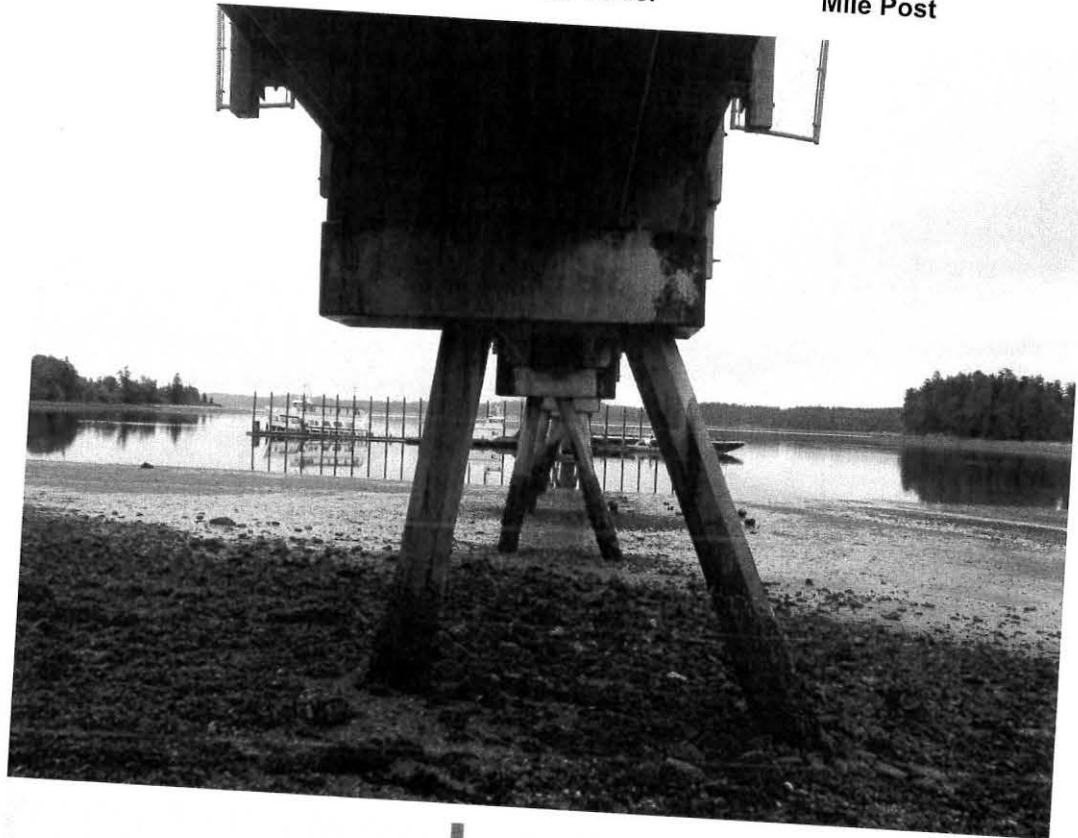
SI-7

8125 CONCRETE SUBMERGED PILE/COLUMN:
 Many of the piles are not placed symmetrically (photo #7). Pier 2 shown in the photo results in a unbalanced loading on the piles.

Many of the piles are not placed symmetrically.

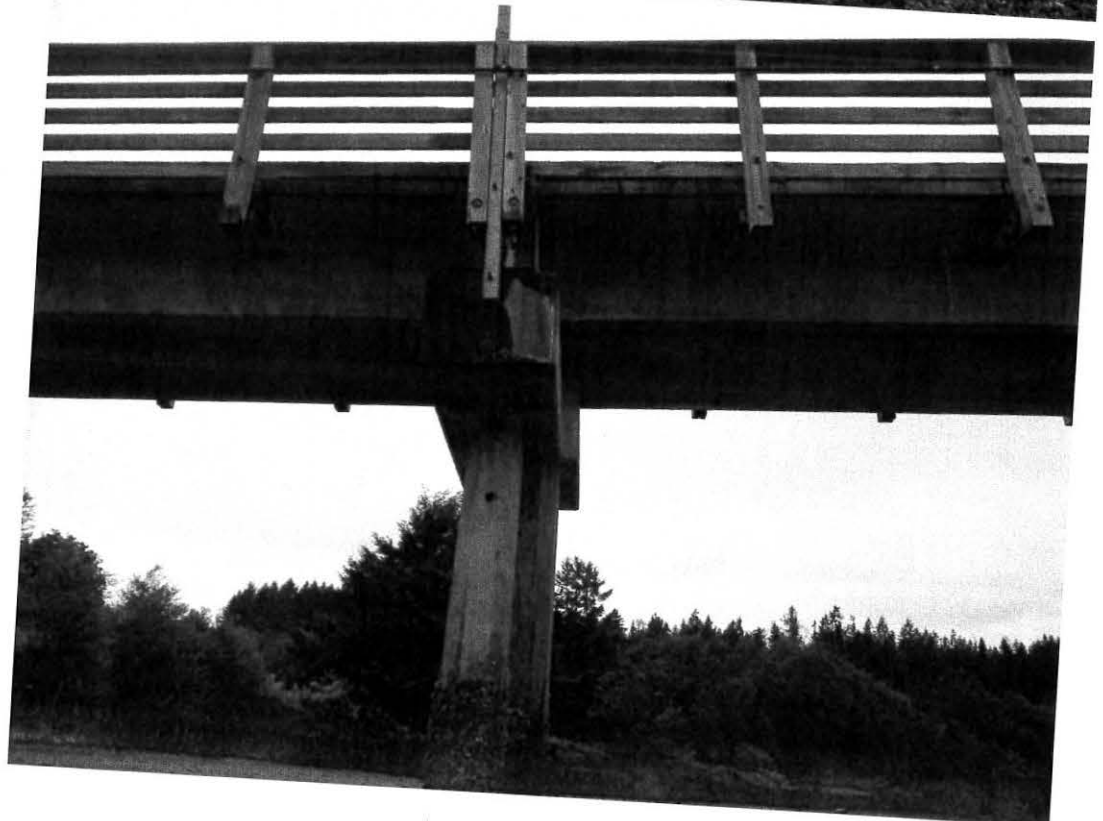
SI-8

Pier 3 concrete cap was widened 6" to accommodate misplaced Pile 3A.

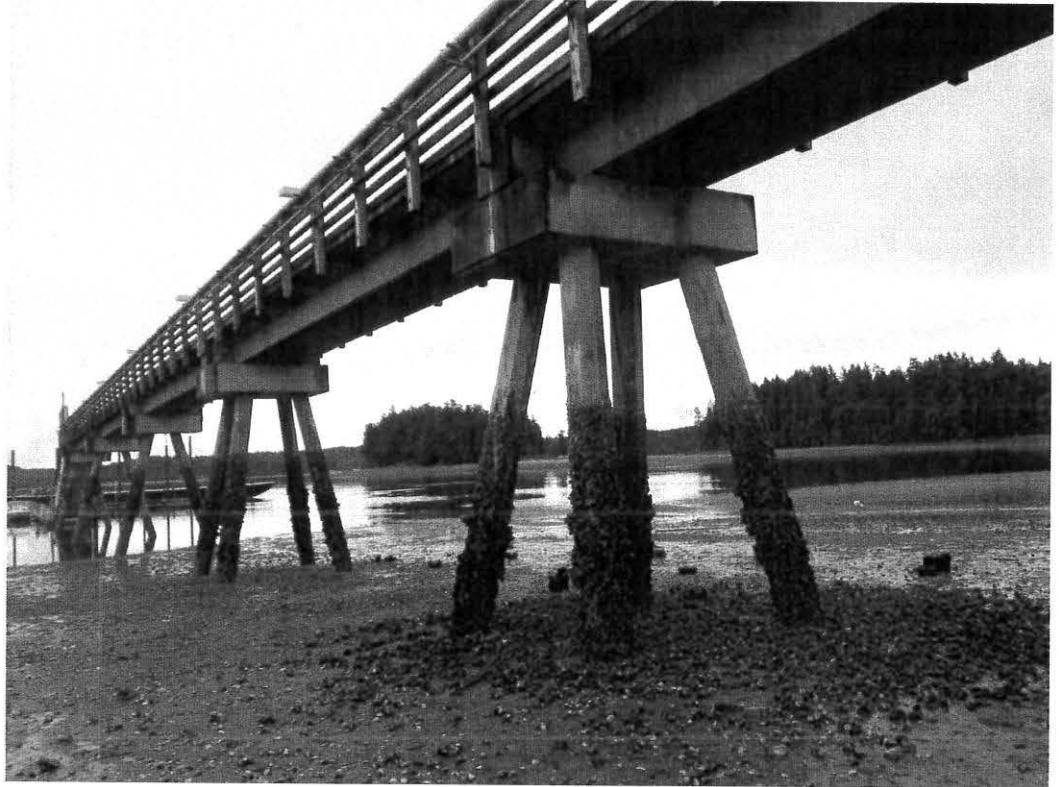
SI-9

Pier 4 and Pier 5 caps both were widened 6" to accommodate misplaced piles.
