**SimplexGrinnell #458 & JCI  
9520 10th Avenue South, Suite 100  
Seattle, WA 98108  
RE: Western State Hospital; Lakewood, WA  
318,000 Gallon Bolted STP  
August 3, 2018  
Ms. Melissa Fraser  
Systems Integrity Representative  
(206) 291-1439  
Job No. 318298-A**

## STANDPIPE INSPECTION REPORT

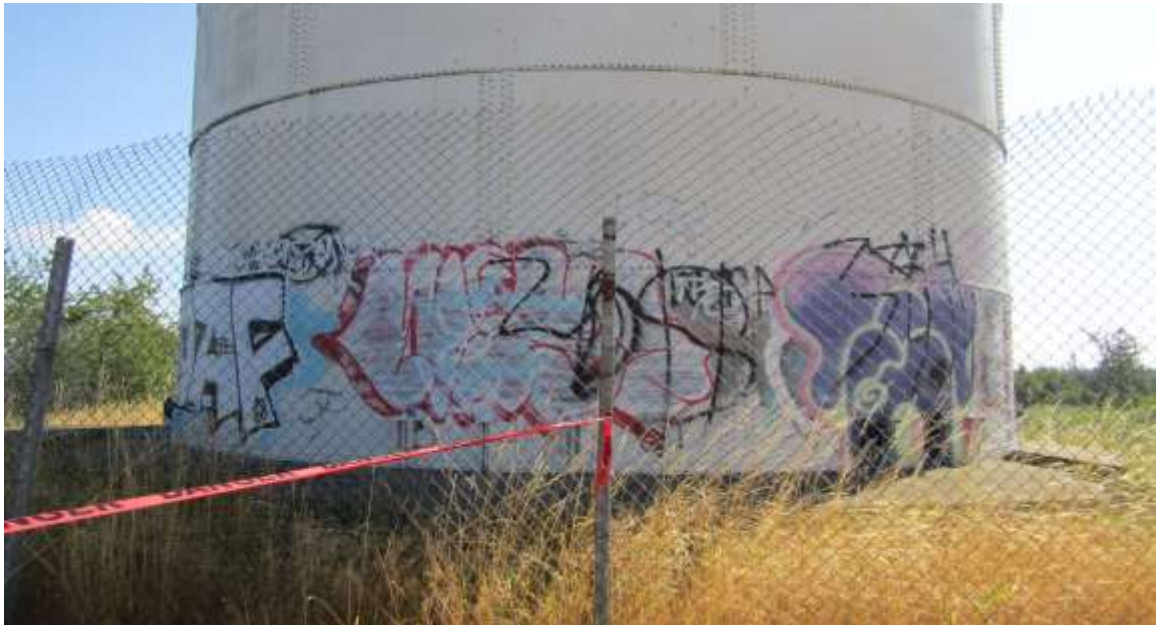
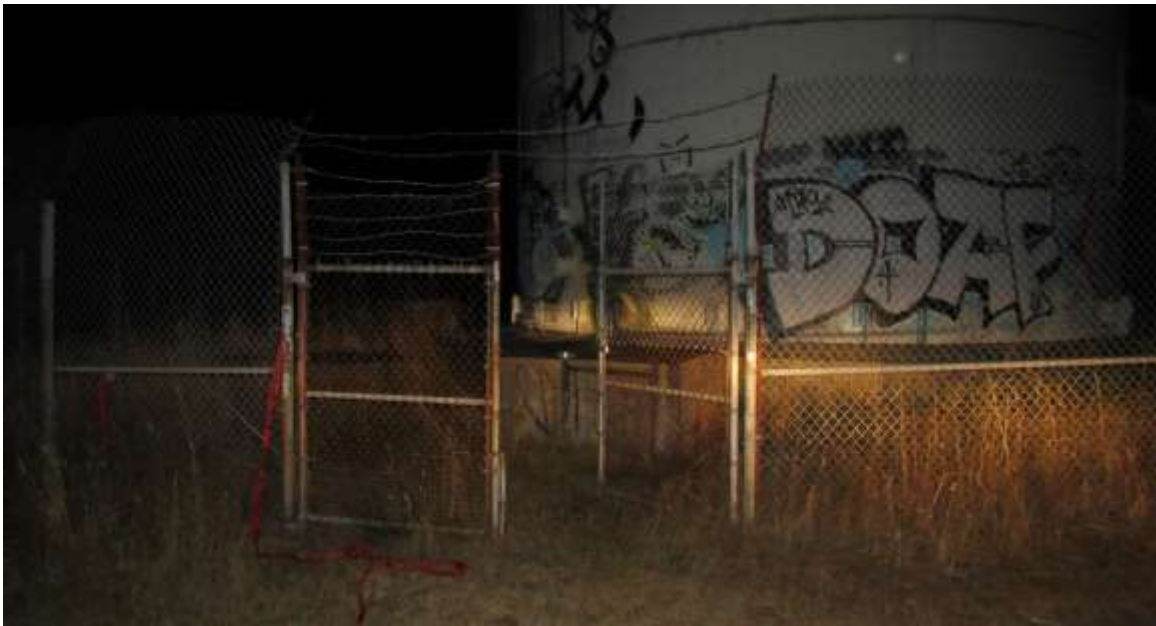
Photos show the tank is secured with fencing. There is no signage on the fence. We recommend posting a **No Trespassing** sign.

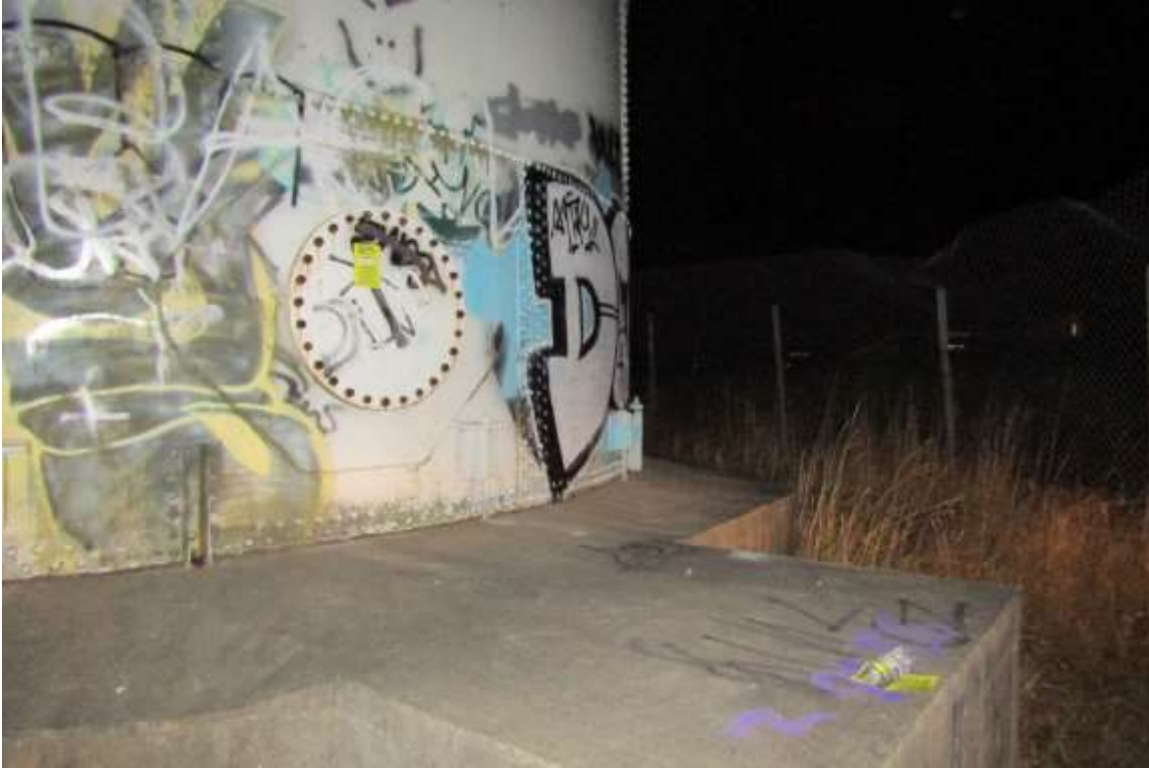
Photo shows the foundation, which is in compliance with [AWWA D103-09; 13.5.1: Height above ground](#) and appears to be in good condition.

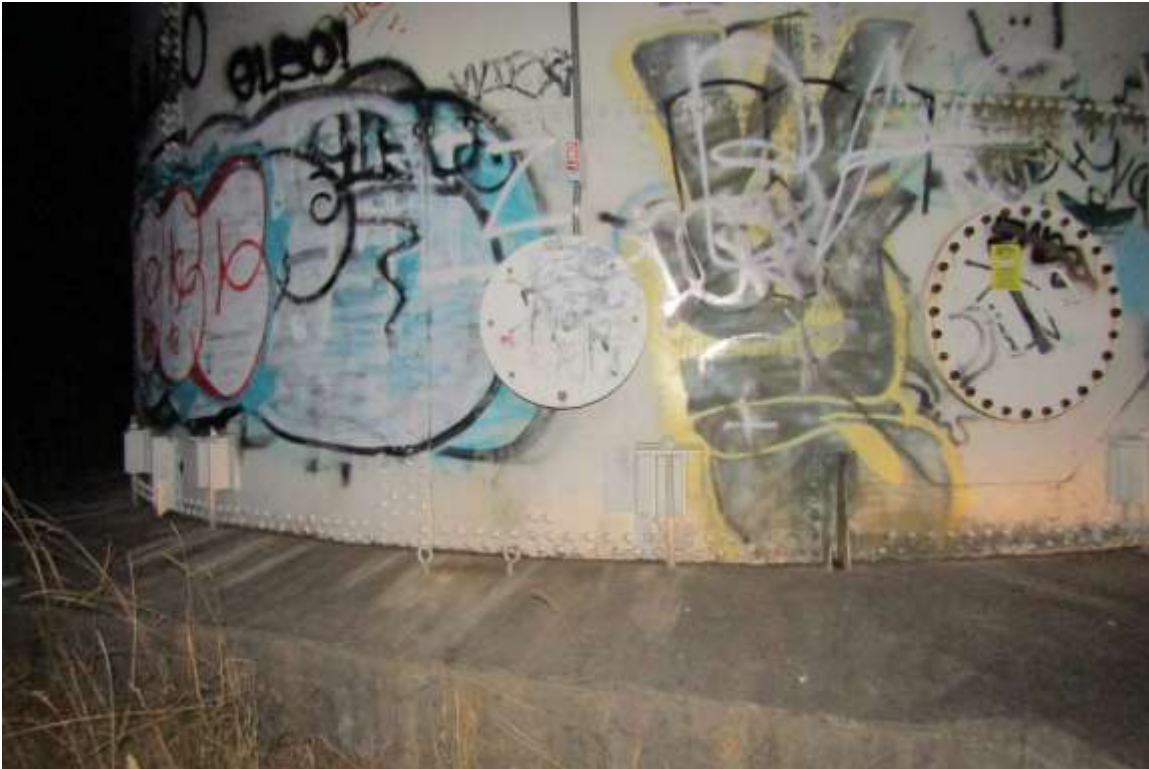
Photo shows the condition of the foundation. **NFPA 22-2018; 12.2.1.2** states, "... the junction of the tank bottom and the top of the concrete foundation shall be tightly sealed to prevent water from entering the base." We recommend repairing any cracks and spalling in the concrete with a commercial non-shrinking grout, caulking around the base of the tank to foundation connection to prevent water from entering under the tank, then sealing the foundation with a sealant.

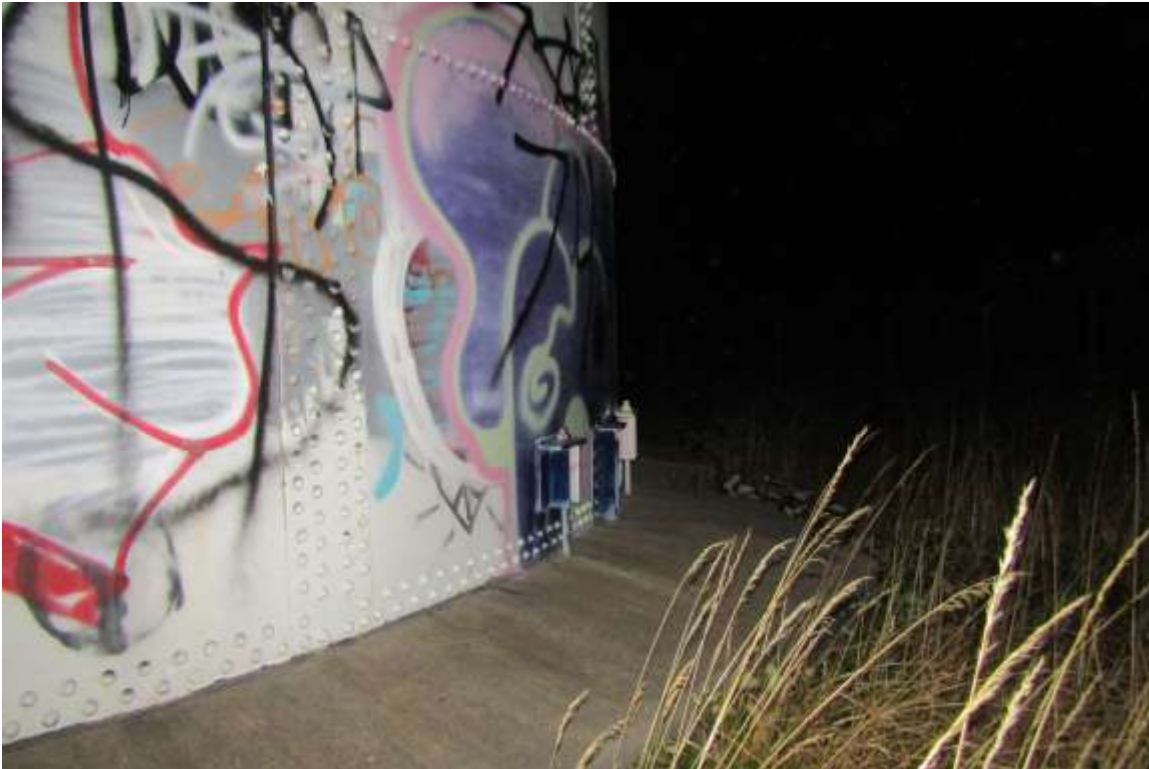
Photo shows more of the condition of the tank. **NFPA 780-2017; 5.4: Metal Towers and Tanks** states, "Metal towers and tanks constructed so as to receive a stroke of lightning without damage shall require only bonding to grounding electrodes..." We recommend electrically grounding the tank for lightning protection as required by **OSH Act of 1970 Section 5** and **NFPA 780-2017; 5.4: Metal Towers and Tanks**.

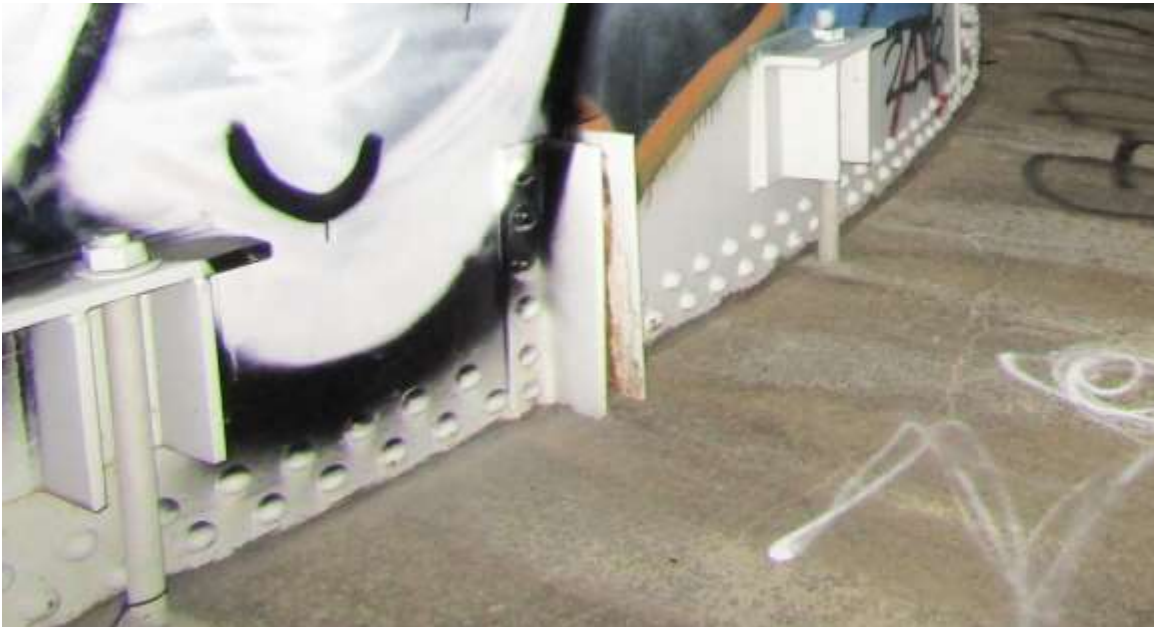
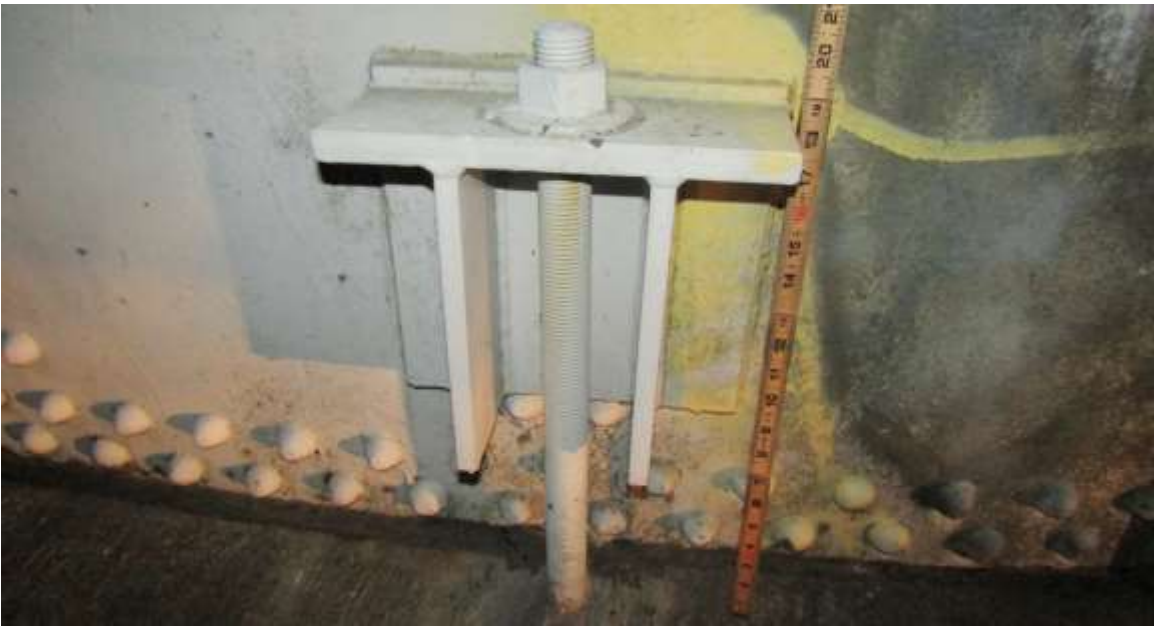
Photos show the condition of the anchor bolts. **AWWA D103-09; 5.9.1.1 Required anchorage** states, "Anchor bolts shall be provided when the wind or seismic loads exceed the limits for self-anchored tanks." We recommend cleaning the area around the anchor bolts, tightening the anchor nuts to specifications, then tack welding the circumference of the nut-to-base plate connections and tack welding the bolt-to-nut connections for preventive maintenance.

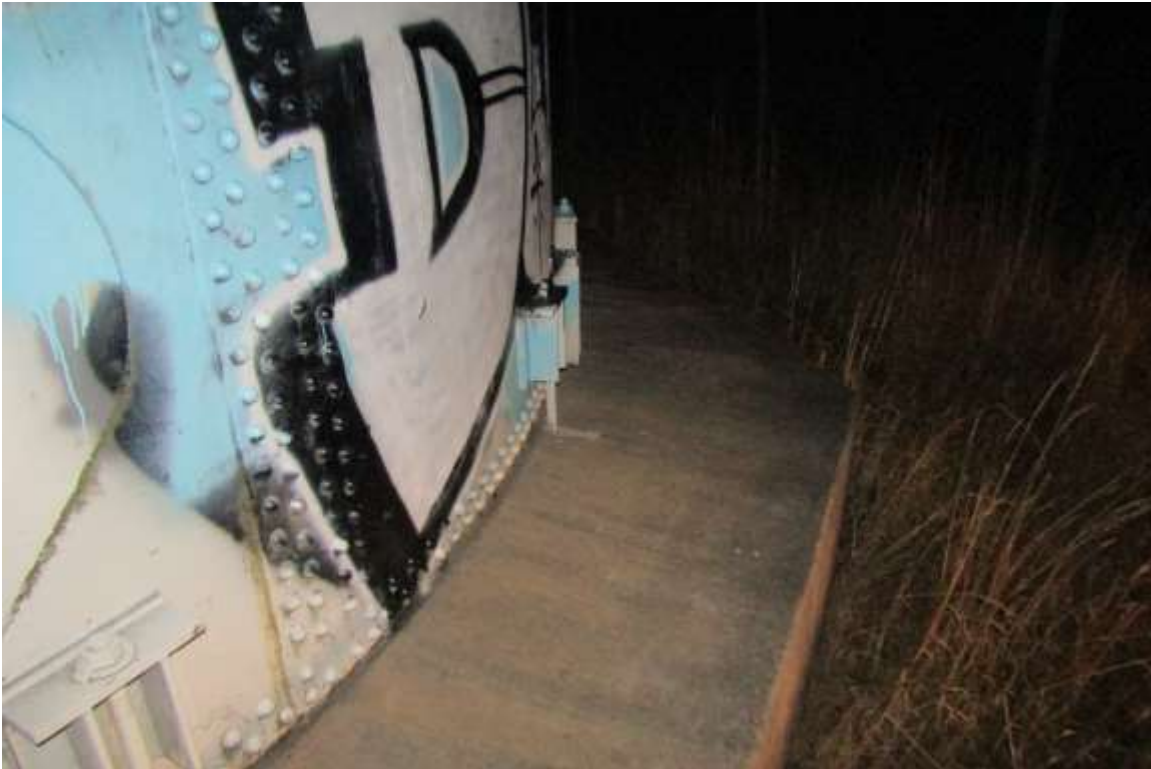
Photo shows the condition of the shell. Currently there is no drain valve. We recommend installing a frost proof drain valve near the shell-to-floor connection, complete with a locking device to prevent unauthorized draining of the tank and a splash pad to direct water away from the foundation. Splash pad to be installed by owner.

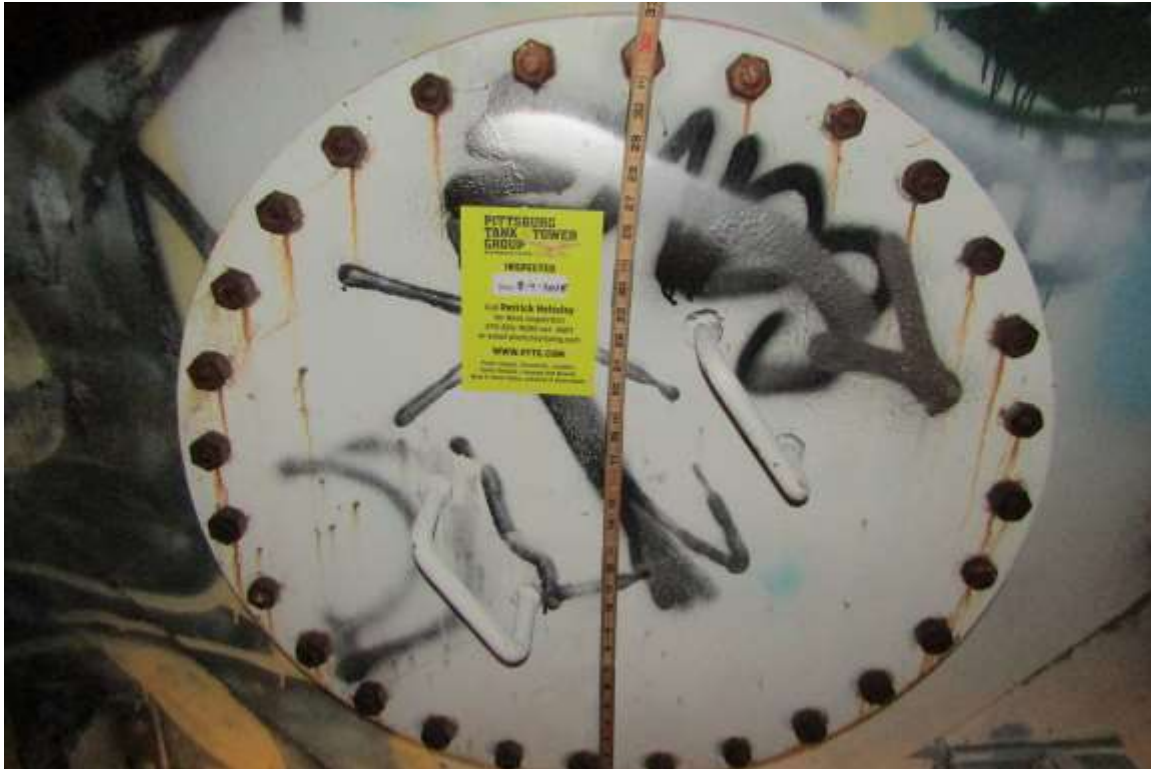
Photo shows the condition of the 24" primary shell manway. **NFPA 22-2018; 14.7.2.1.1** states, "The design of the manholes for steel tanks shall be in accordance with ...and **AWWA D103** for bolted steel tanks." The primary manway requires the following to be in compliance with **NFPA 22-2018; 14.7.2.1.1, AWWA D103-09; 7.1: Shell Manholes** and **OSHA 1910.146(c)(2) Confined spaces**.

We recommend:

- Install a davit arm on primary shell manway
- Install a 30" secondary shell manway 180° from primary manway
- Post **Confined Space Entry** signs
- Install maintenance free galvanized steel bolts

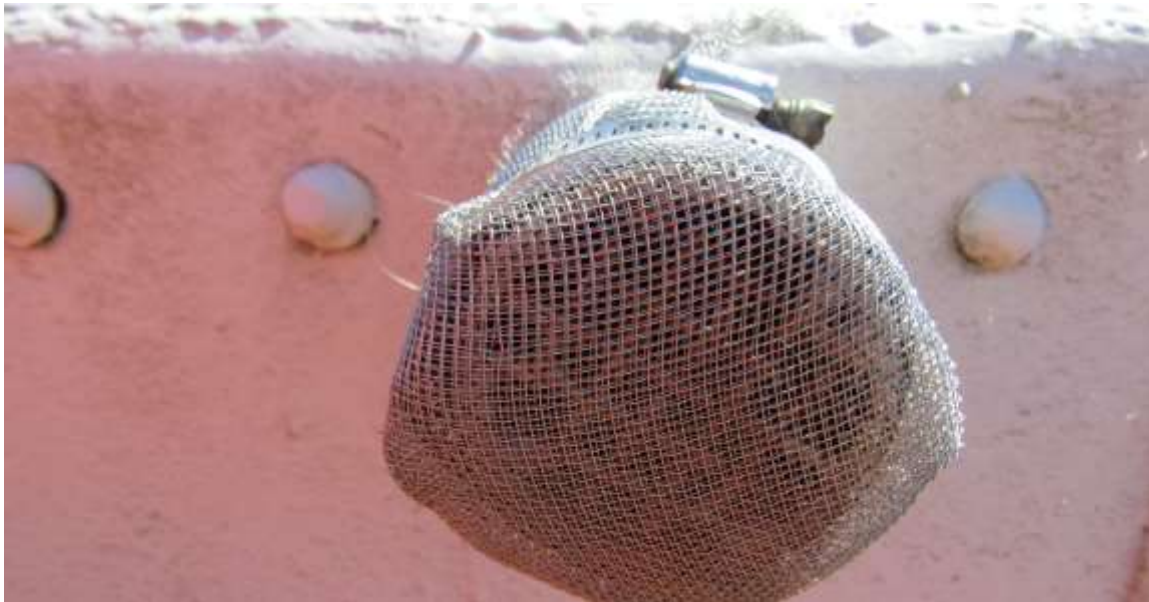
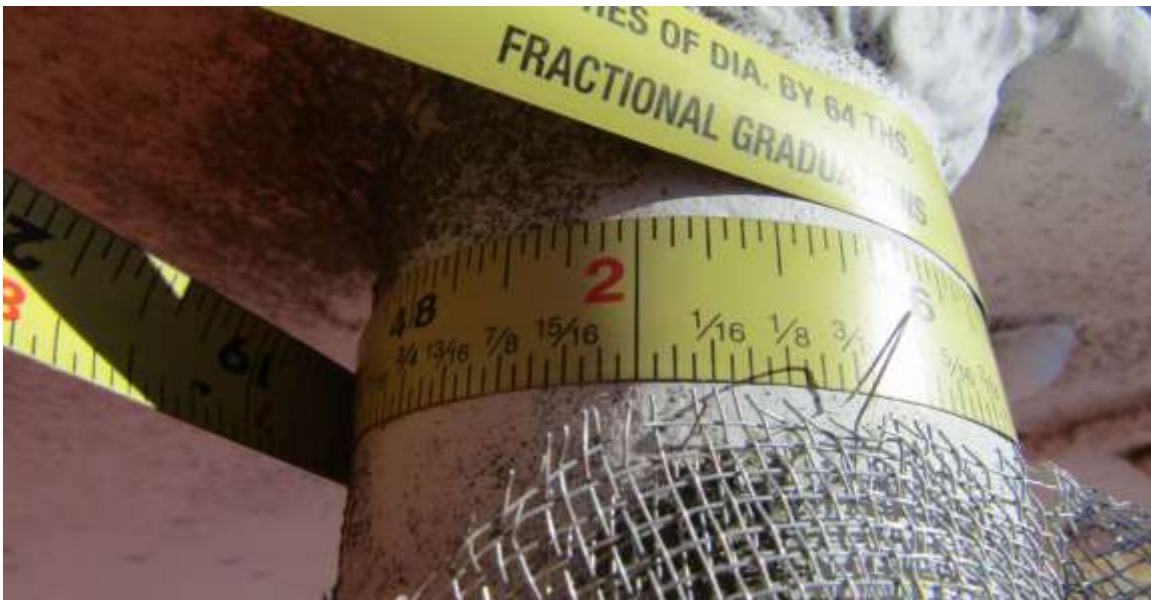
Photos shows the condition of the 2" stub overflow pipe. **NFPA 22-2018; 14.6.3.2** states, "The pipe shall be extended with a slight downward pitch to discharge beyond the tank or balcony and away from the ladders and shall be adequately supported." We recommend extending the overflow down the exterior to grade with same size pipe, complete with standoffs every 10' on center, an elbow at the base fitted with a flapper valve and screen to prevent the ingress of contaminants into the water supply, and a splash pad to direct the water away from the tank foundation. Splash pad to be installed by owner.

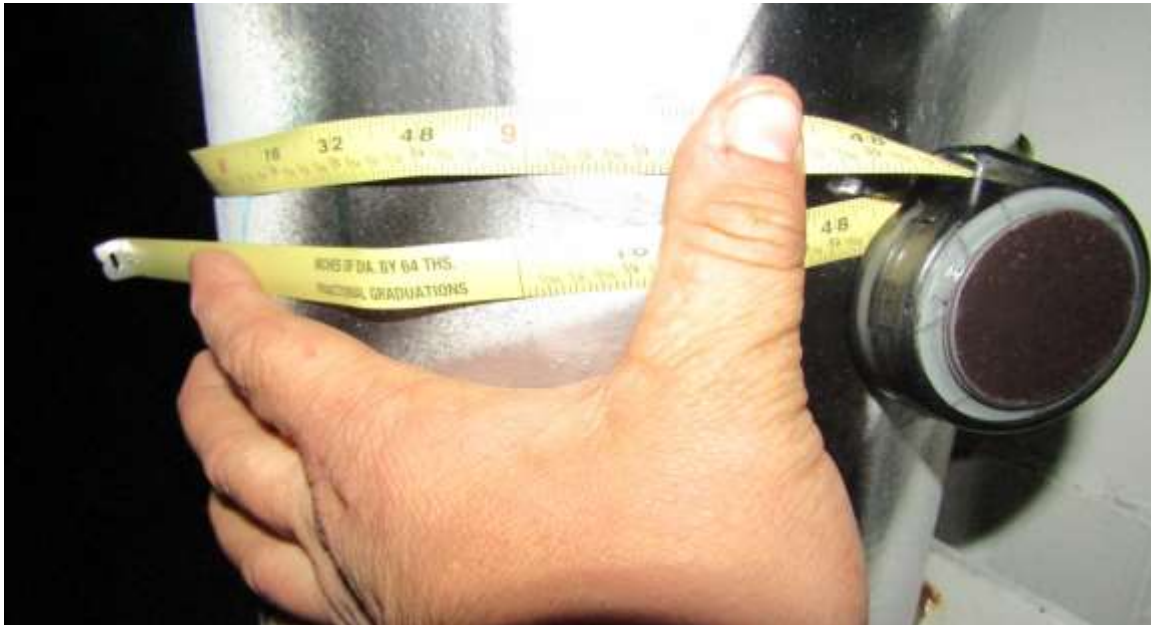
Photos show the 8" overflow pipe system, which is equipped with a flapper valve as required by [AWWA D103-09; 7.3: Overflow](#).

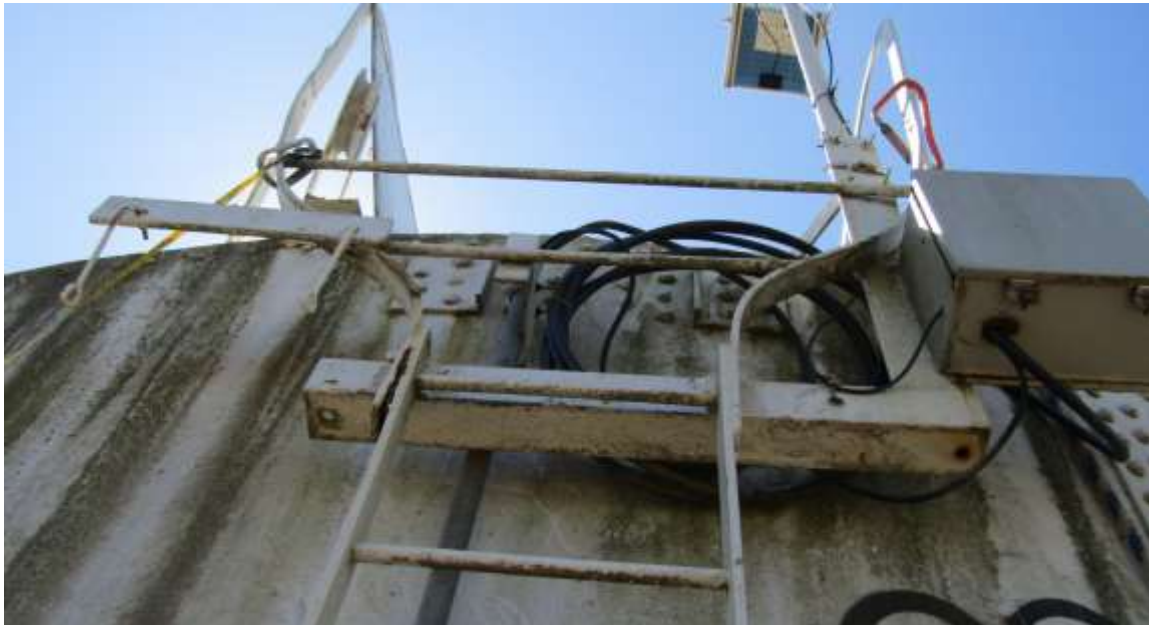
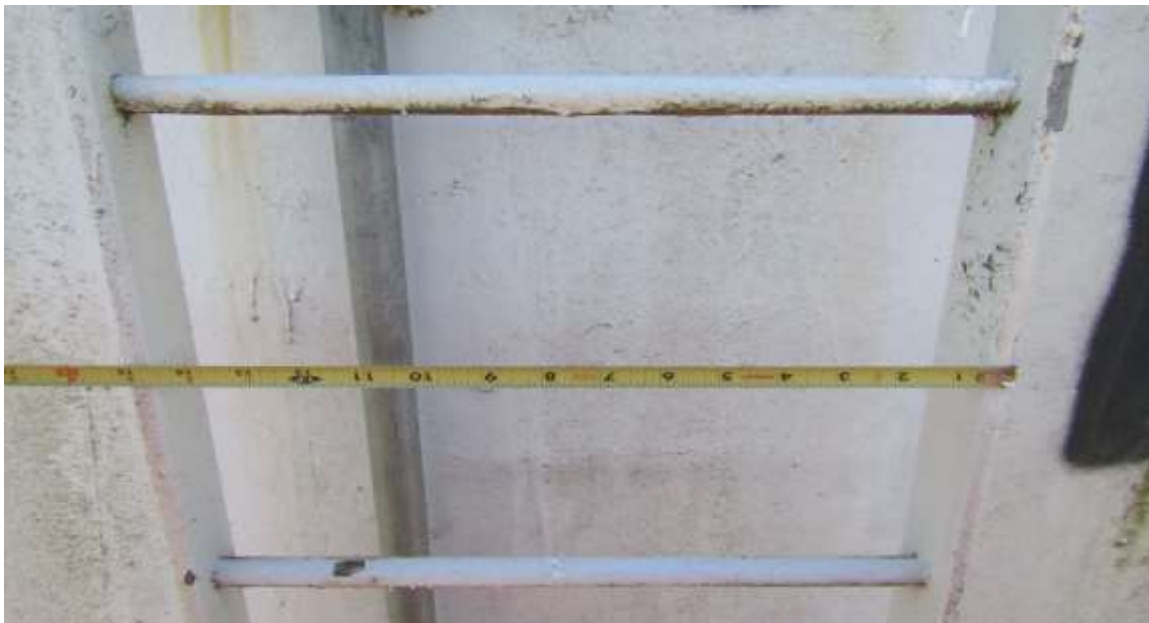
Shell access ladder in above photos is not equipped with anti-skid rungs and is only 15" wide. **OSHA 1910.23(b)(4)** states, "Ladder rungs, steps, and cleats have a minimum clear width of... 16 inches (41 cm)..." We recommend installing an **OSHA** compliant shell access ladder complete with standoffs every 10' on center and anti-skid rungs, a cable type ladder safety device, a lockable ladder guard to prevent unauthorized access and posting a **Fall Protection Required** sign at the base of the ladder.

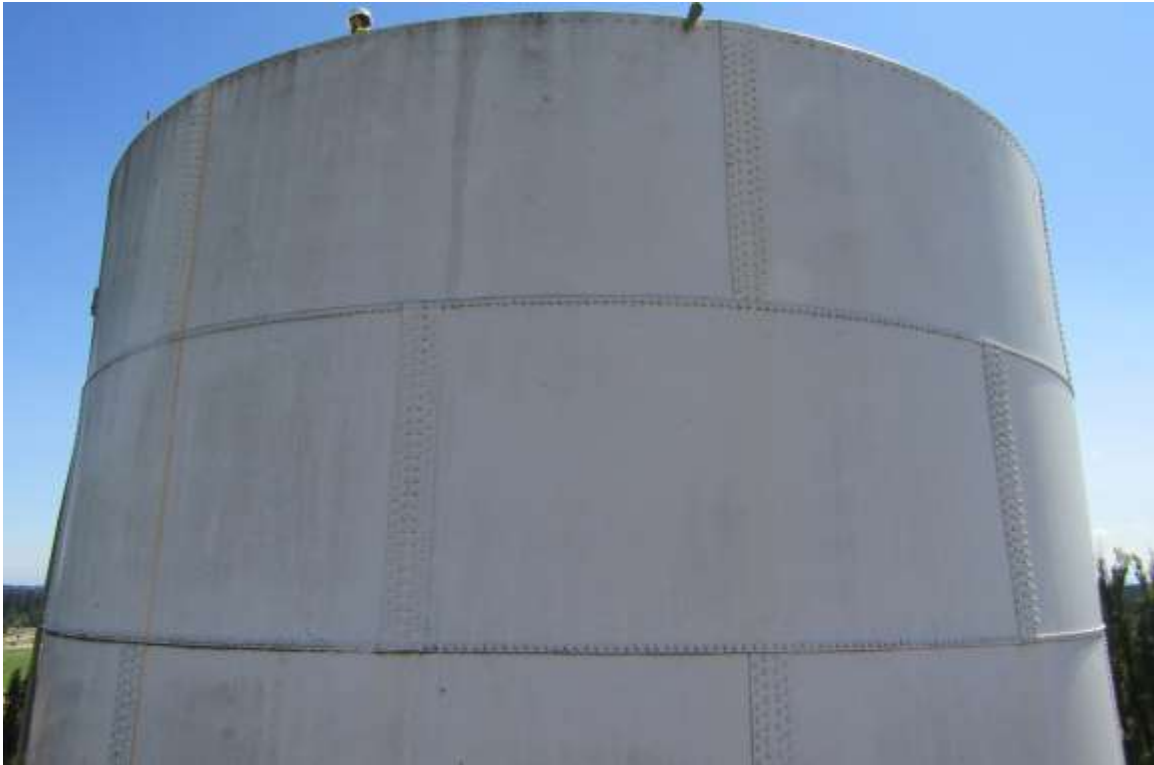
Photo shows the tank is not equipped with a liquid level indicator. **NFPA 22-2018; 14.1.8\* Water-Level Gauge** states, "A water-level gauge of suitable design shall be provided. It shall be carefully installed, adjusted, and properly maintained." We recommend installing a liquid level indicator, complete with target board and float.

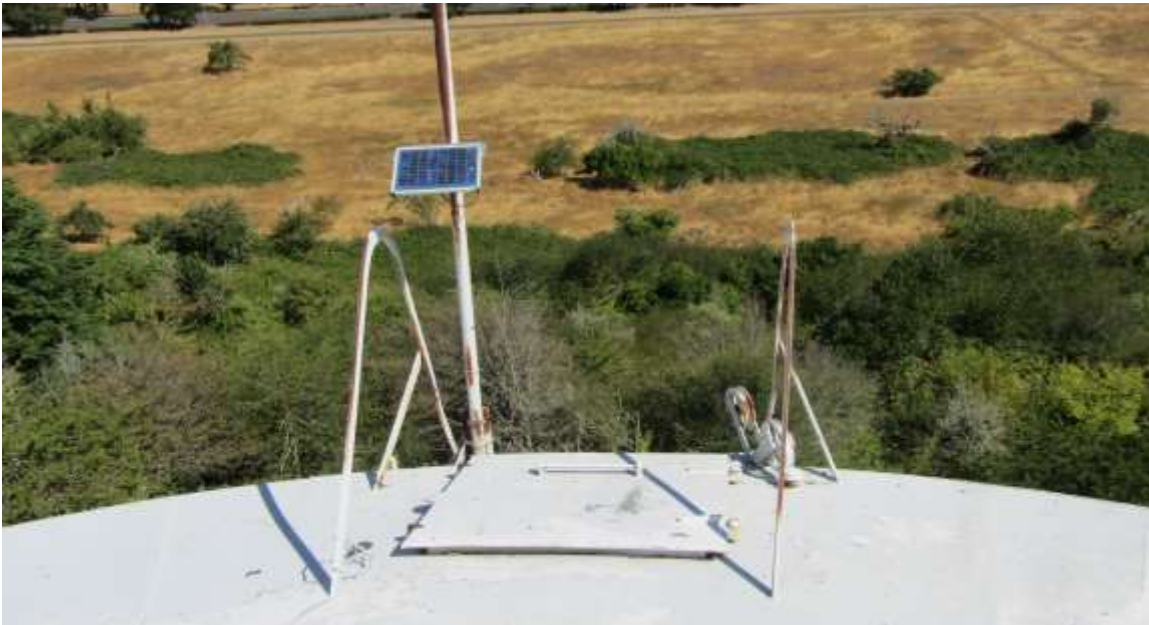
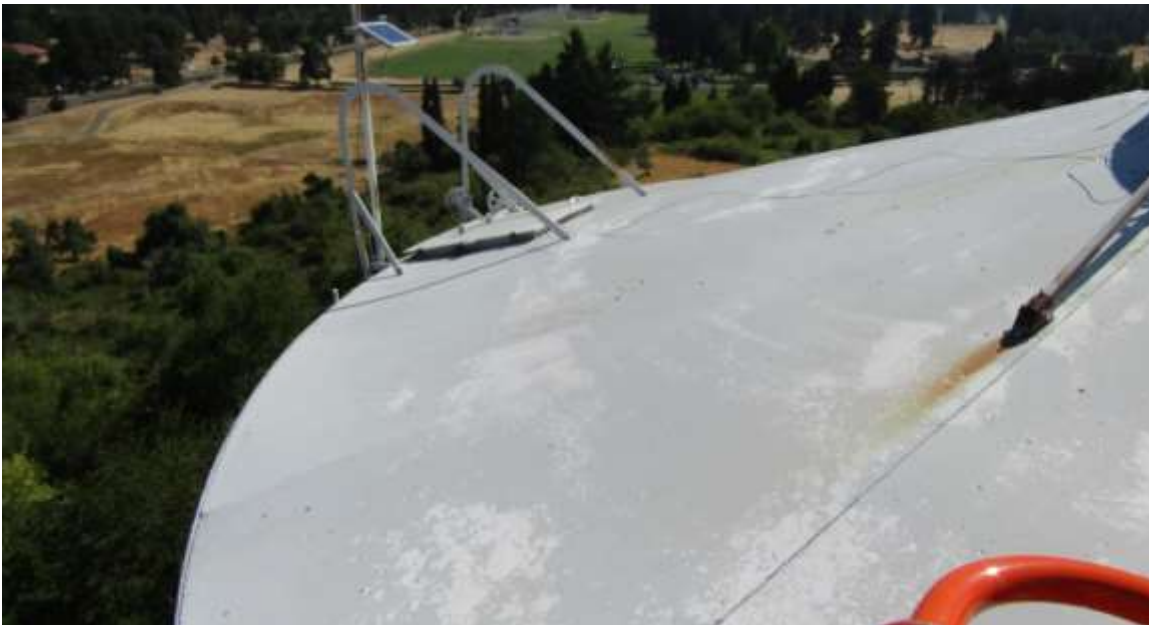
Photos show the tank roof edge is not equipped with a required handrail system for fall protection. **OSHA 1910.28(b)(1)(i)** states, "...the employer must ensure that each employee on a walking-working surface with an unprotected side or edge that is 4 feet (1.2 m) or more above a lower level is protected from falling by one or more of the following: **1910.28(b)(1)(i)(A) Guardrail systems.**" We recommend installing an **OSHA** compliant 42" high handrail system around the circumference of the tank roof, complete with intermediate rail, toeboard and a swing gate at the junction of the shell-to-roof access ladder and tank roof.

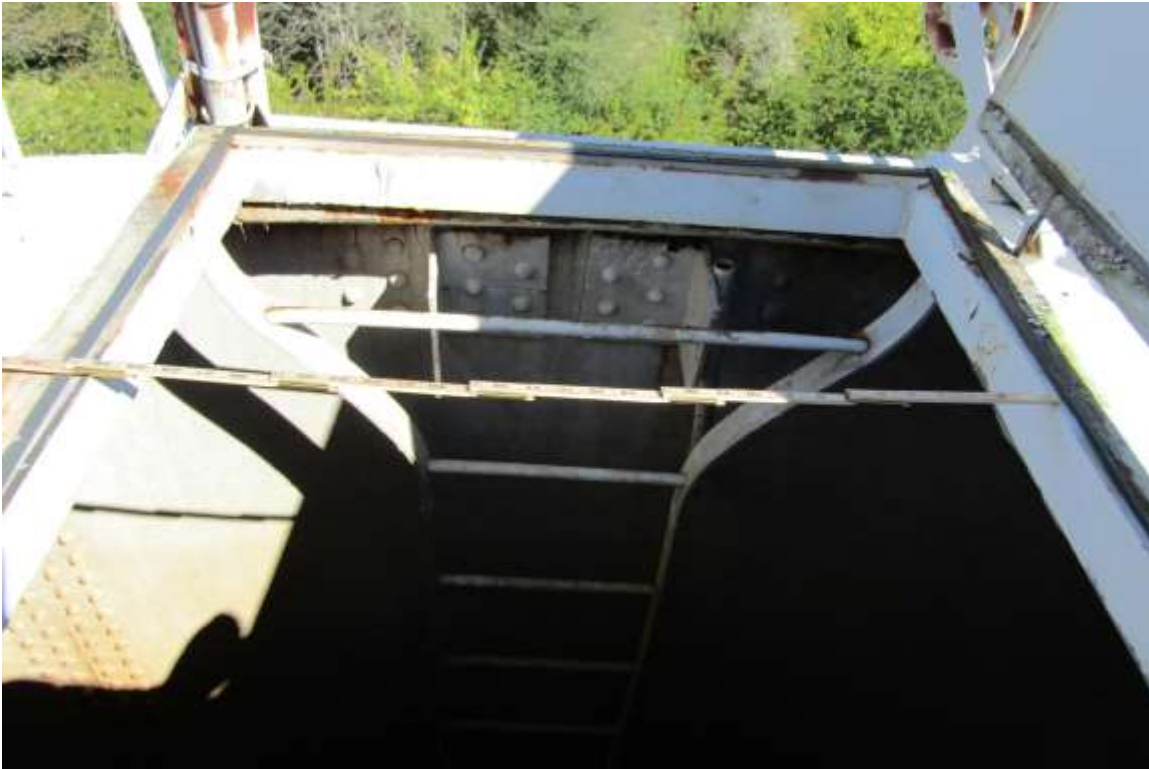
Photo shows the condition of the existing 30" roof hatch. Roof openings on this tank require the following to be in compliance with **AWWA D103-09; 7.6: Roof Openings** and **OSHA 1910.146(c)(2) Confined spaces**.

We recommend:

- Replace 30" primary hatch cover with a 2" overlapping cover
- Install 30" secondary hatch 180° from primary roof hatch
- Post **Confined Space Entry** signs
- Install lock on primary hatch

We further recommend installing an **OSHA** compliant interior access ladder complete with standoffs every 10' on center, and cable type ladder safety devices at the suggested secondary roof hatch.

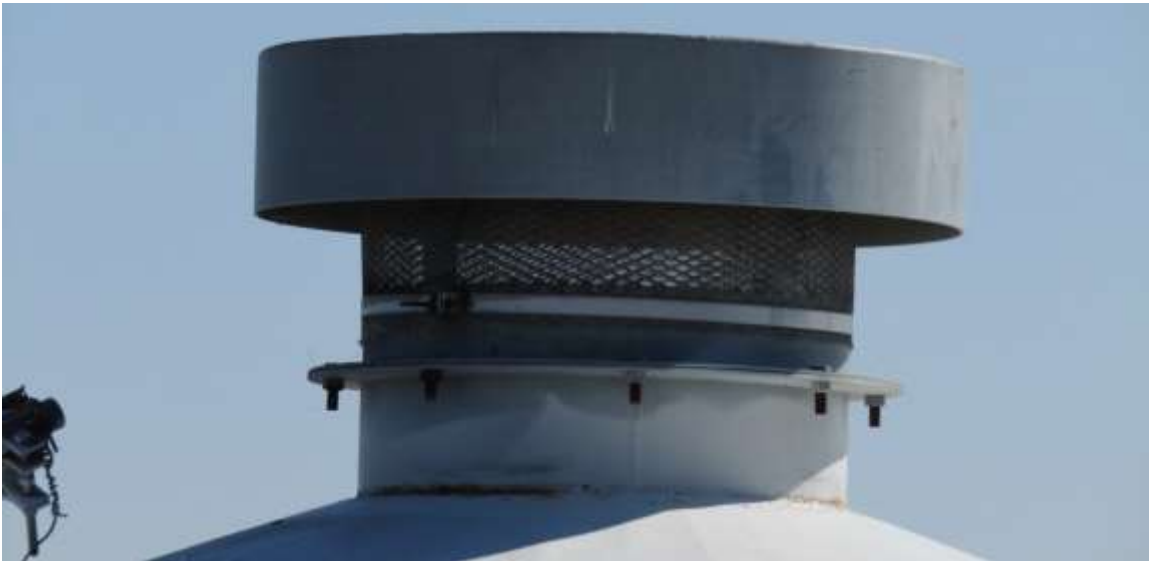
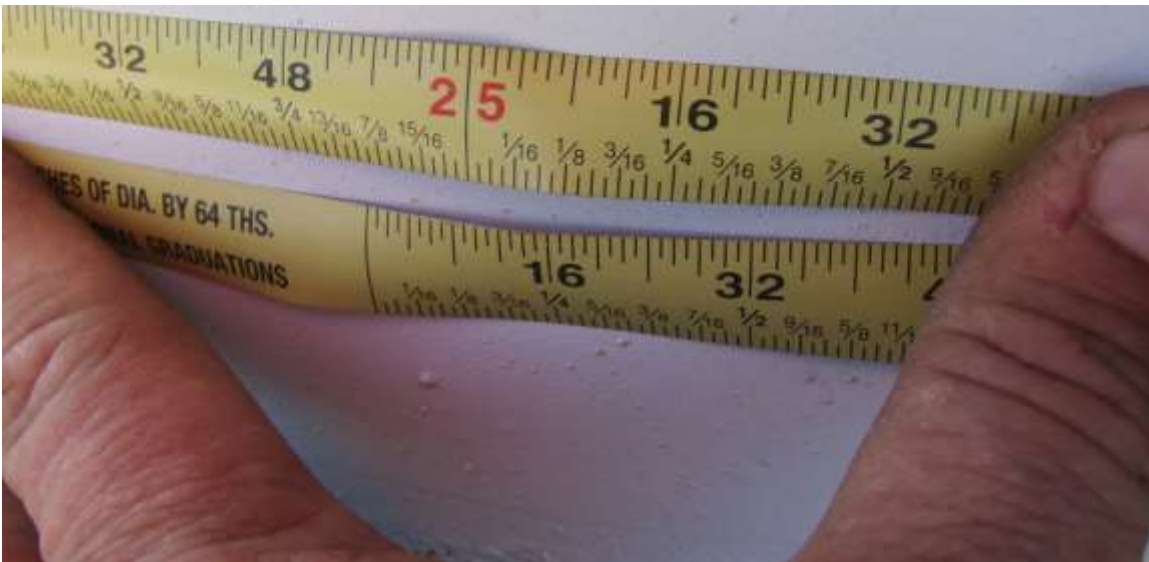
Photos show the condition of the existing 25" roof vent. **NFPA 22-2018; 4.15.3** states, "A corrosion-resistant screen or perforated plate with  $\frac{3}{8}$  in. (9.5 mm) holes, to exclude birds or other animals, shall be provided and have a net area at least equal to the vent line." **This vent is allowing the ingress of rain and wind-borne contaminants into the water system. An improperly vented tank may cause external pressure to act on the tank which can cause buckling even at low pressure differential.** We recommend replacing the existing roof vent with a vacuum-pressure, frost proof vent and screen in compliance with **NFPA 22-2018; 4.15: Roof Vent.**

**This work should be performed on an emergency basis.**

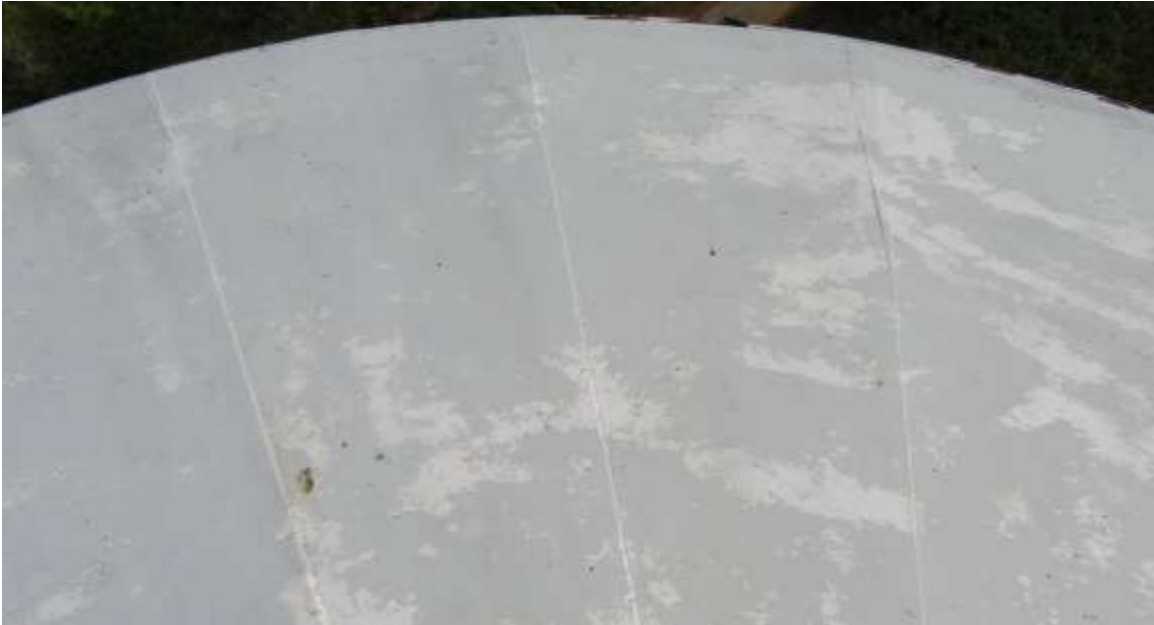
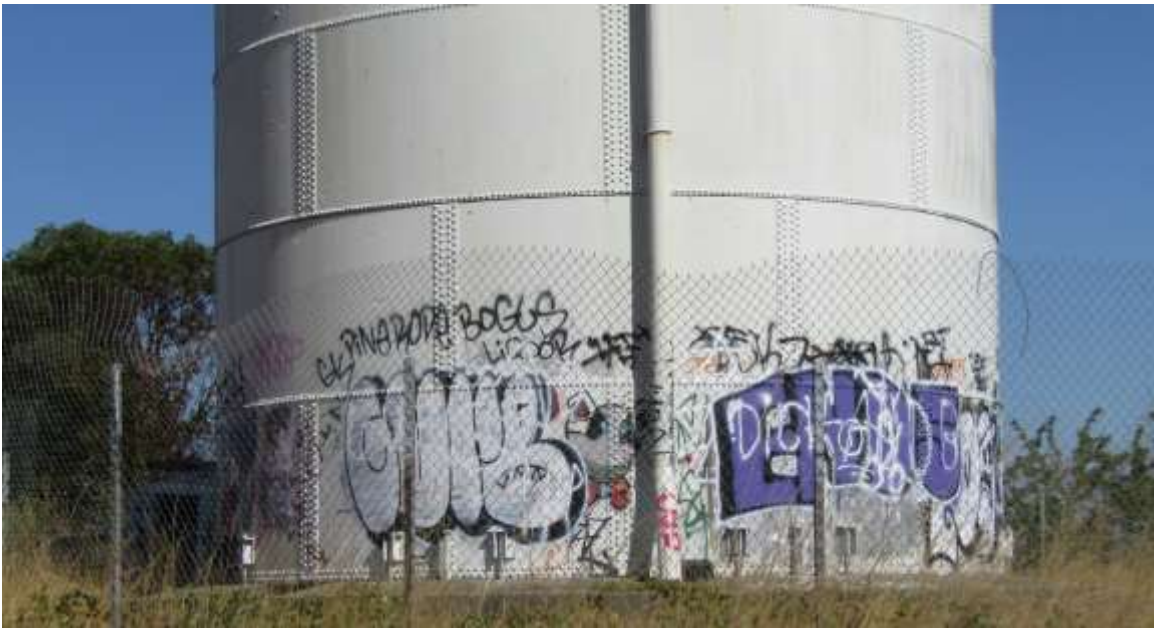
Photos show the tank exterior coating system. We recommend pressure washing the tank exterior with biodegradable detergent injection (minimum 1,500 psi at 1.5 gpm), spot prime and apply one (1) full coat of epoxy mastic, followed by a top coat of polyurethane.

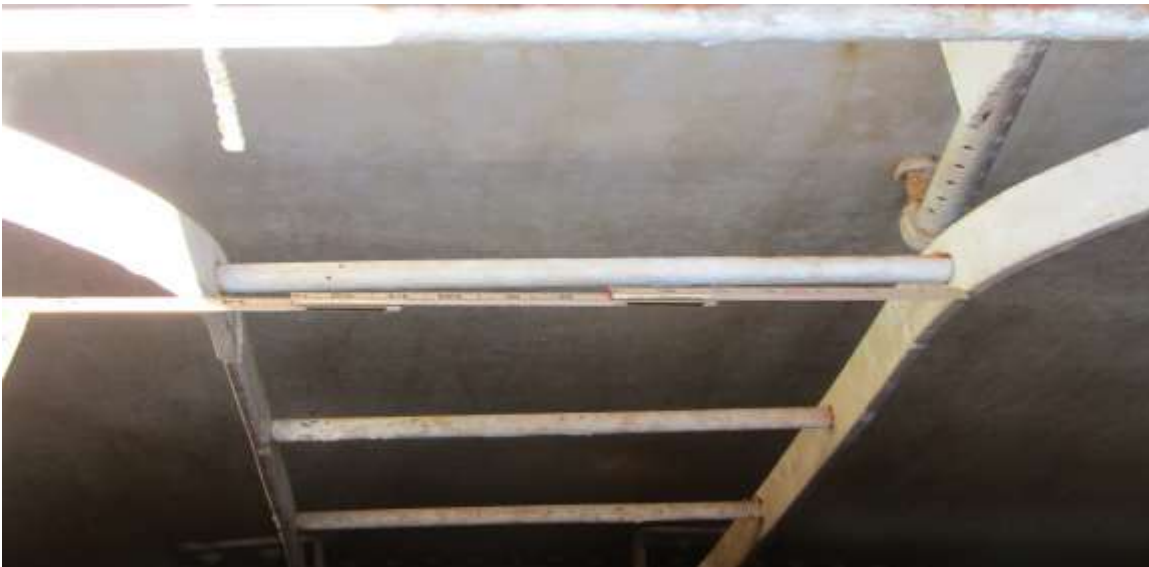
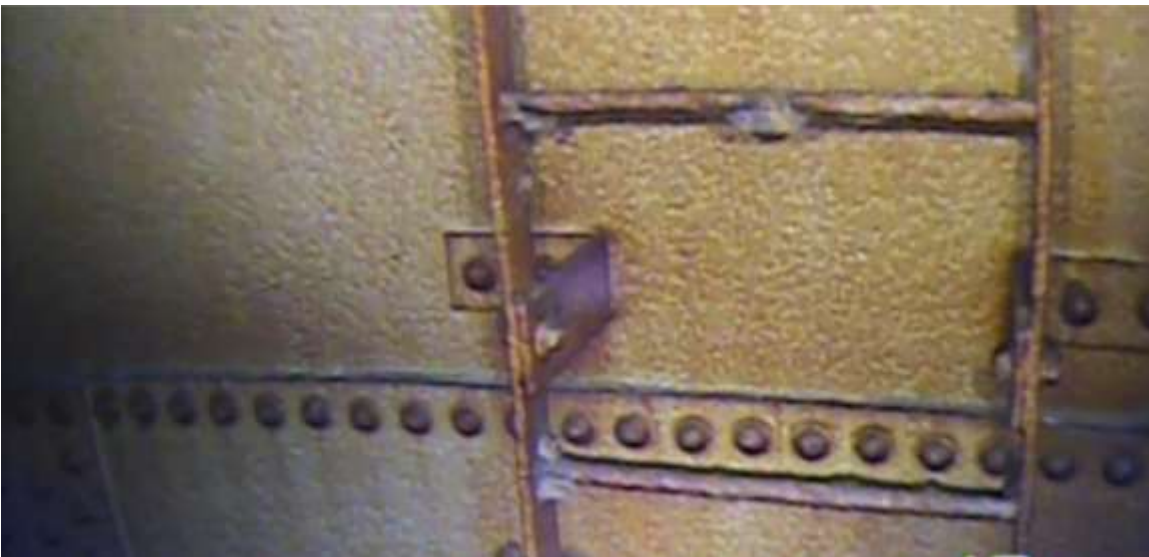
Interior access ladder in above photo is 15" wide, and is seriously deteriorated. **OSHA 1910.23(b)(10)** states, "Any ladder with structural or other defects is immediately tagged "Dangerous: Do Not Use" or with similar language in accordance with § **1910.145** and removed from service until repaired in accordance with § **1910.22(d)**, or replaced;..." We recommend installing an **OSHA** compliant interior access ladder complete with standoffs every 10' on center and anti-skid rungs, and a cable type ladder safety device.

**This ladder should be replaced on an emergency basis.**

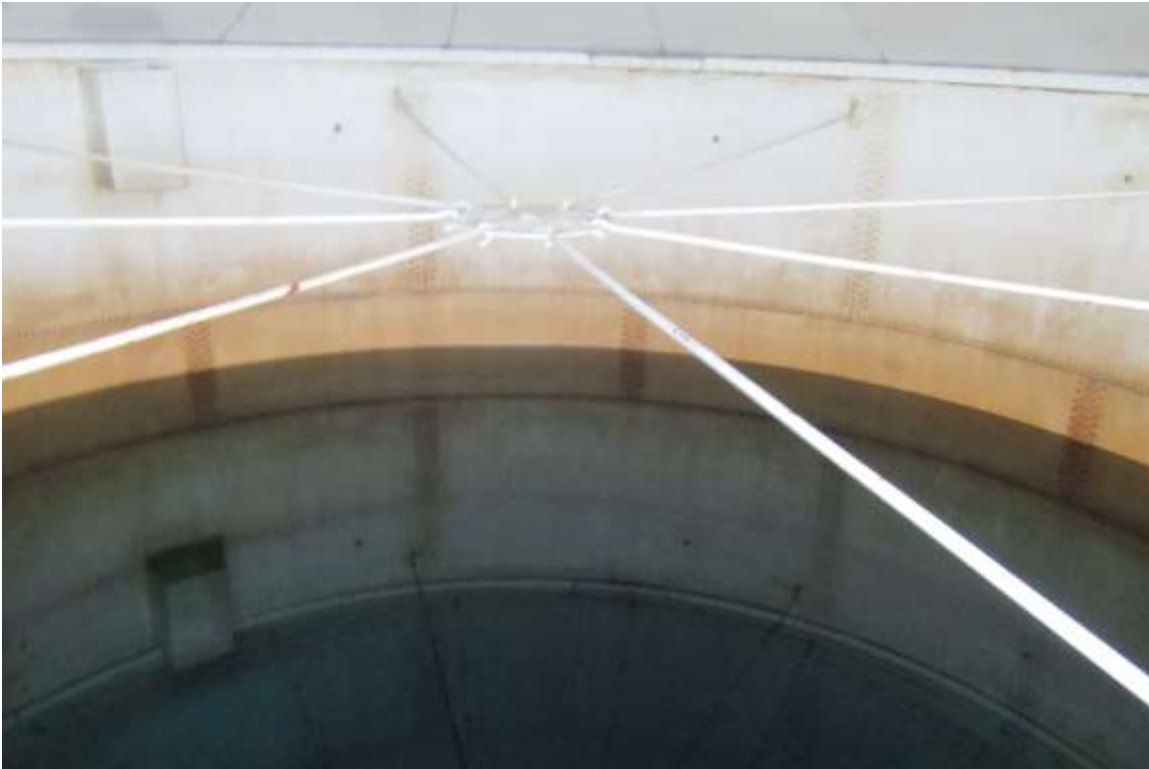
Photo shows the condition of the spider rods and hub assembly. The assembly does not affect the structural integrity of the tank, it was for erection purposes only. We recommend removing the spider rod assembly from the tank.

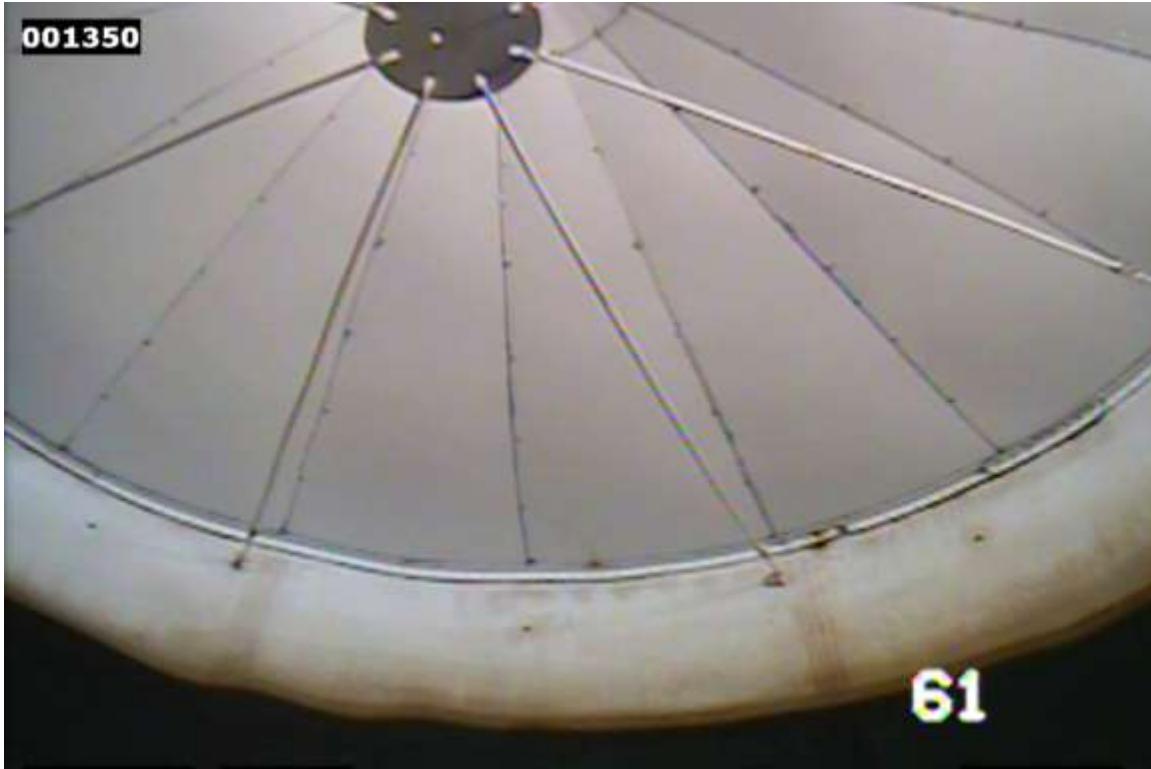
Photo shows the interior roof, which appears to be in good condition.

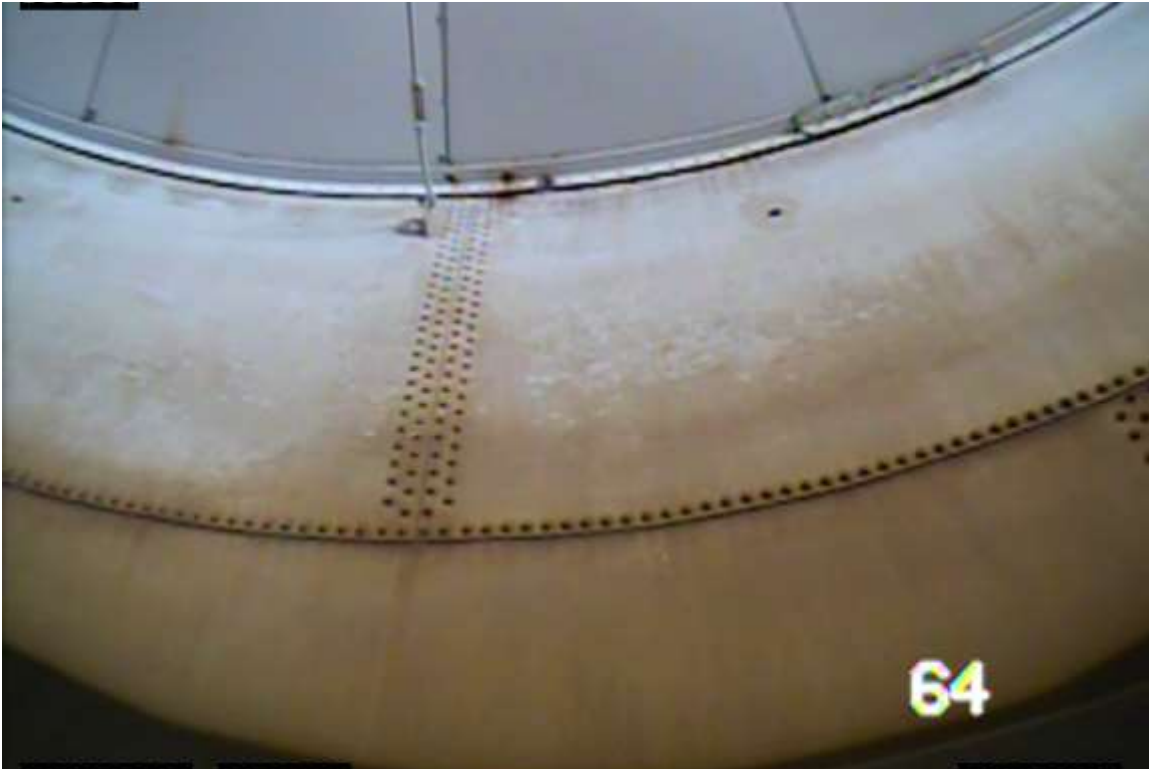
Photo shows the interior roof-to-rim angle connection, which appears to be in good condition.
