**SimplexGrinnell #458 & JCI  
9520 10th Avenue South, Suite 100  
Seattle, WA 98108  
RE: Western State Hospital; Lakewood, WA  
318,000 Gallon Bolted STP  
August 3, 2018  
Ms. Melissa Fraser  
Systems Integrity Representative  
(206) 291-1439  
Job No. 318298-A**

## STANDPIPE INSPECTION REPORT

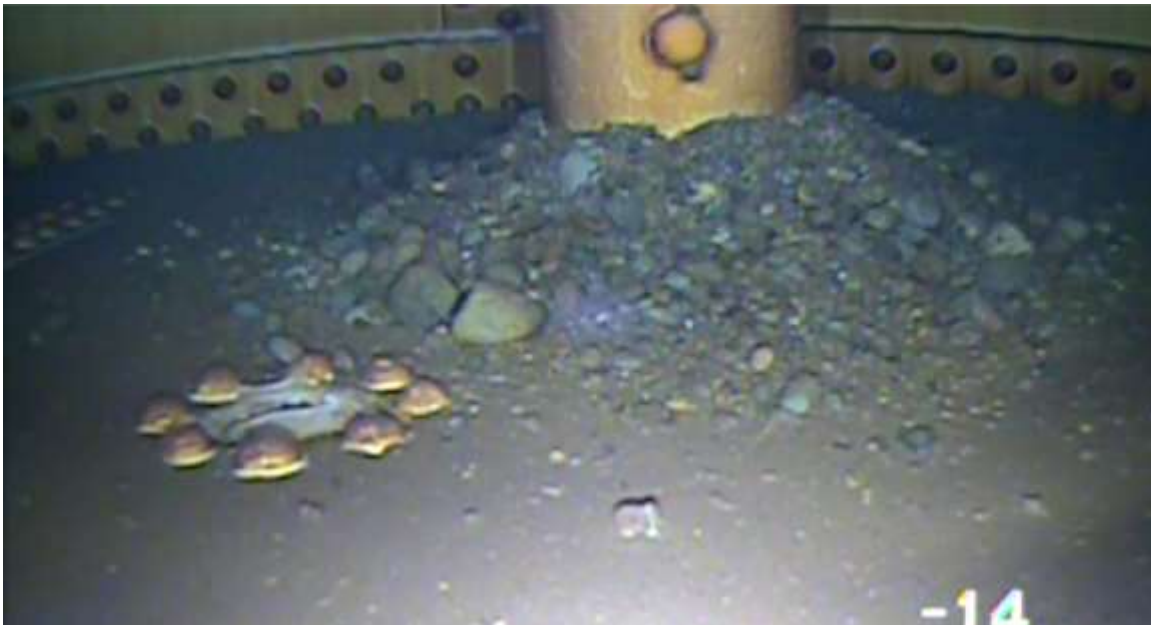
Photos show sediment and debris in the tank interior prior to the performance of the tank clean out.

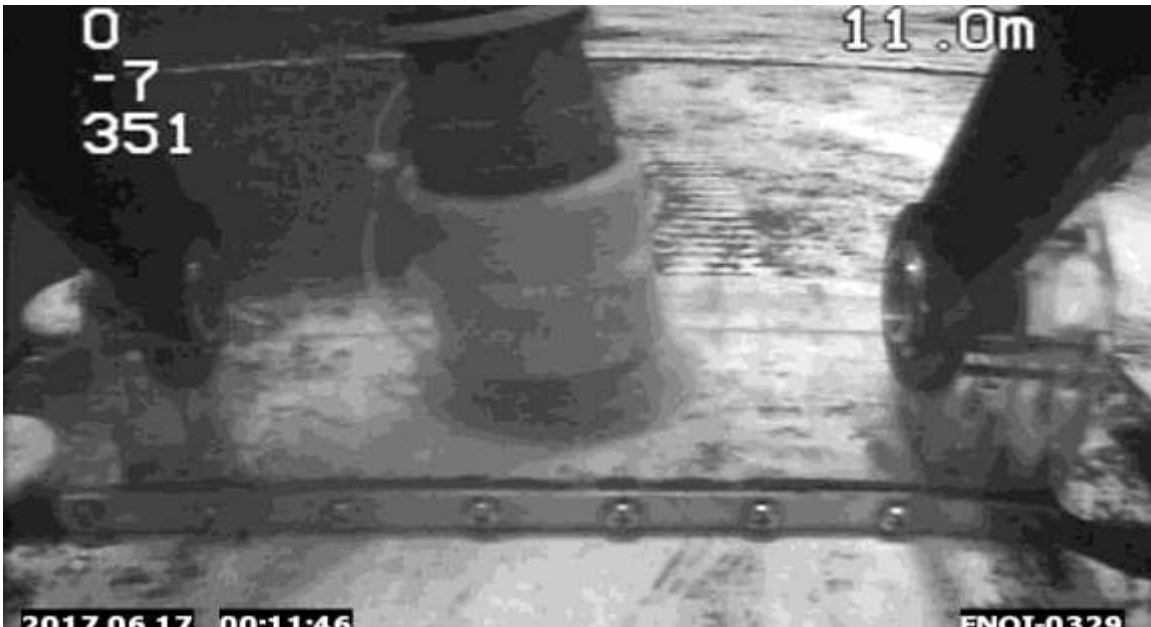
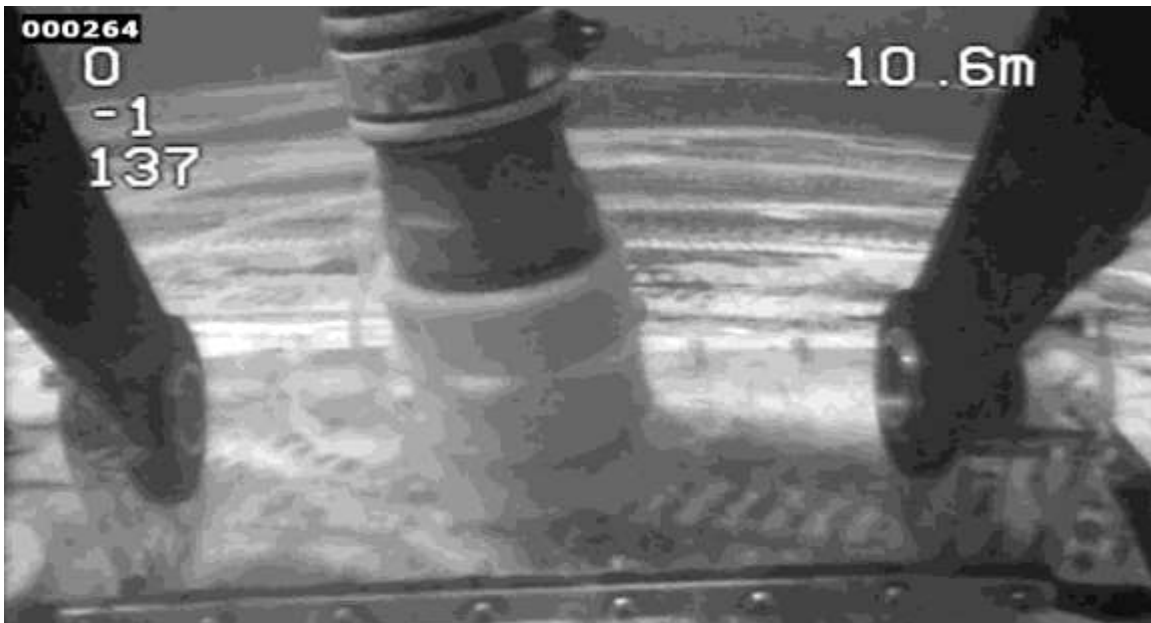
Photos show the tank interior during the performance of the tank clean out.

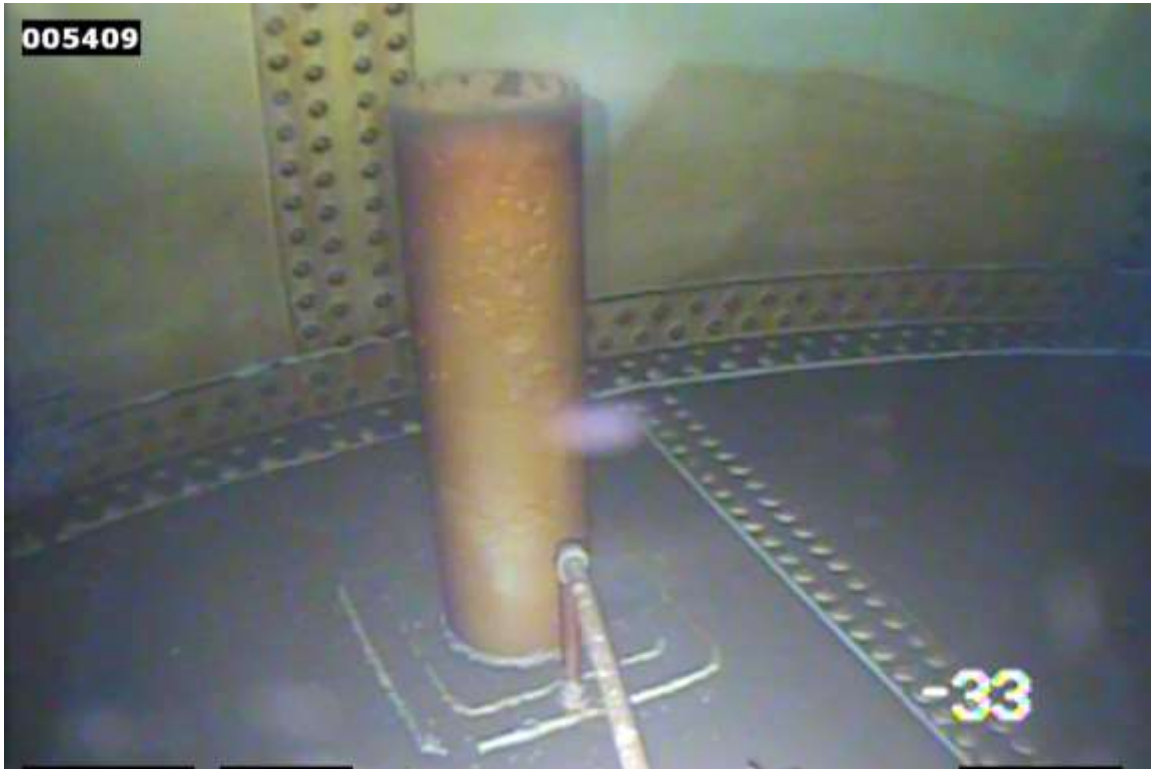
Photo shows a suction pipe on the interior of the tank. **NFPA 22-2018; 14.2.13.1** states, “ The discharge outlet for every suction tank shall be equipped with an anti-vortex plate assembly.” We recommend installing a properly sized anti-vortex plate on the suction pipe to prevent formation of a vortex.

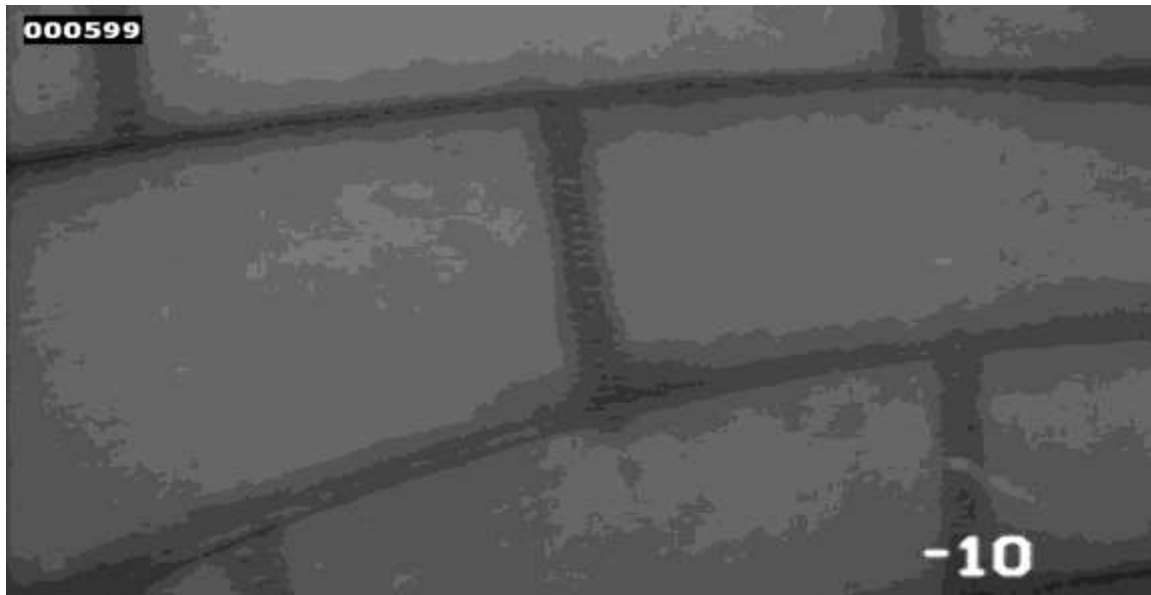
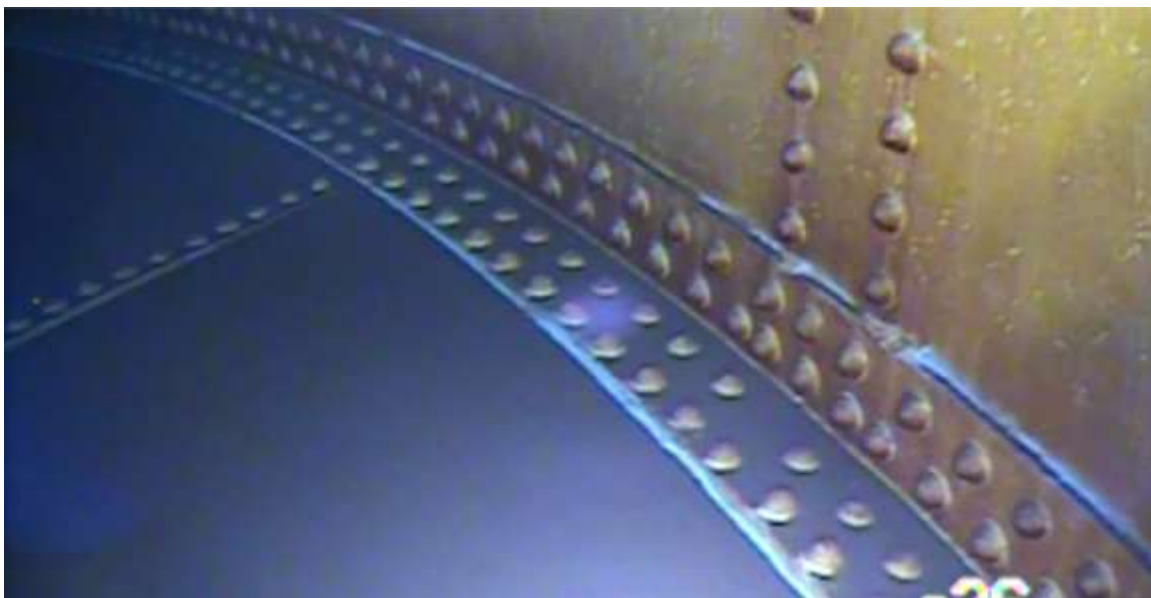
Photos show the tank interior bolt seams. We recommend cleaning the interior seams, then as needed applying a high solids CIM 1000 Trowel grade rubberized coating to all horizontal and vertical seams on the tank interior shell, floor and around the circumference of the shell-to-floor connection. This coating allows up to 350% elongation due to contraction and expansion caused by thermal shifts as well as filling and draining of the tank. All seams will be dry prior to application for proper adhesion. CIM is a flexible coating that also responds to potential leaks. This product is applied thicker than most coatings at up to 30 mils resulting in longer life.
