**SimplexGrinnell #458 & JCI
9520 10th Avenue South, Suite 100
Seattle, WA 98108
RE: Western State Hospital; Lakewood, WA
400,000 Gallon STP
August 4, 2018
Ms. Melissa Fraser
Systems Integrity Representative
(206) 291-1439
Job No. 318298-B**

STANDPIPE INSPECTION REPORT

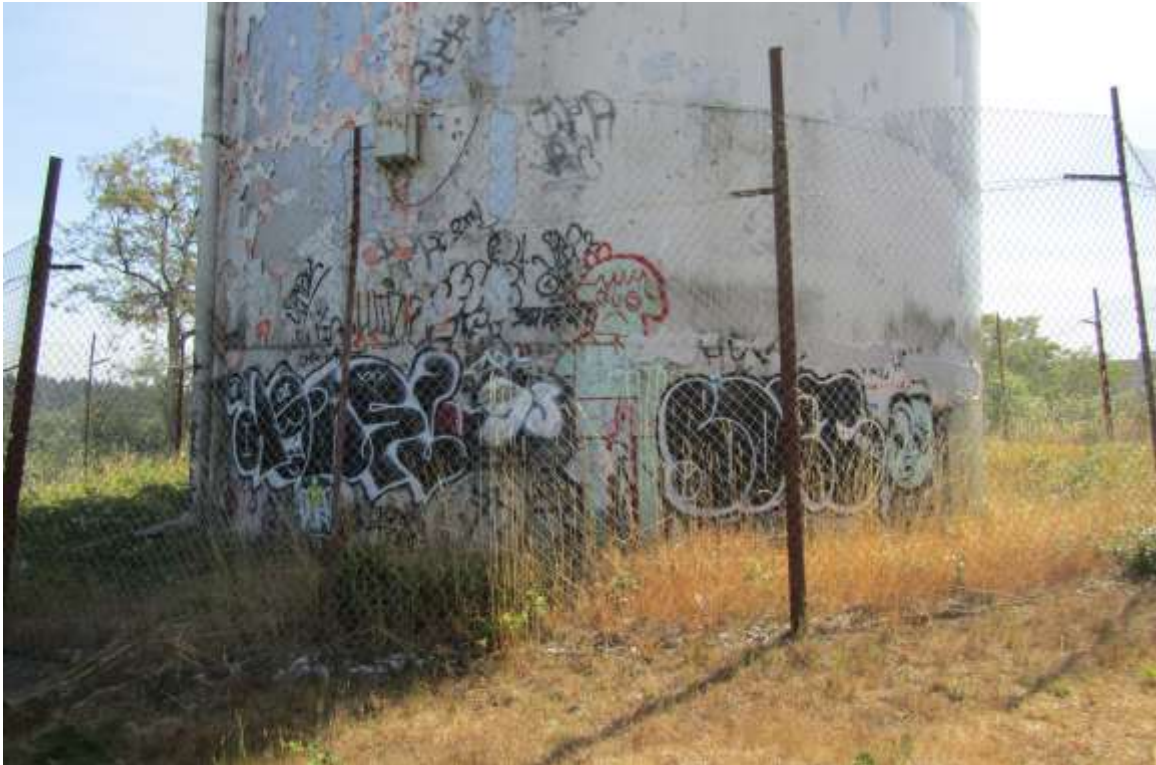
Photo shows the tank is secured with fencing. There is no signage on the fence. We recommend posting **No Trespassing** sign.

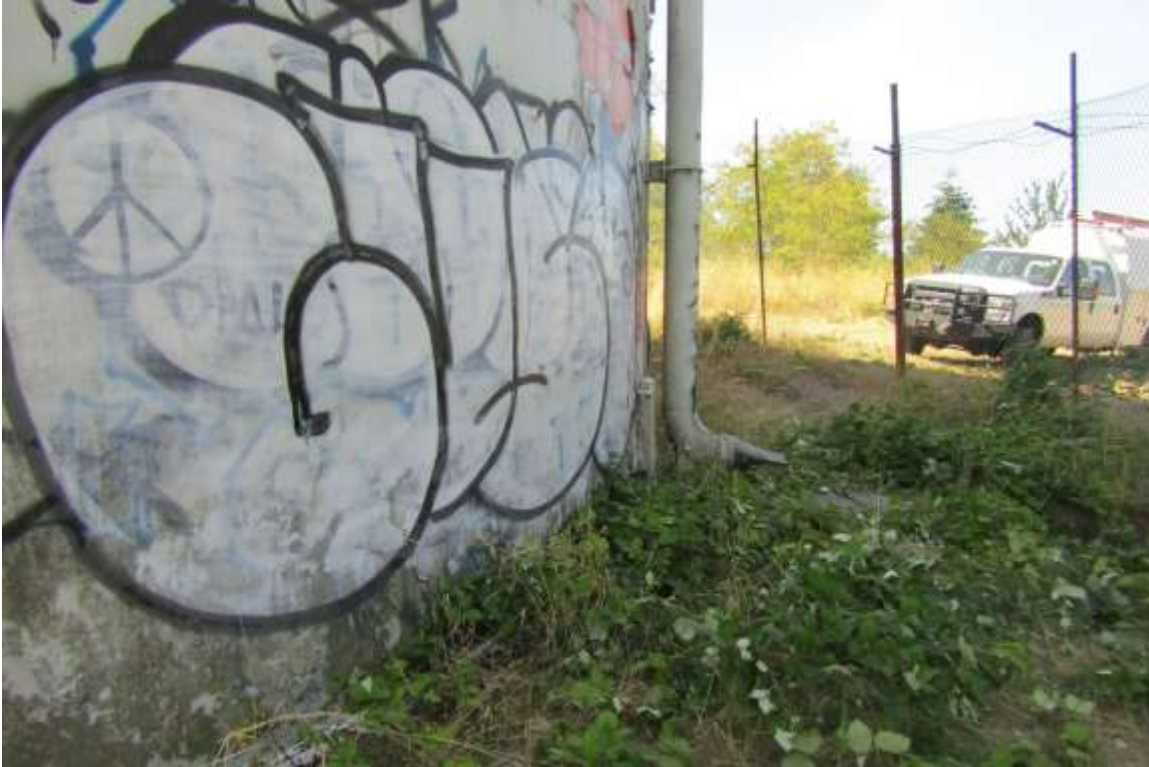
Photo shows the condition of the foundation. **AWWA D100-11; 12.7.1 Height aboveground** states, "The tops of the concrete foundations shall be a minimum of 6" above the finished grade, unless otherwise specified." We recommend clearing any dirt, debris and other loose gravel away from the tank foundation, down to a minimum 6" below top of foundation. This should be done by a local excavating company.

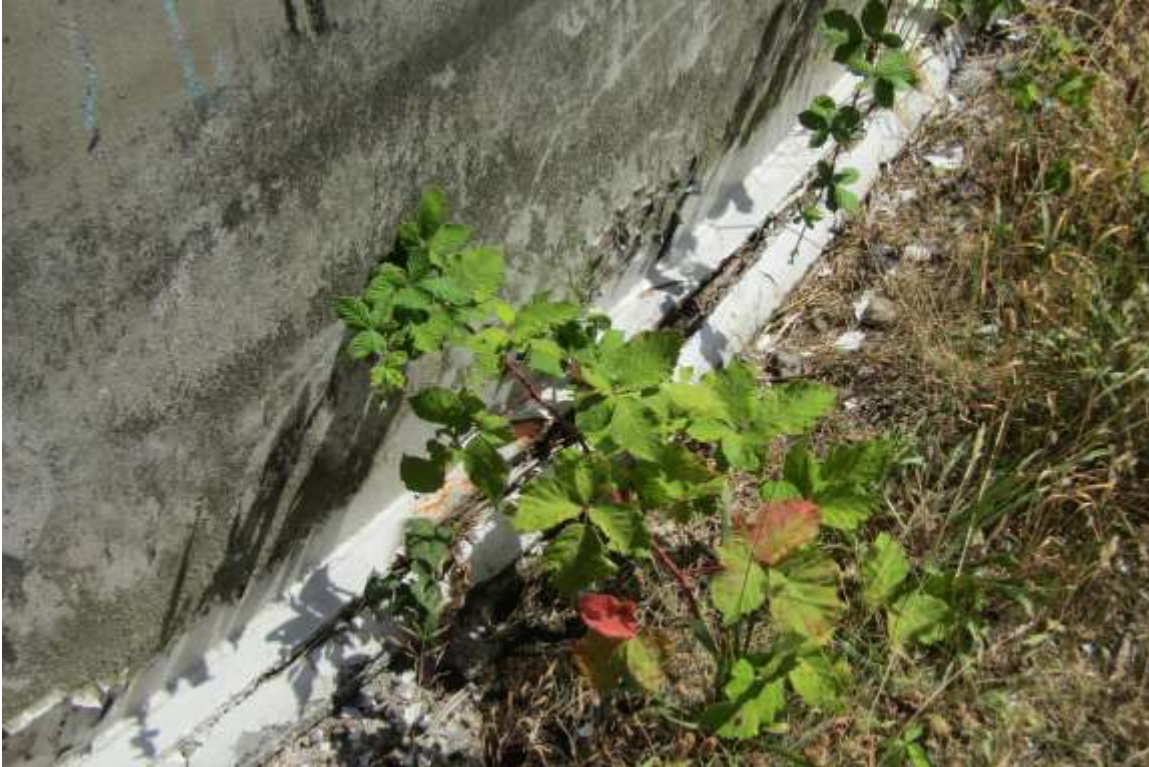
Photo shows the condition of the foundation. **NFPA 22-2018; 12.2.1.2** states, "... the junction of the tank bottom and the top of the concrete foundation shall be tightly sealed to prevent water from entering the base." We recommend repairing any cracks and spalling in the concrete with a commercial non-shrinking grout, caulking/grouting around the base of the tank to foundation connection to prevent water from entering under the tank, then sealing the foundation with a sealant.

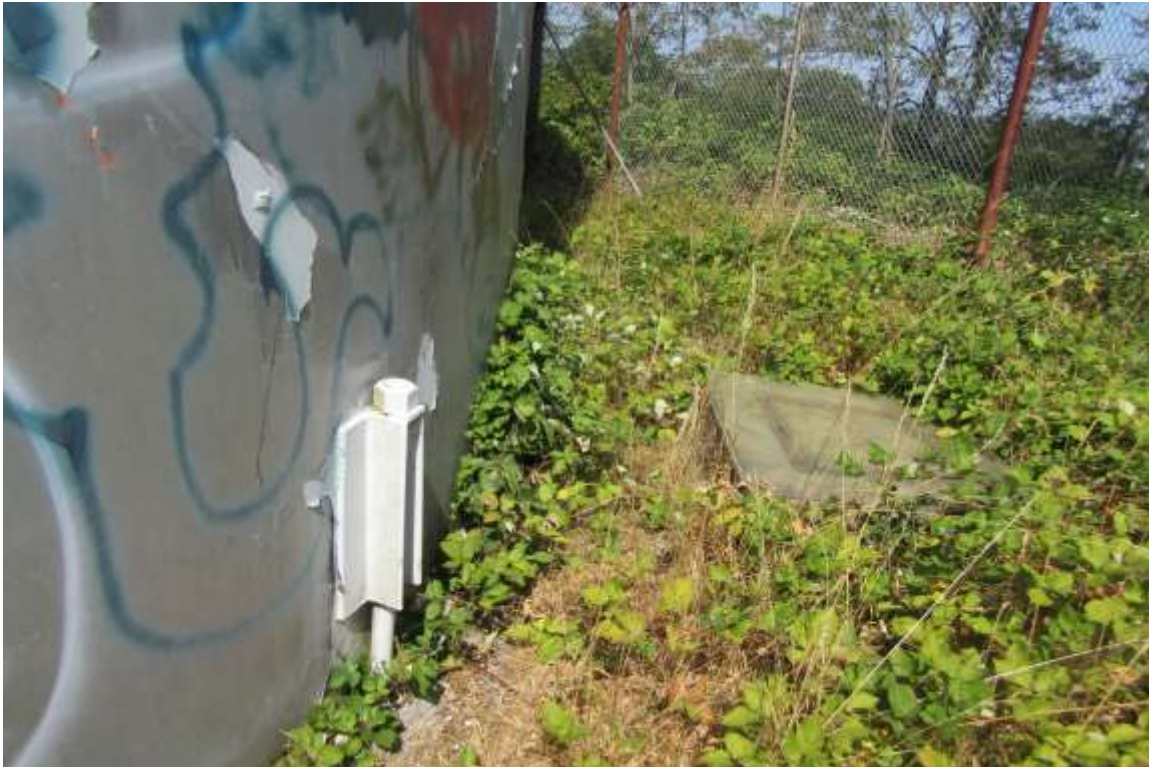
Photo shows the tank has no grounding system. We recommend electrically grounding the tank for lightning protection as required by **OSH Act of 1970 Section 5** and **NFPA 780-2017; 5.4 Metal Towers and Tanks**.

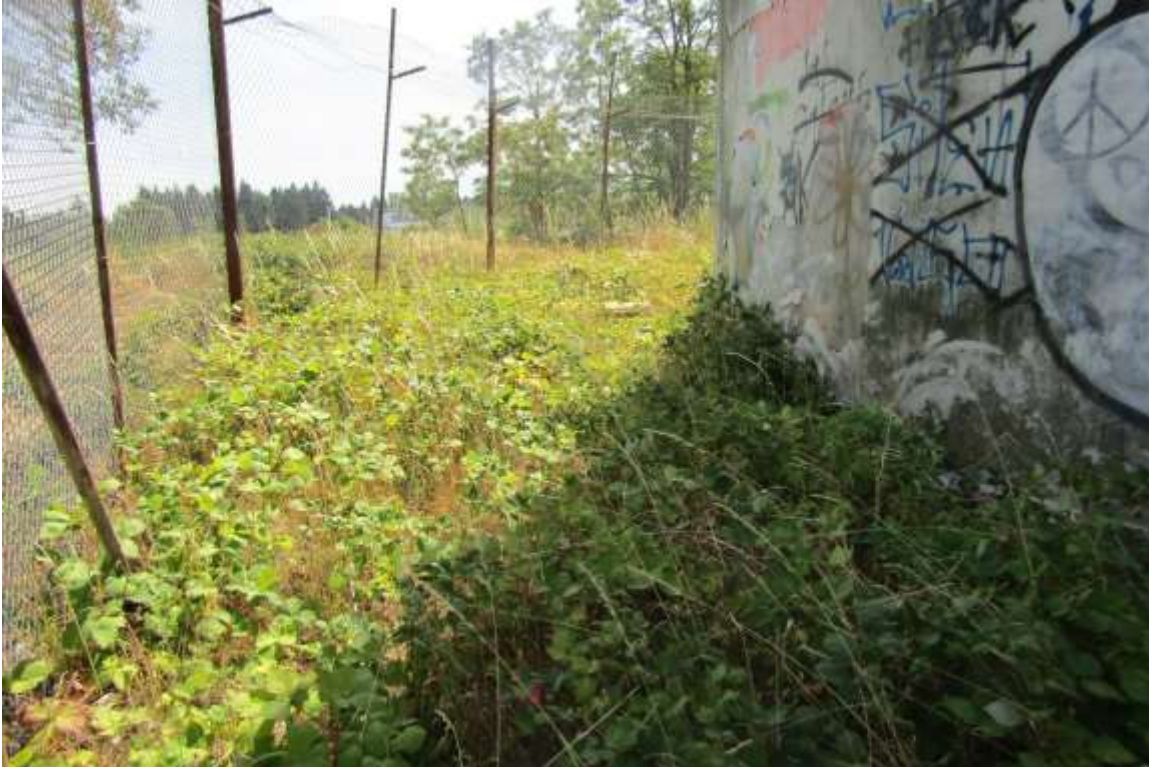
Photo shows the condition of the tank site. **Notice the vegetation growth around the tank foundation.** This could lead to deterioration of the structural components of the tank. **OSHA 1910.176(c)** states, "Storage areas shall be kept free from accumulation of materials that constitute hazards from tripping, fire, explosion, or pest harborage. Vegetation control will be exercised when necessary." We recommend removing the vegetation from around the tank foundation. This should be done by others.

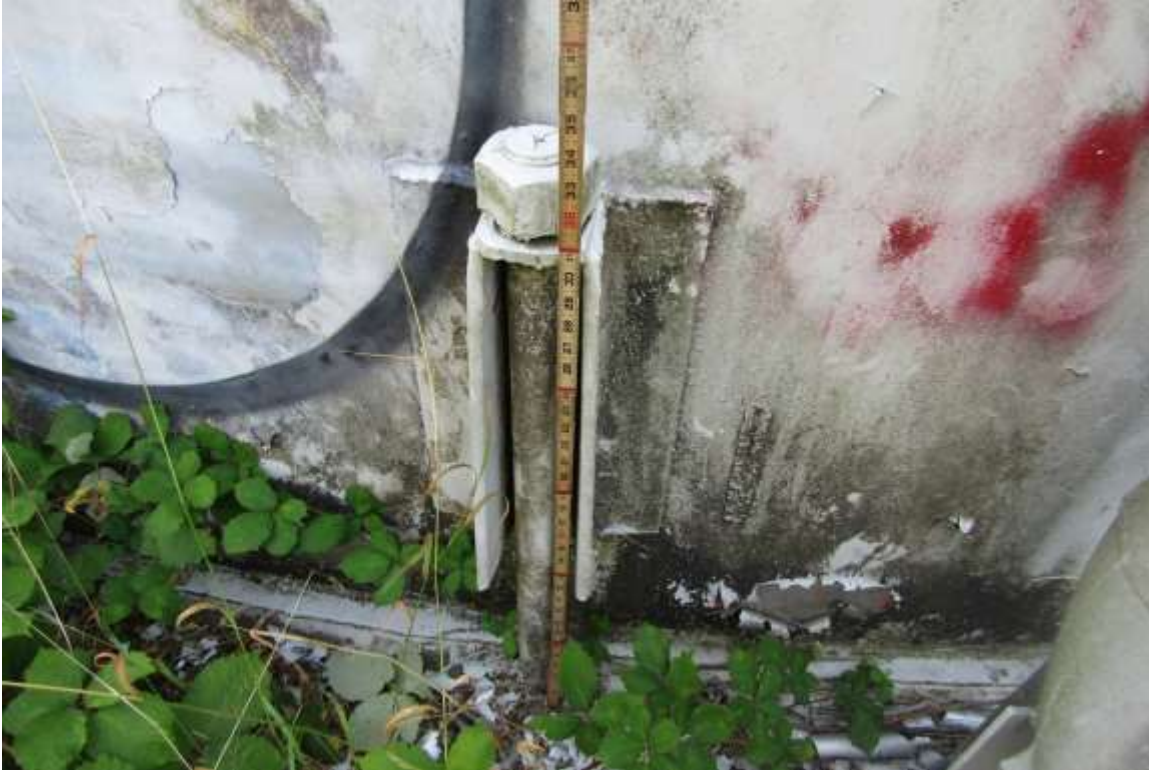
Photo shows the condition of one (1) of the six (6) anchor bolts. **AWWA D100-11; 3.8.1.1 Required anchorage** states, “For ground-supported flat-bottom reservoirs and standpipes, mechanical anchorage shall be provided when the wind or seismic loads exceed the limits for self-anchored tanks.” We recommend cleaning the area around the anchor bolts, tightening the anchor nuts, then tack welding the circumference of the nut-to-base plate connections and bolt-to-nut connections to reinforce.

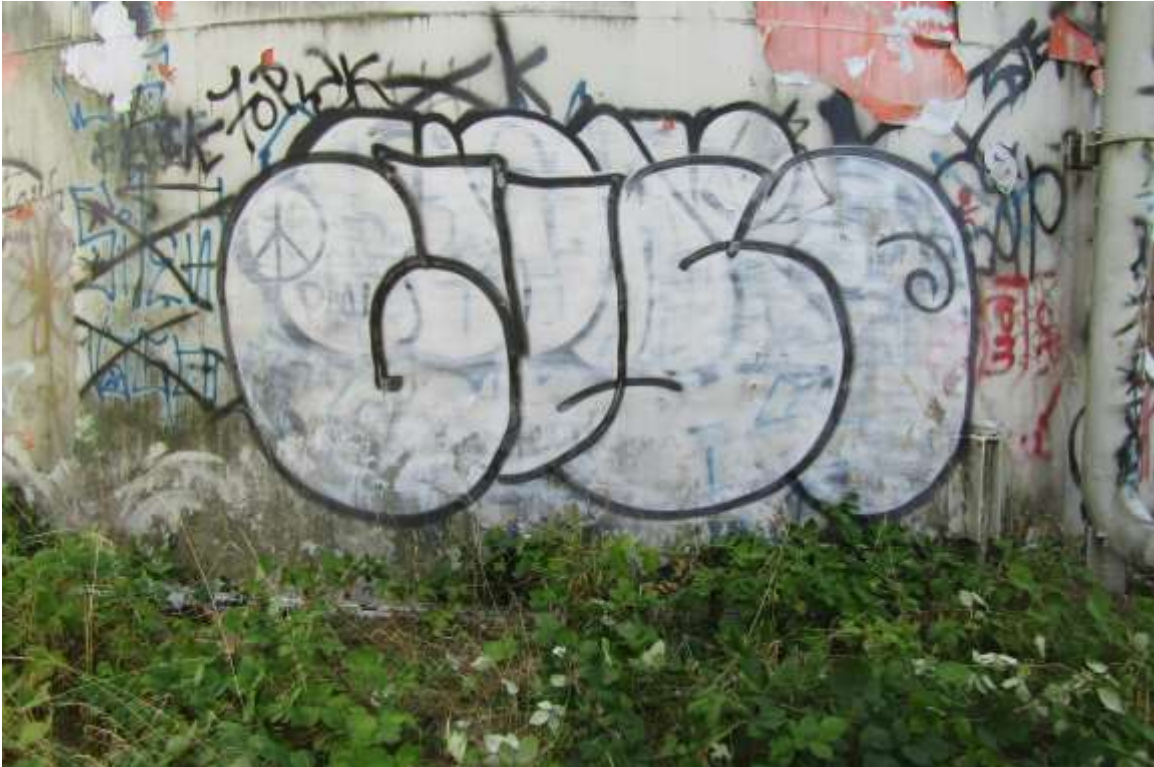
Photo shows the condition of the shell. Currently there is no drain valve. We recommend installing a frost proof drain valve near the shell-to-floor connection, complete with a locking device to prevent unauthorized draining of the tank and a splash pad to direct water away from the foundation. Splash pad to be installed by owner.

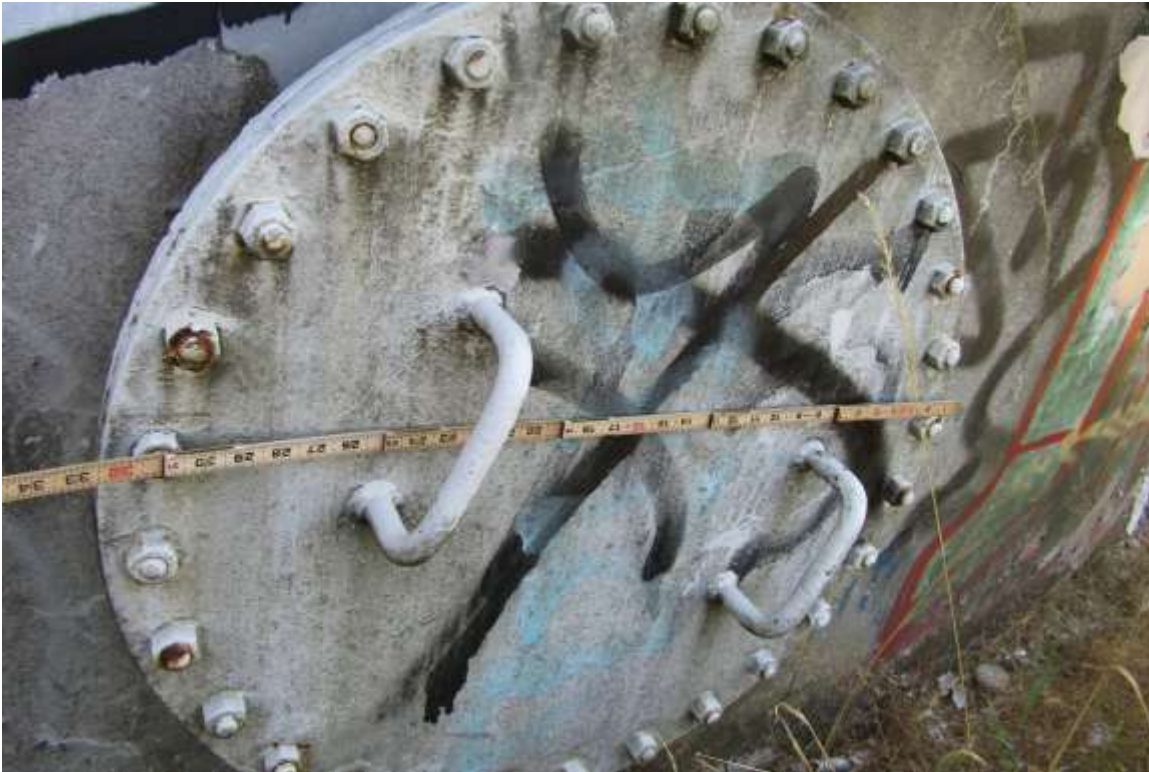
Photo shows the condition of the 24" primary shell manway. The following is required for the tank to be in compliance with [AWWA D100-11; 7.4.4 Shell manholes](#), [NFPA 22-2018; 14.7.2.1.1](#) and [OSHA 1910.146\(c\)\(2\) Confined spaces](#).

We recommend:

- Install davit arm on primary shell manway
- Install 30" secondary shell manway 180° from primary manway
- Post **Confined Space Entry** signs
- Install maintenance free galvanized steel bolts

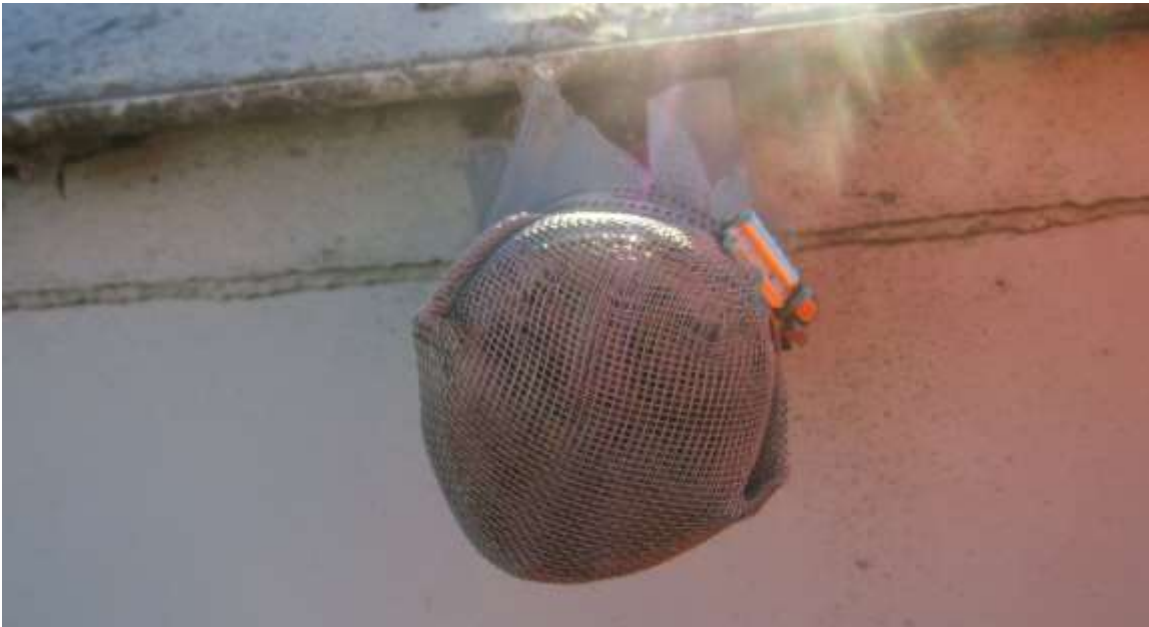
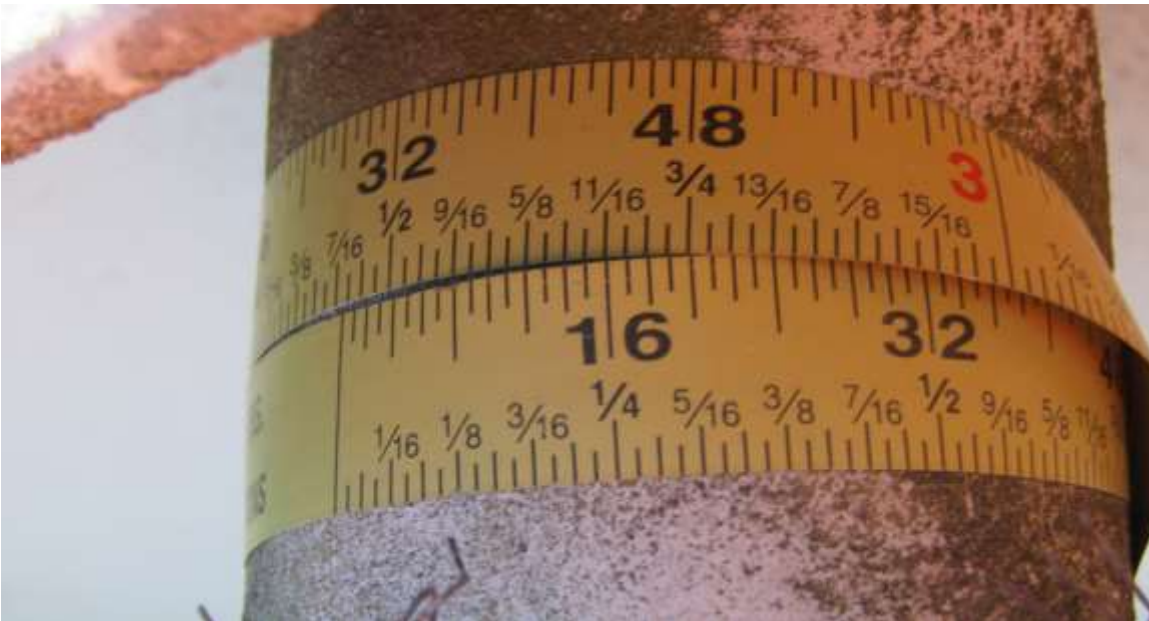
Photos show the condition of the 2" stub overflow pipe. We recommend extending the overflow down the exterior to grade with same size pipe, complete with standoffs every 10' on center, an elbow at the base fitted with a flapper valve and screen to prevent the ingress of contaminants into the water supply, and a splash pad to direct the water away from the tank foundation. Splash pad to be installed by owner.

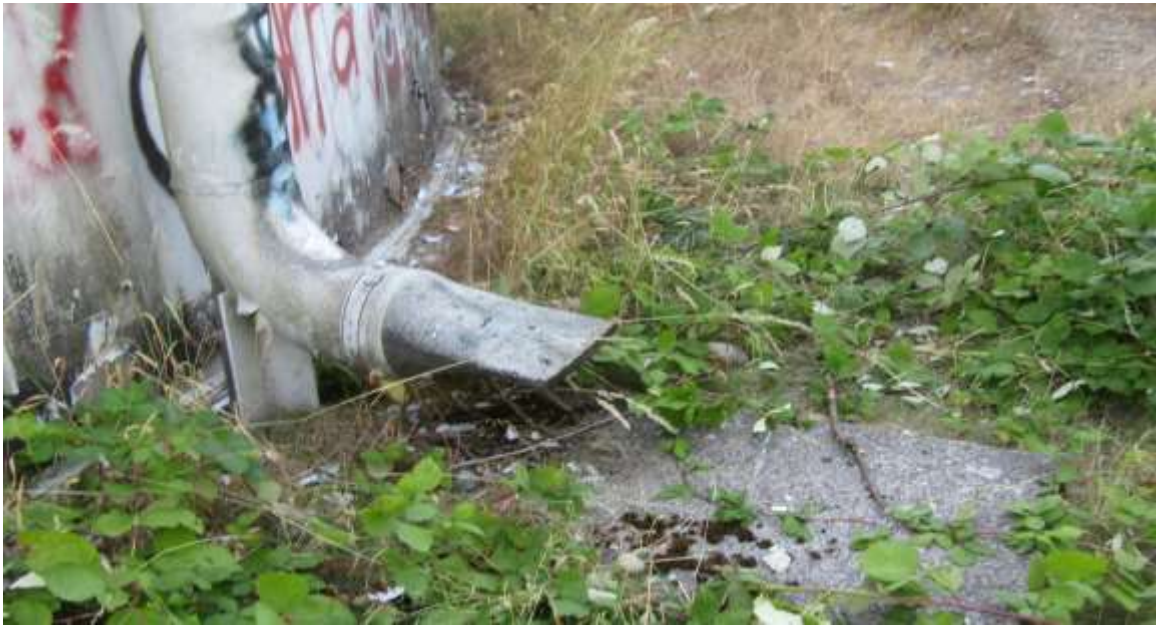
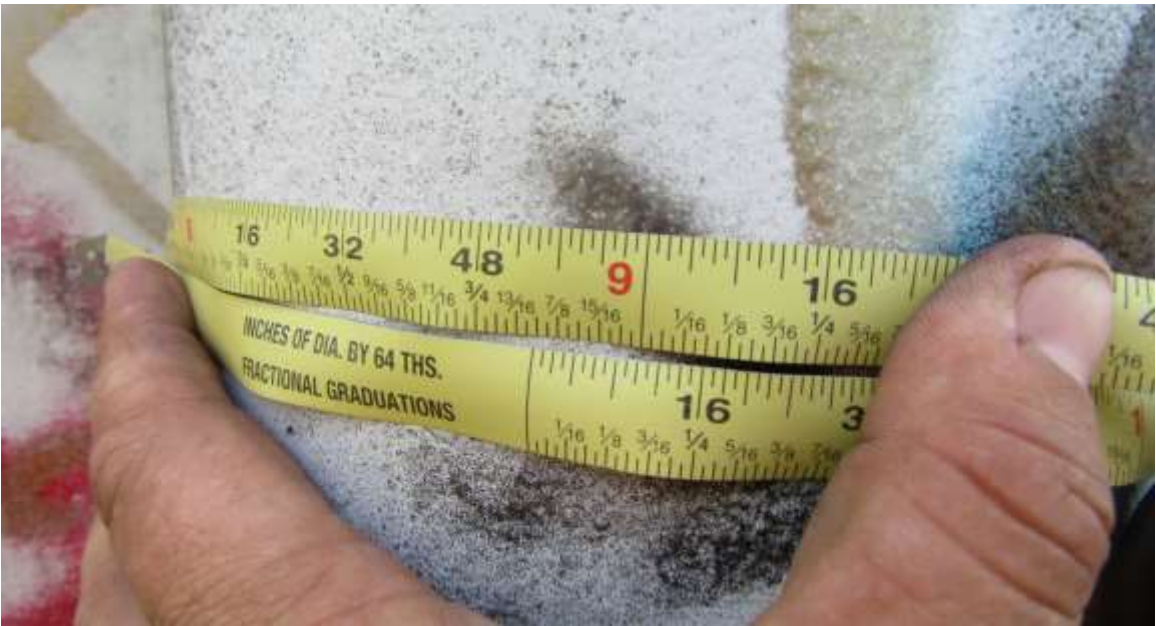
Photos show the 8" overflow pipe system, which is equipped with a flapper valve as required by [AWWA D100-11; 7.3 Overflow.](#)

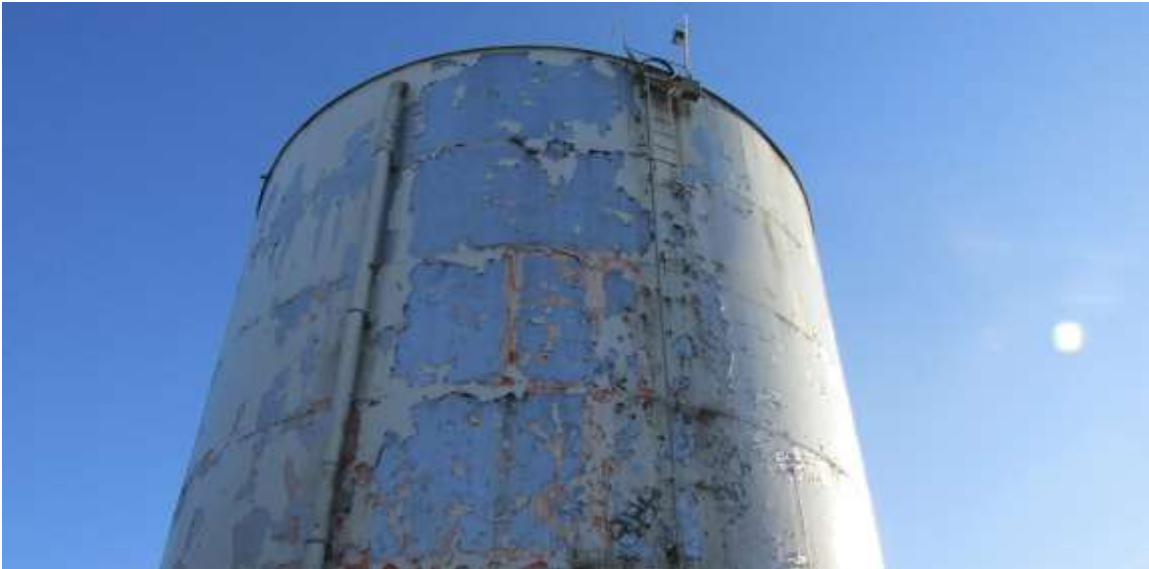
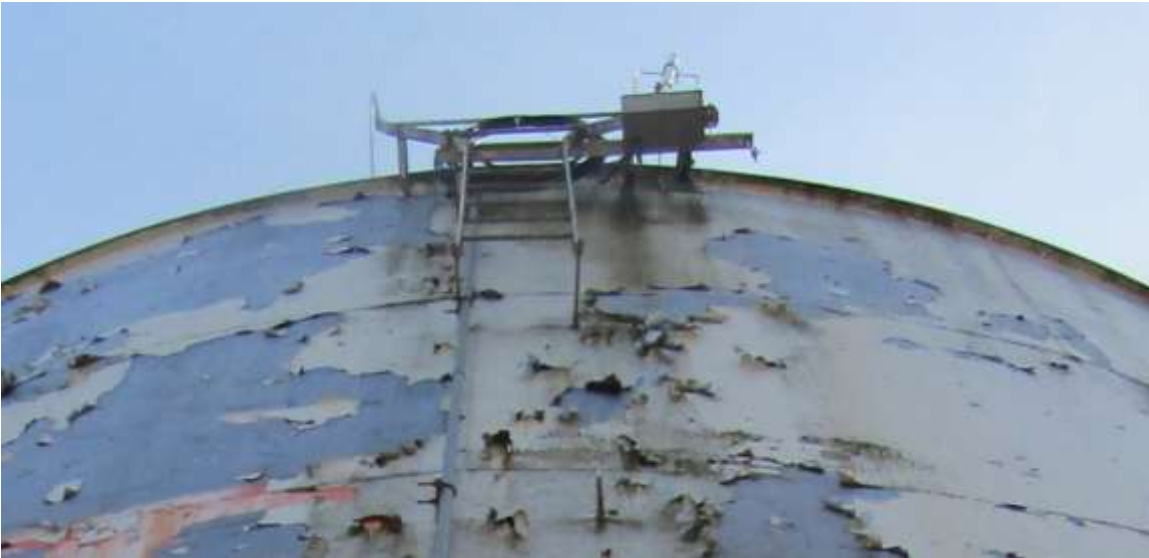
Shell access ladder in above photos is seriously deteriorated. **OSHA 1910.23 (b)(10)** states, “Any ladder with structural or other defects is immediately tagged “Dangerous: Do Not Use” or with similar language in accordance with § **1910.145** and removed from service until repaired in accordance with § **1910.22(d)**, or replaced;...” We recommend replacing the existing ladder with an **OSHA** compliant shell access ladder complete with standoffs every 10' on center, a cable type ladder safety device, a lockable ladder guard to prevent unauthorized access and posting a **Fall Protection Required** sign.

This ladder should be replaced on an emergency basis.

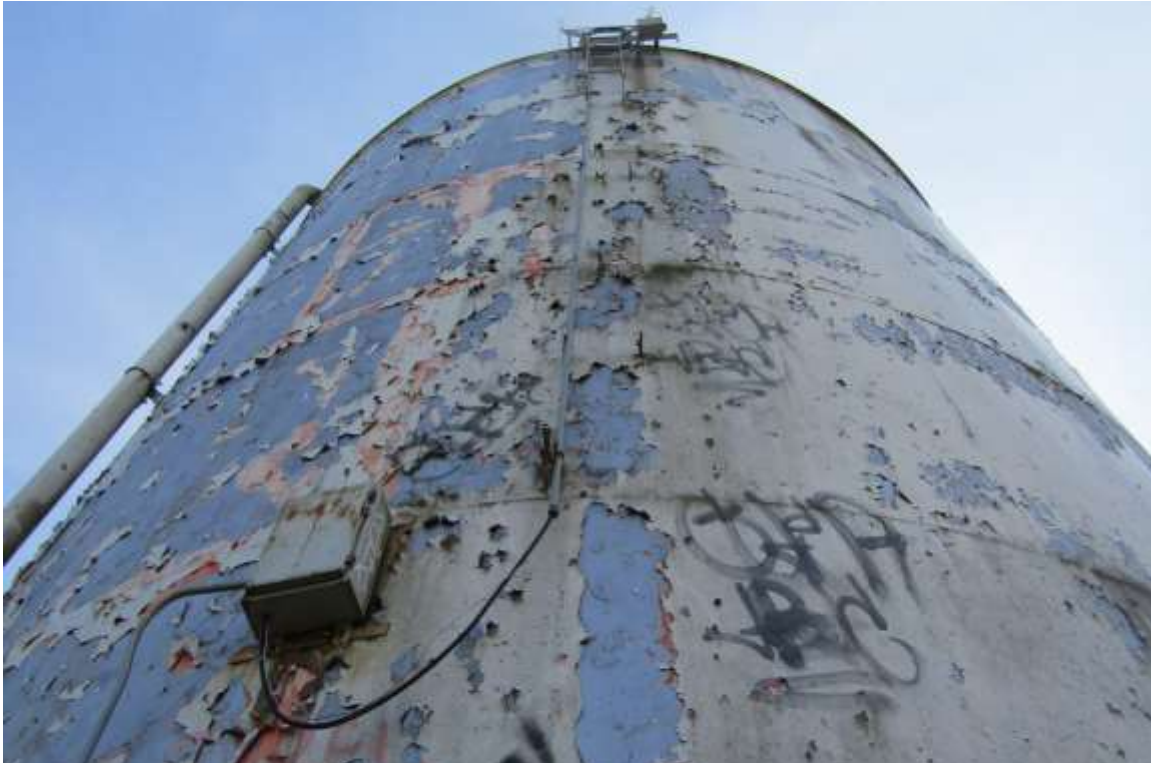
Photo shows the tank is not equipped with a liquid level indicator. **NFPA 22-2018; 14.1.8* Water-Level Gauge** states, "A water-level gauge of suitable design shall be provided. It shall be carefully installed, adjusted, and properly maintained." We recommend installing a liquid level indicator, complete with target board and float.

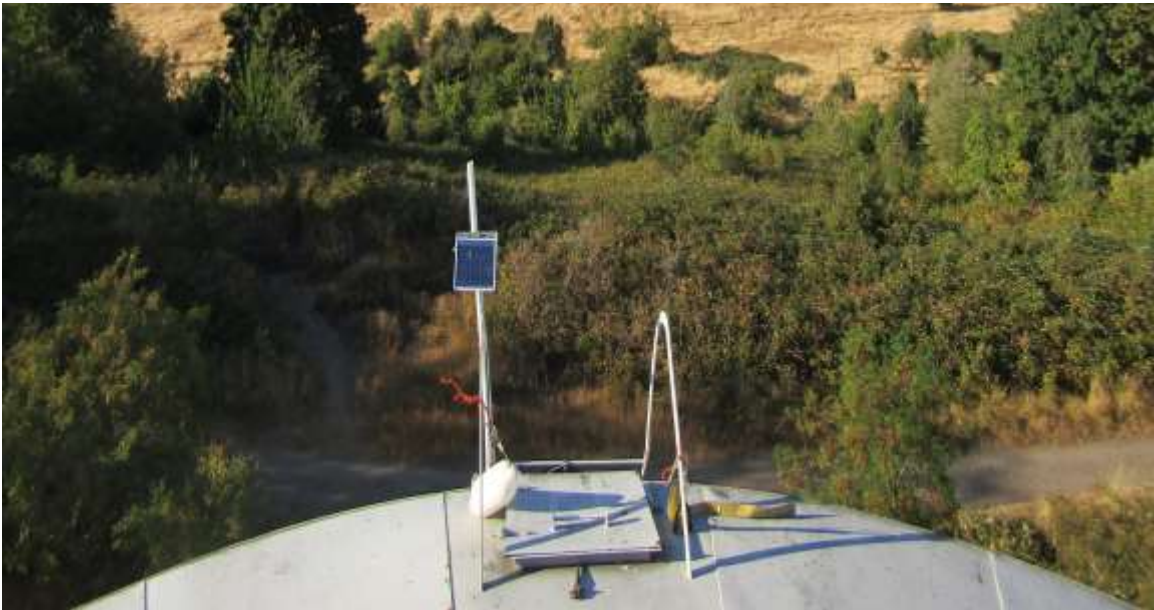
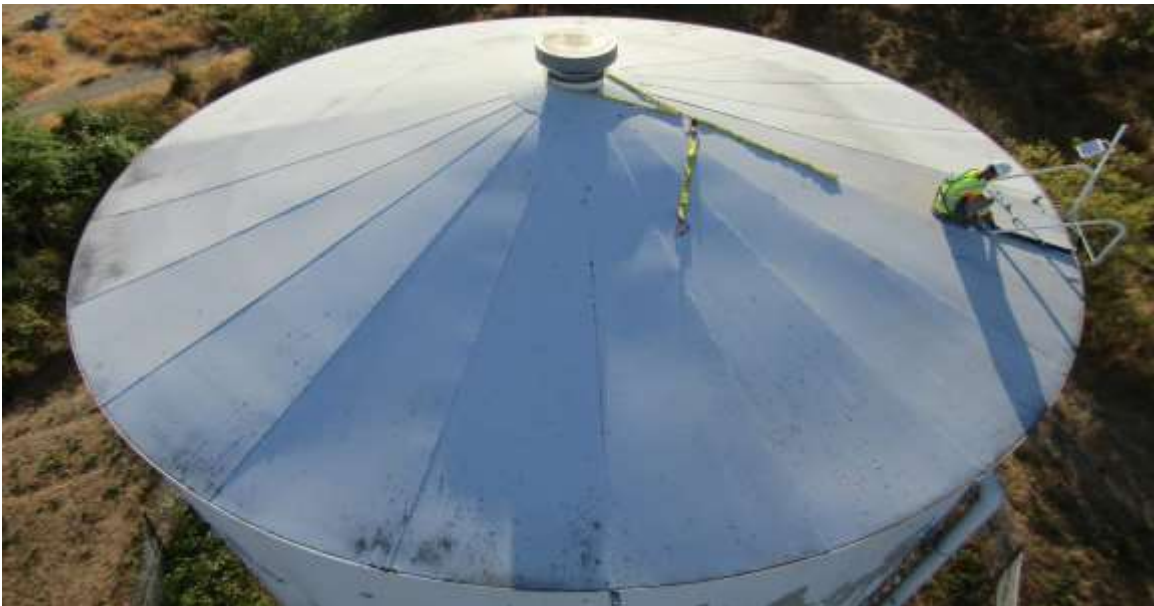
Photos show the tank roof edge is not equipped with a required handrail system for fall protection. **OSHA 1910.28(b)(1)(i)** states, "...the employer must ensure that each employee on a walking-working surface with an unprotected side or edge that is 4 feet (1.2 m) or more above a lower level is protected from falling by one or more of the following: **1910.28(b)(1)(i)(A) Guardrail systems.**"

We recommend installing an **OSHA** compliant 42" high handrail system around the circumference of the tank roof, complete with intermediate rail, toeboard and a swing gate at the junction of the shell-to-roof access ladder and tank roof.

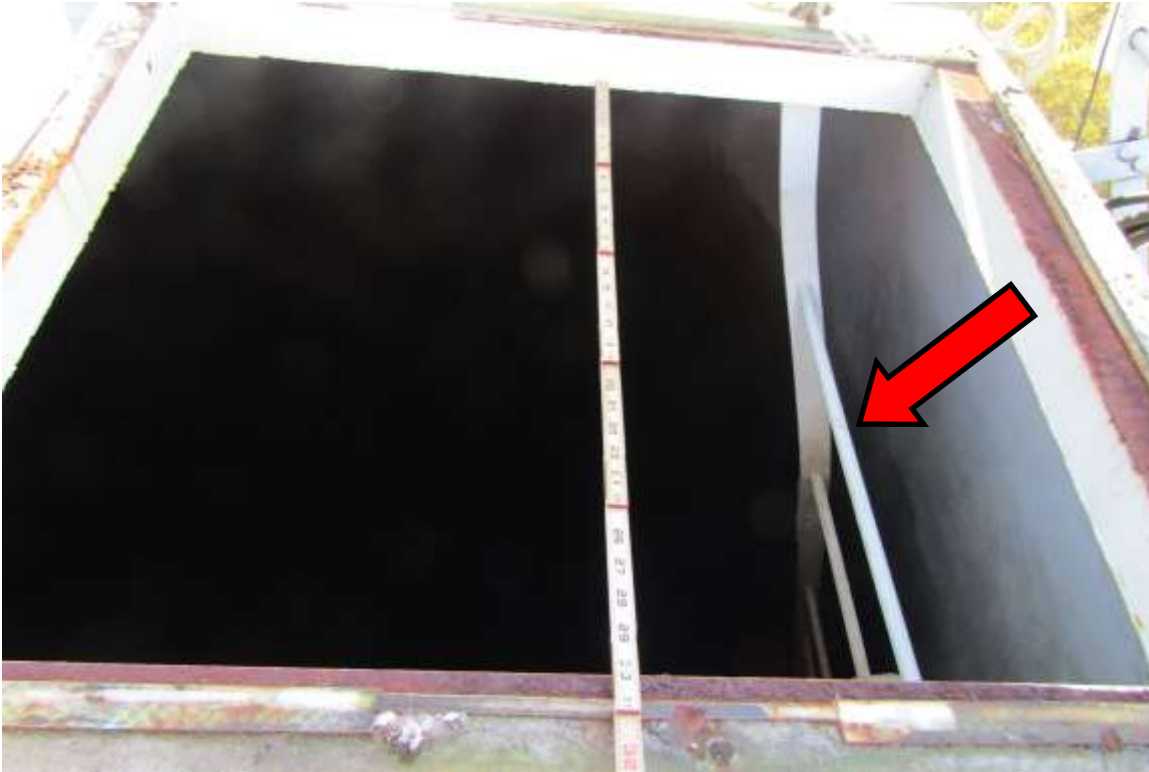
Photo shows the condition of the 30" primary roof hatch. **AWWA D100-11; 7.4.3.1** states, "The opening shall have a curb at least 4 in. (102 mm) high, and the cover shall have a downward overlap of at least 2 in. (51 mm)." Roof openings on this tank require the following to be in compliance with **AWWA D100-11; 7.4.3 Roof openings** and **OSHA 1910.146(c)(2) Confined spaces**.

We recommend:

Replace 30 primary hatch cover with a 2" overlapping cover
Install 30" secondary hatch 180° from primary roof hatch
Post **Confined Space Entry** signs
Install lock on primary hatch

We further recommend installing **OSHA** compliant interior access ladders complete with standoffs every 10' on center, and cable type ladder safety devices at the primary and suggested secondary roof hatches.

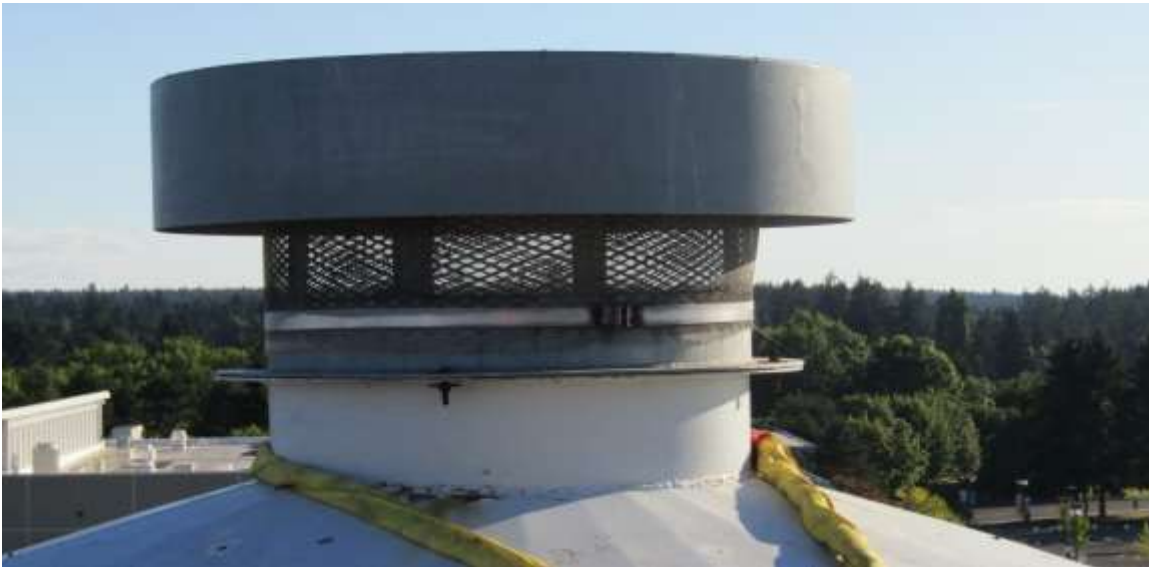
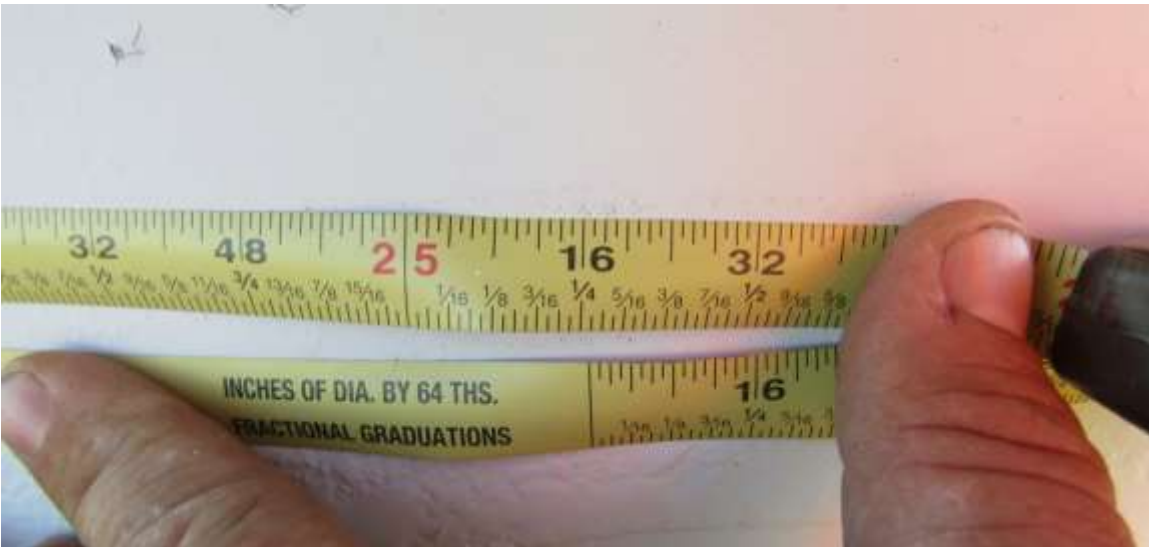
Photos show the condition of the existing 25" roof vent. **NFPA 22-2018; 4.15.5** states, "The screen or perforated plate shall be protected against the accumulation of sleet." **This vent is allowing the ingress of rain and wind-borne contaminants into the water system. An improperly vented tank may cause external pressure to act on the tank which can cause buckling even at low pressure differential.** We recommend replacing the existing roof vent with a vacuum-pressure, frost proof vent and screen.

This work should be performed on an emergency basis.

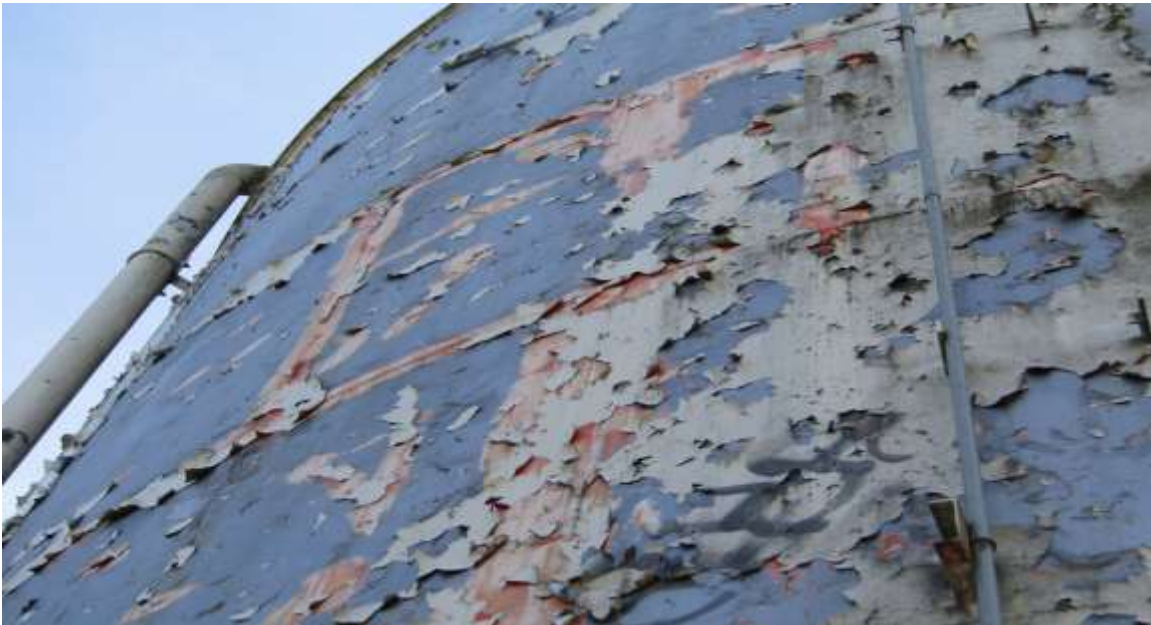
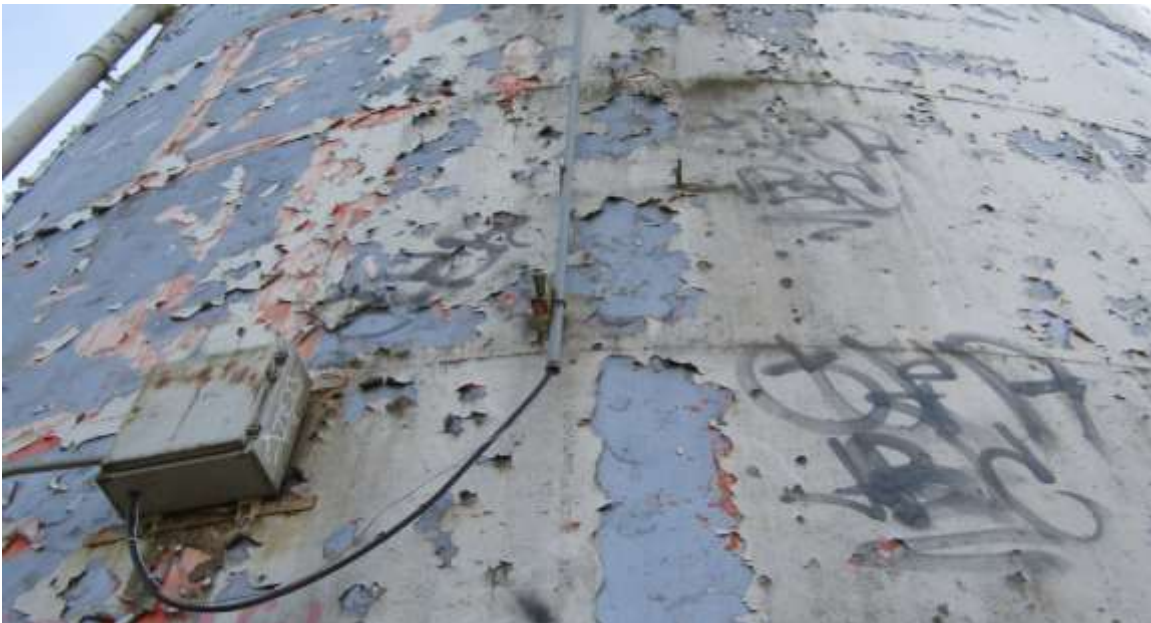
Photos show the tank exterior coating system. We recommend pressure washing the tank exterior with biodegradable detergent injection (minimum 3,500 psi at 3.0 gpm) then removing all loose rust and scale with wire brushes and hand scrapers in accordance with SSPC#2 (hand tool cleaning), spot priming and applying one (1) finish coat of acrylic paint.

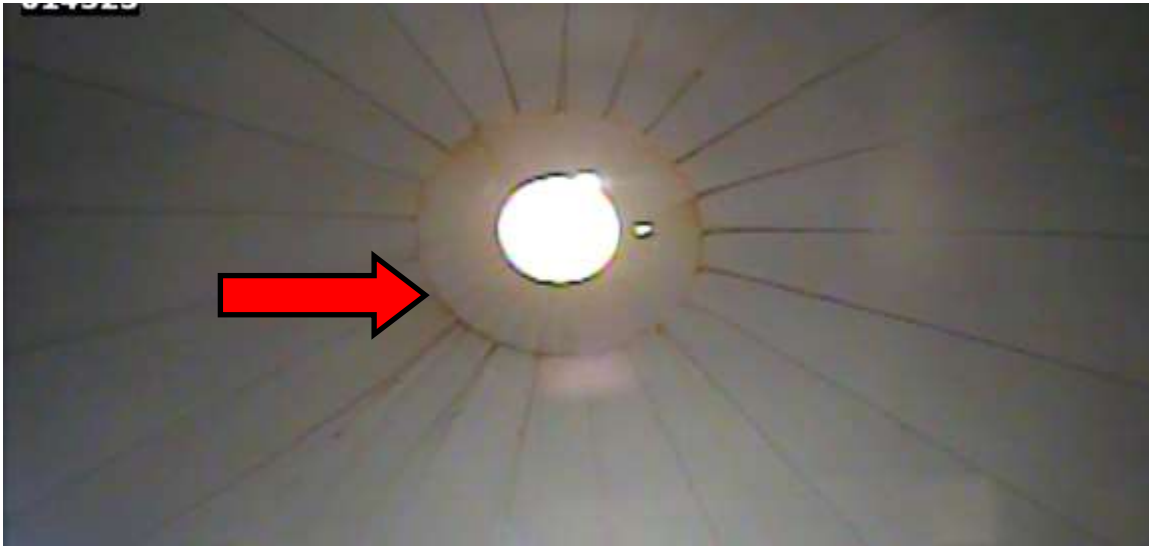
Top photo shows the condition of the interior roof. Notice the rust forming at the roof lap seams. We recommend seam sealing using Sikaflex® 1a on all unwelded interior roof lap seams to prevent failure of a new interior liner. This work is to be performed in conjunction with application of new interior liner.

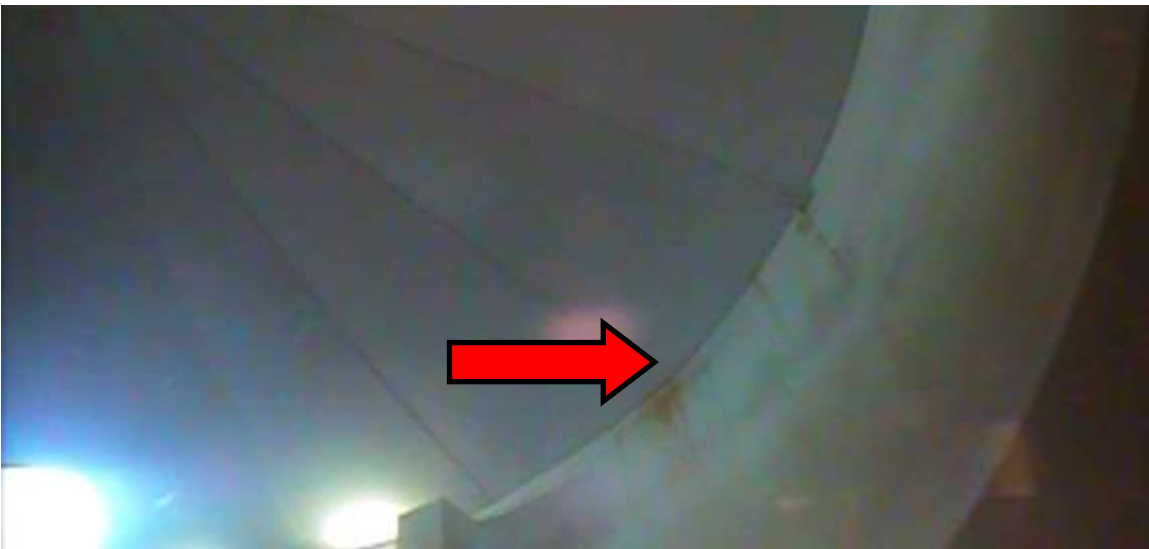
Bottom photo shows the condition of the interior roof-to-rim angle connection. Notice the rust forming in the crevice between the roof and rim angle. We recommend seam sealing using Sikaflex® 1a around the circumference of this connection to prevent failure of a new interior liner. This work is to be performed in conjunction with application of new interior liner.

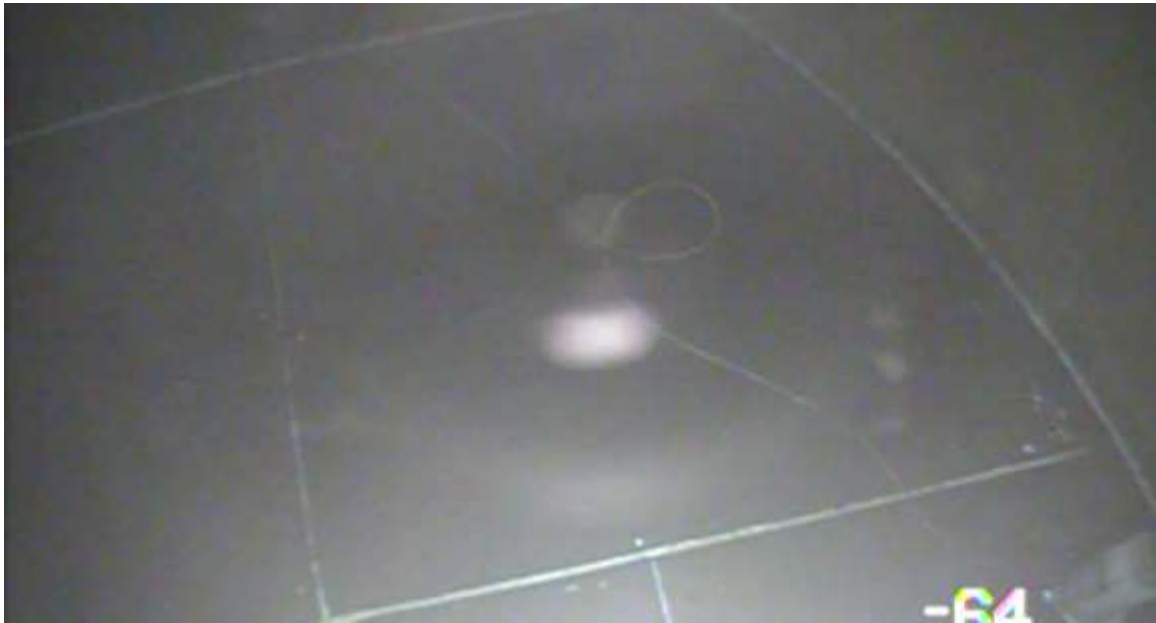
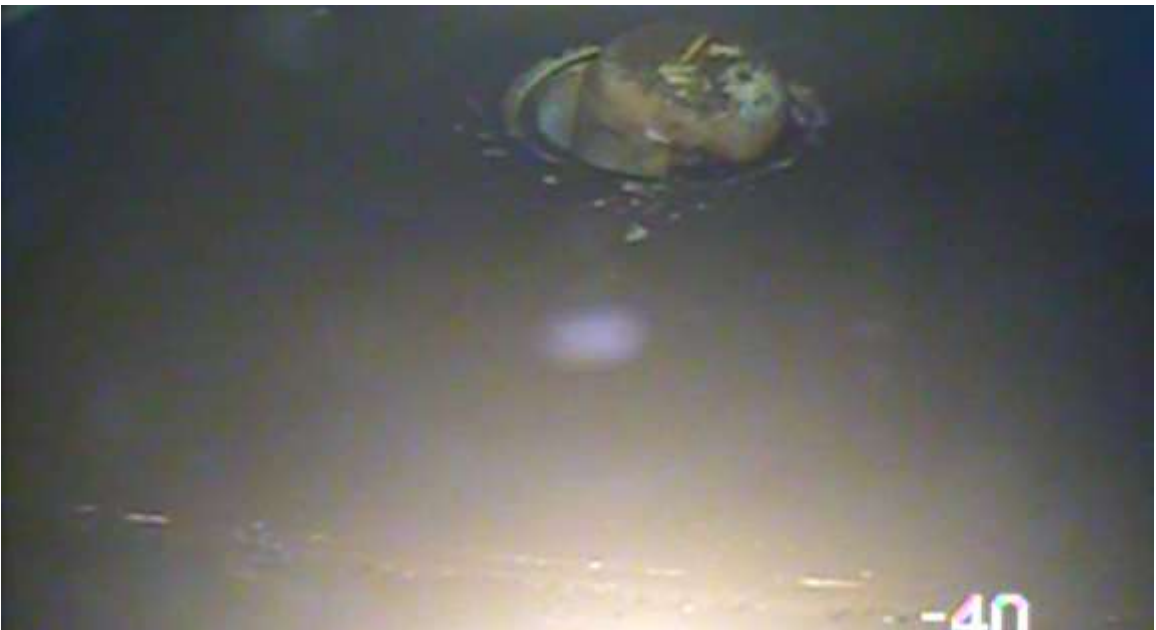
Photos show sediment in the tank interior prior to the performance of the tank clean out.
