**SimplexGrinnell #458 & JCI
9520 10th Avenue South, Suite 100
Seattle, WA 98108
RE: Western State Hospital; Lakewood, WA
400,000 Gallon STP
August 4, 2018
Ms. Melissa Fraser
Systems Integrity Representative
(206) 291-1439
Job No. 318298-B**

STANDPIPE INSPECTION REPORT

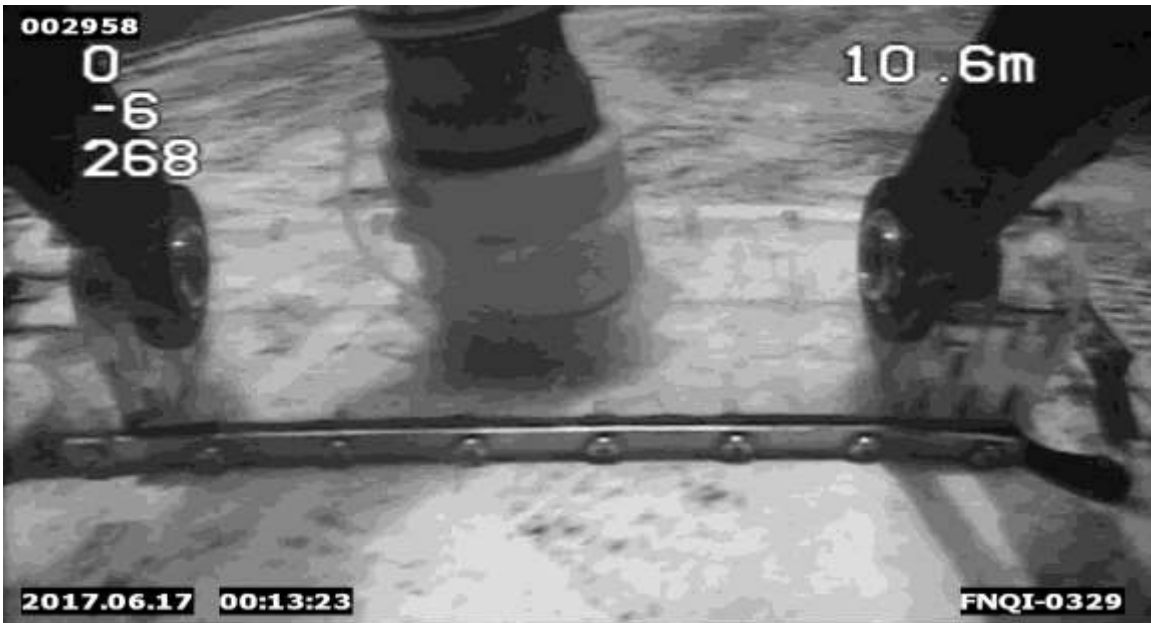
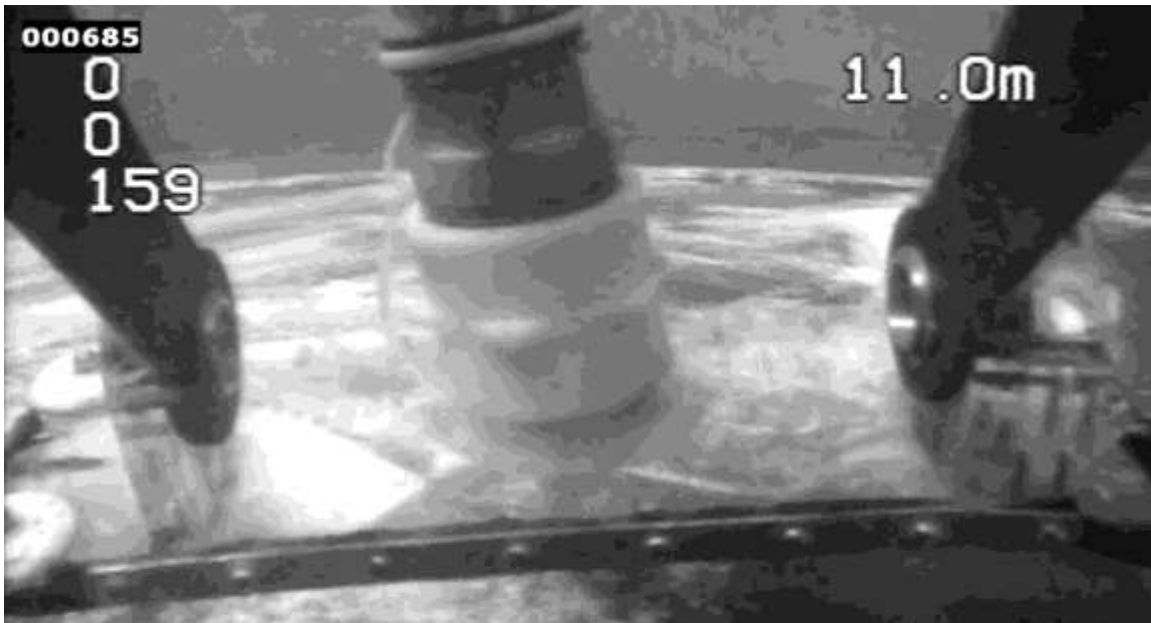
Photos show the tank interior during the performance of the tank clean out.

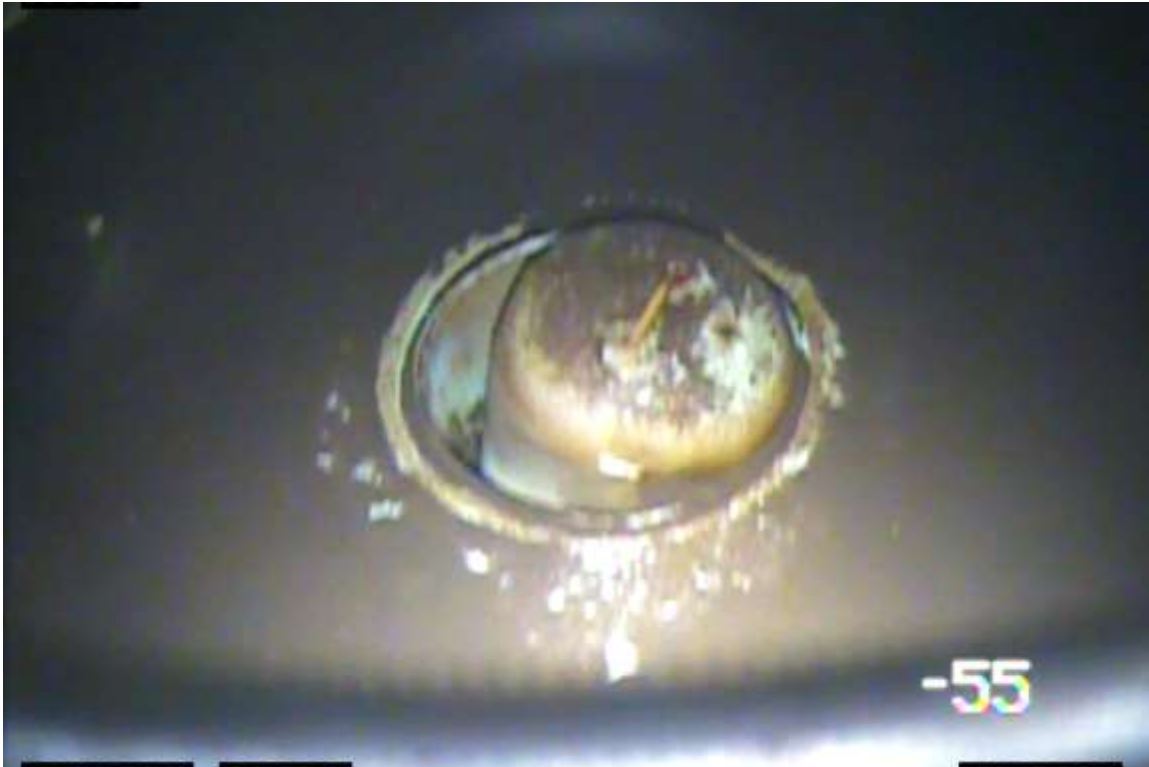
Photo shows a suction pipe on the interior of the tank. **NFPA 22-2018; 14.2.13.1** states, “ The discharge outlet for every suction tank shall be equipped with an anti-vortex plate assembly.” We recommend installing a properly sized anti-vortex plate on the suction pipe to prevent formation of a vortex.

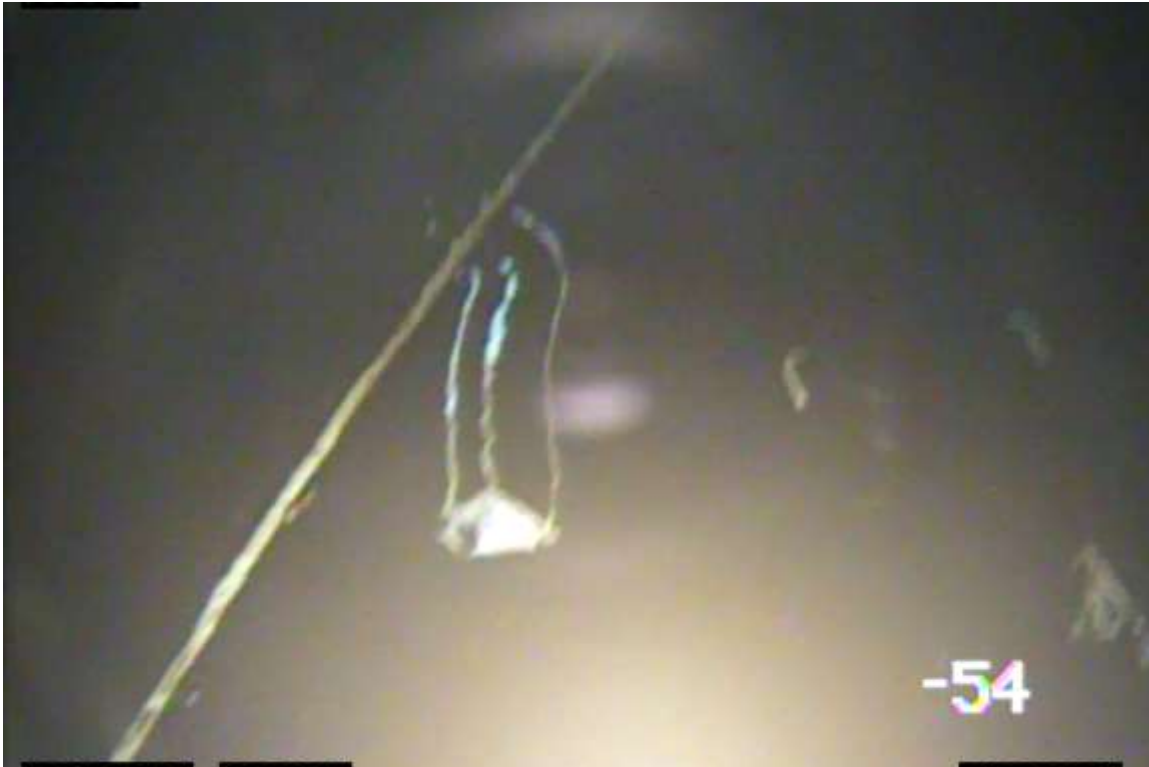
Photo shows the condition of the tank floor. If buckling is present we recommend stabilizing the floor by pumping grout to the underneath side of the floor where the buckling is occurring in compliance with [NFPA 25-2017; 9.4.1](#). This will be done by installing couplings in the tank floor, pumping grout at 15# psi, filling the voided areas to prevent any further buckling, then vacuum testing the floor. Any defective seams will be repaired by welding.

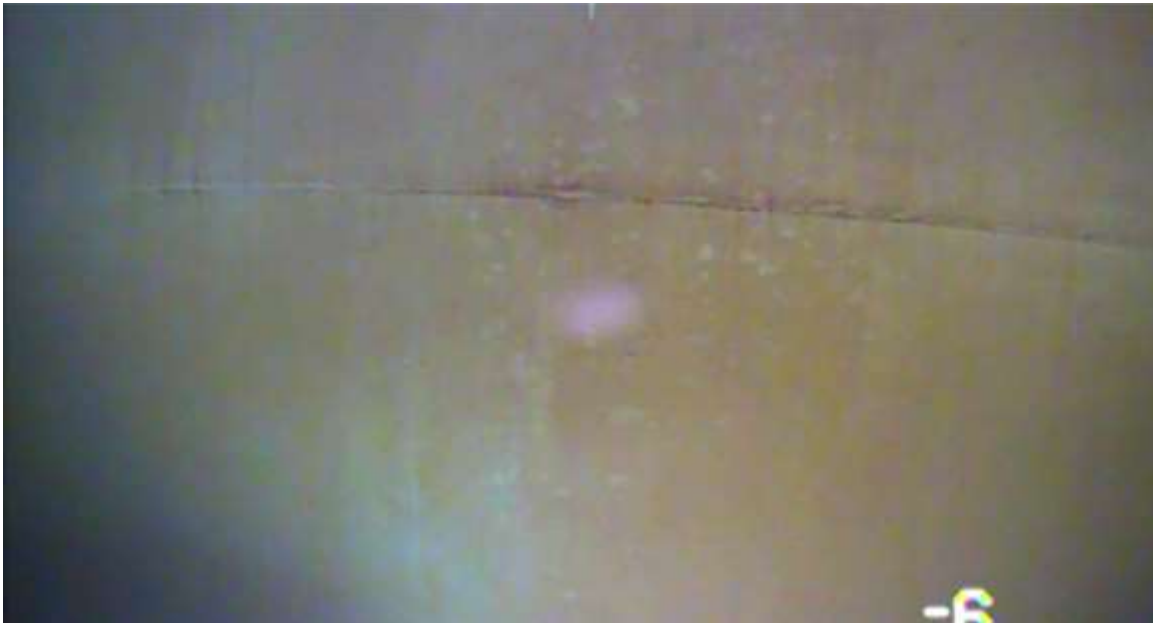
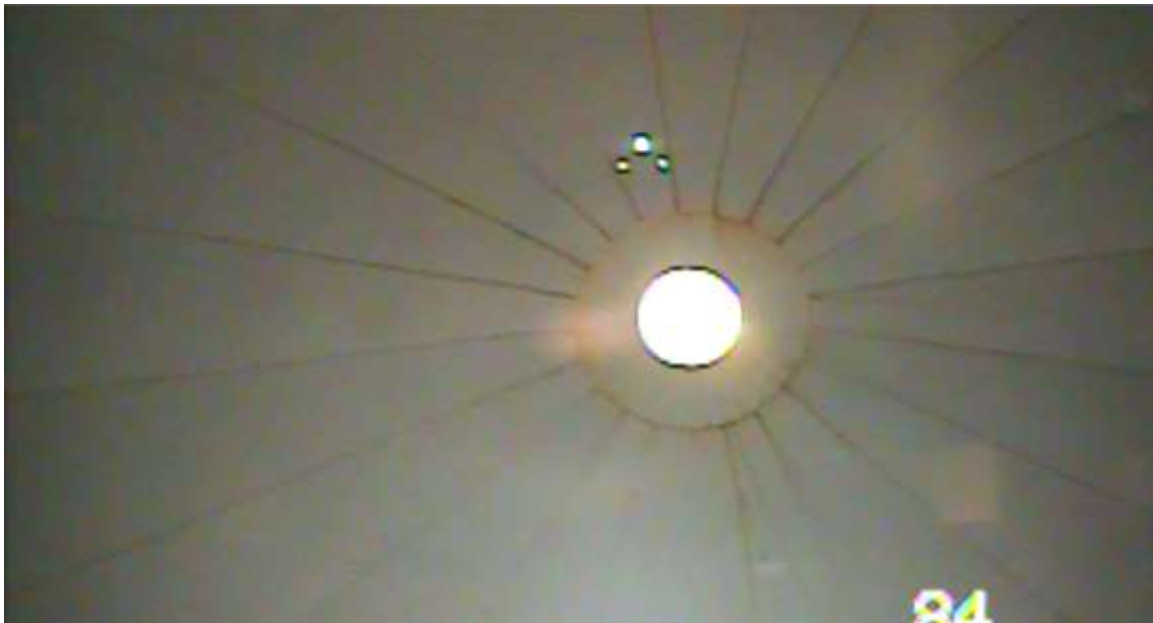
Photos show the condition of the interior coating system. We recommend sandblasting all rusted and abraded interior areas to SSPC-SP10 (near white), and brush blasting all remaining interior areas to SSPC-SP7; then applying one (1) spot coat of epoxy primer to all areas sandblasted to #10, stripe coating all weld seams, and applying epoxy to the entire tank, to achieve 8 to 10 mils of total dry film thickness. Total mil thickness will include a combination of the existing and new coating.
