Washington State
Department of Transportation
Bridge Preservation Dive Team

UNDERWATER INSPECTION REPORT
FOR THE
MCNEIL IS. STILL HARBOR DOCK
BRIDGE NO. DOC-6
STRUCTURE ID 00200441

Inspection Date April 26, 2017

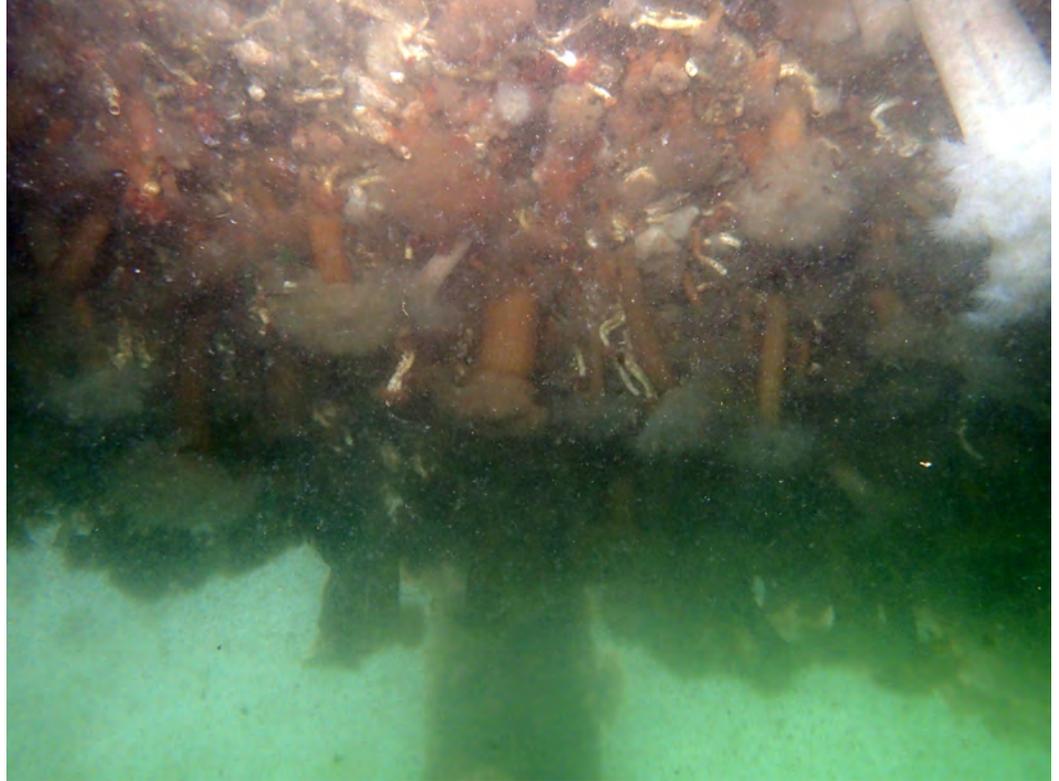
UW-1

8701	<p>CONCRETE FLOATING PONTOON: The previous inspections found dock float A listing upwards of 5" was measured close to level in 2017 due to timber water repairs. Trip hazards between floats have been reduced greatly. Prior to the repair, the listing of the pontoon segments indicates the pontoon polystyrene has degraded and taken on water through the water bolt holes. There is a serviceability issue which may reappear after a significant storm from the north. Seven of the dock segments have been repaired since the 2013 inspection, Condition State 2.</p> <p>Underwater Inspection Findings: The submerged surfaces of the pontoons are covered in heavy marine growth, making a detailed inspection very difficult. Spot cleaning revealed no defects. See Photo #UW-1.</p>

8701 Ferry Concrete Floating Pontoon
Photo Type: G - General
Orientation:
Date: 5/23/2013
Repairs:
Typical heavy marine growth on floating dock sections.

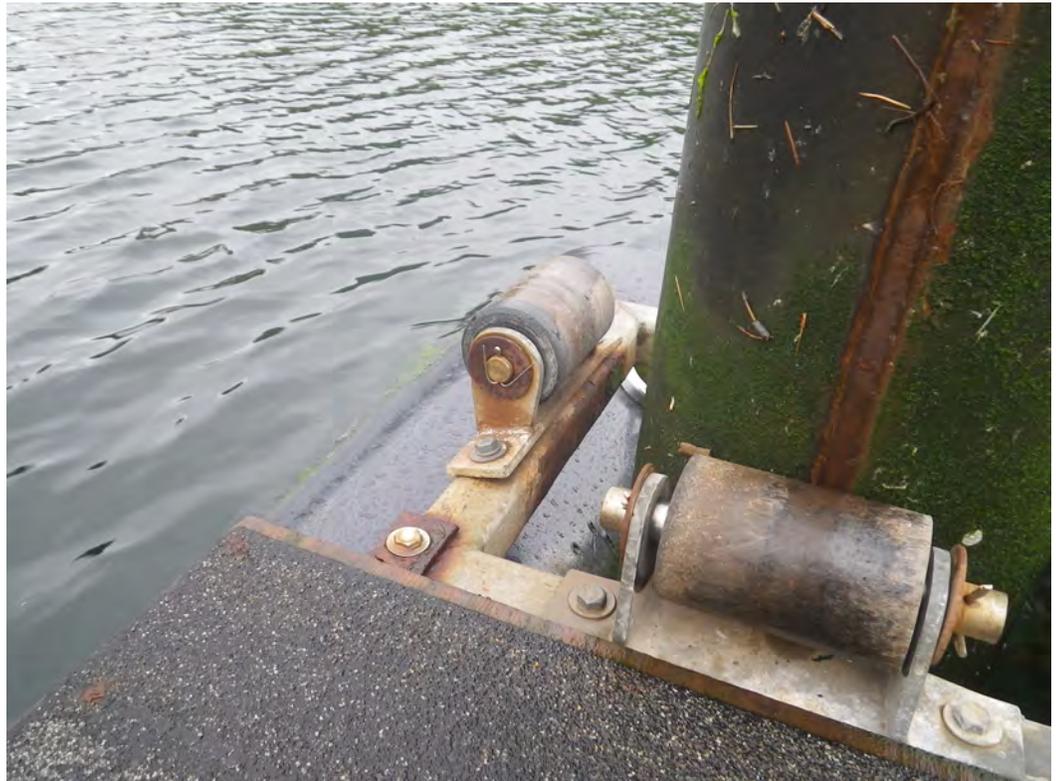
SI-27

8703 Spud Piling & Wells
Photo Type: G - General
Orientation:
Date: 4/26/2017
Repairs:
Spud pile rollers are all intact, some are bent from storm events.

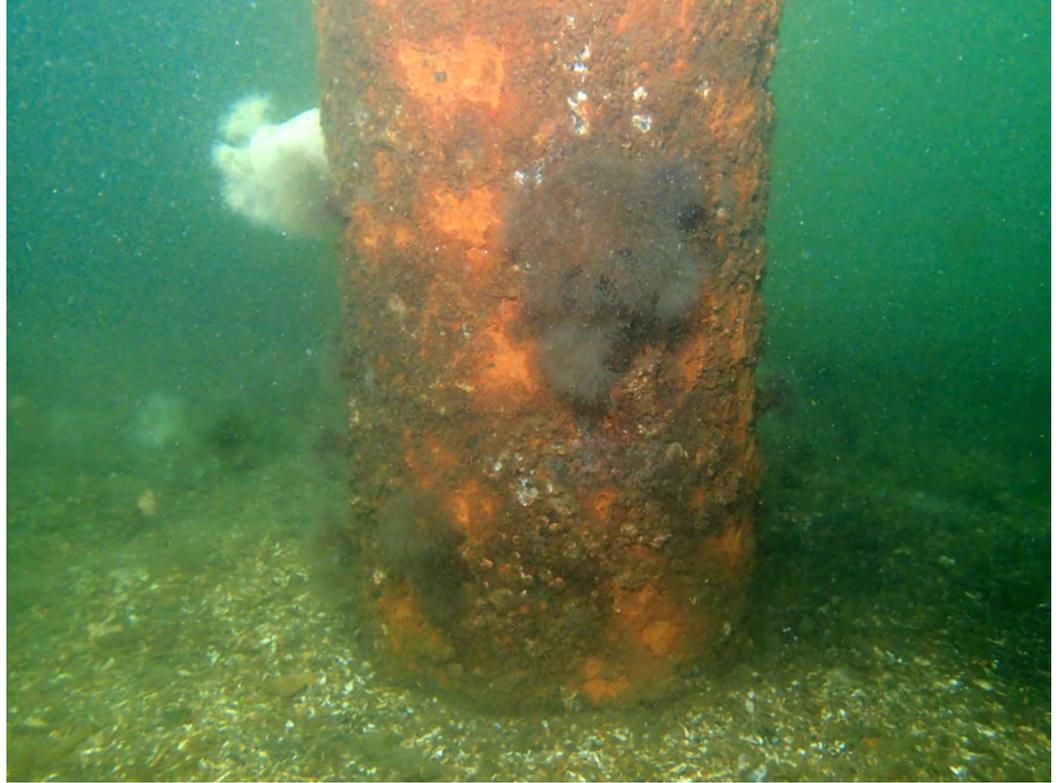
UW-2

8703 Spud Piling & Wells
Photo Type: I - In Depth
Orientation:
Date: 5/23/2013
Repairs:
T-dock Pile S; general coating failure and rusting with section loss. Typical of T-dock piles.

Q	95		Steel	MDL - ITZ	25% area surface rust / 75% area marine growth (typical).	UW	4/26/2017
	R	95		Steel	MDL - ITZ	25% area surface rust / 75% area marine growth (typical).	UW	4/26/2017
	S	90		Steel	MDL - ITZ	50% area surface rust / 50% area marine growth (typical) Photo #UW-2 shows typical pile condition underwater.	UW	4/26/2017

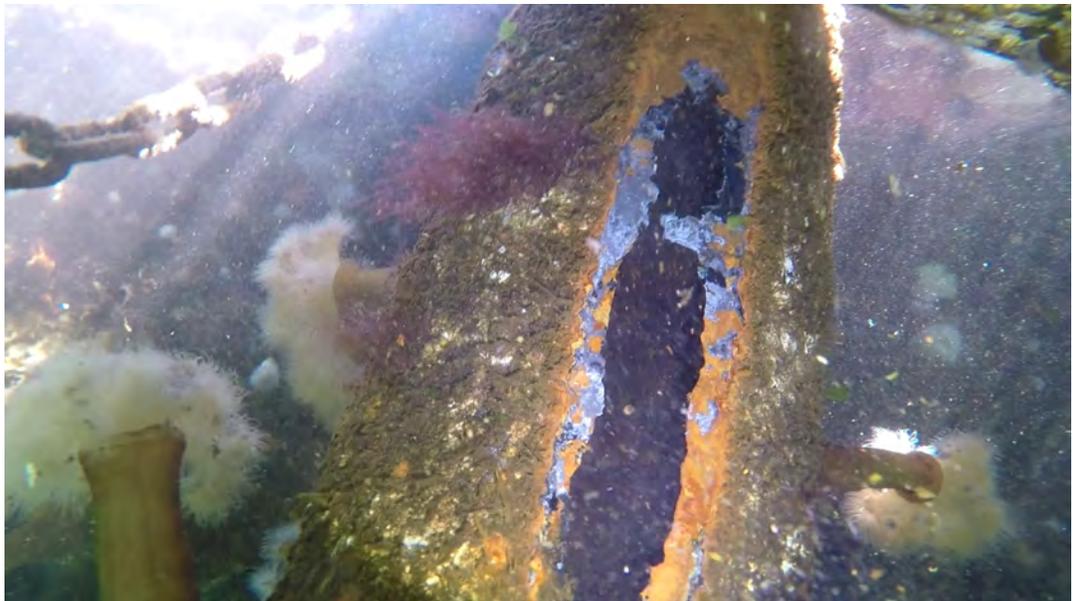
UW-3

8703 Spud Piling & Wells
Photo Type: I - In Depth
Orientation:
Date: 4/27/2017
Repairs:
T-dock, Pile A: 18" H x 4" W hole from mechanical damage.

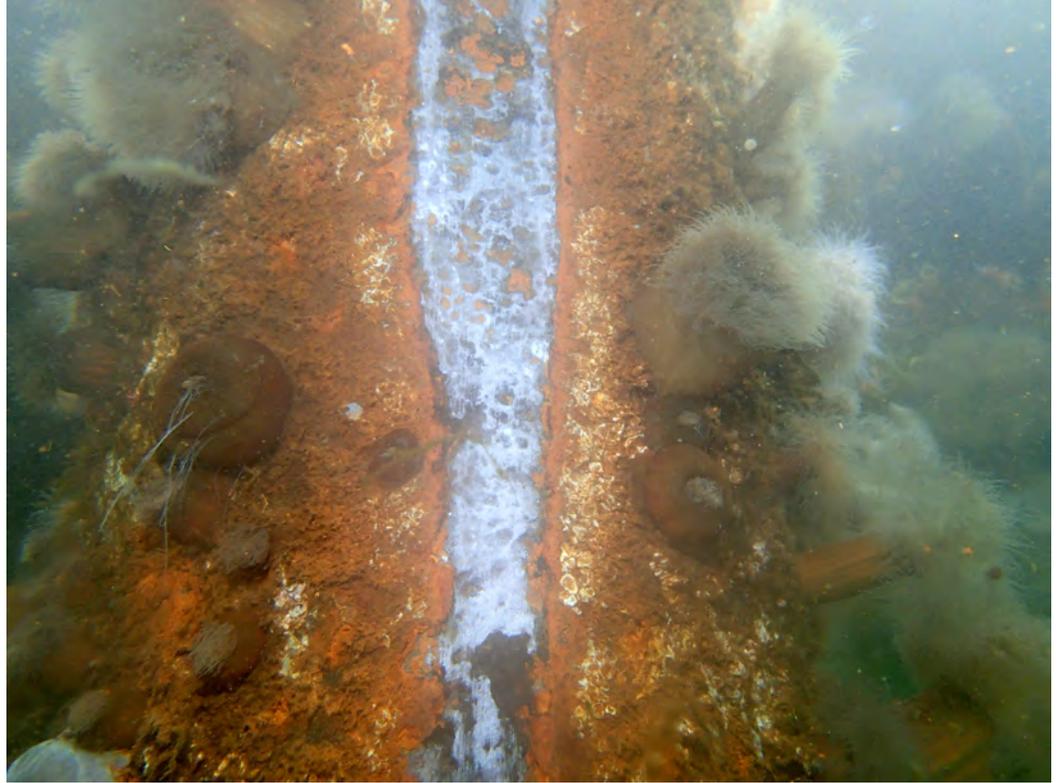
UW-4

8703 Spud Piling & Wells
 Photo Type: I - In Depth
 Orientation:
 Date: 5/23/2013
 Repairs:
 T-dock Pile J; 4" wide mechanical damage (flat spot). 2013 photo; compare to UW-5 for 2017 photo to see progression.

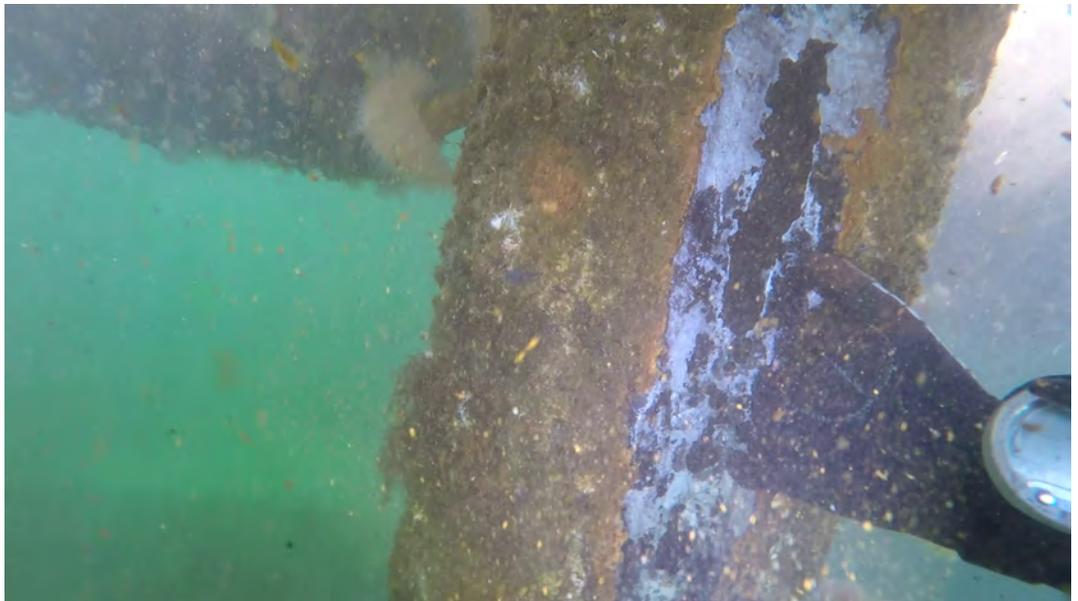
UW-5

8703 Spud Piling & Wells
 Photo Type: I - In Depth
 Orientation:
 Date: 4/27/2017
 Repairs:
 T-dock Pile J: 12" H x 2.5" W hole (was just a flat spot in 2013, see UW-4).

Underwater		4/26/2017	Lead: DON	Co: MBS				
Routine		4/27/2017	Lead: JHL	Co: LAW				
Pile Location			Condition/Damage				Inspection Type	
Bent	Pile	% Area Remaining	RT or YT	RT Pile Circum. (in)	Elevation	Details/Remarks	Routine/UW	Date
	F	75		Steel	MDL - ITZ MDL+8 to +12 MDL+9 MDL+10	25% area surface rust / 75% area marine growth (typical). 4" wide flat spot (mech abrasion; log boom). 12" H x 3" W hole from mech. abrasion (log boom). 3/4" diam. hole from mech. abrasion (log boom).	UW	4/26/2017
	G	95		Steel	MDL - ITZ	25% area surface rust / 75% area marine growth (typical).	UW	4/26/2017
	H	95		Steel	MDL - ITZ	25% area surface rust / 75% area marine growth (typical).	UW	4/26/2017
	I	95		Steel	MDL - ITZ	25% area surface rust / 75% area marine growth (typical).	UW	4/26/2017
	J	75		Steel	MDL - ITZ MDL+7 to +11 MDL+7 MDL+11	25% area surface rust / 75% area marine growth (typical). 4" wide flat spot (mech abrasion; log boom). 3" H x 1" W hole from mech. abrasion (log boom). 12" H x 2.5" W hole from mech. abrasion (log boom). See Photos #UW-4 (2013) and #UW-5 (2017)	UW	4/26/2017

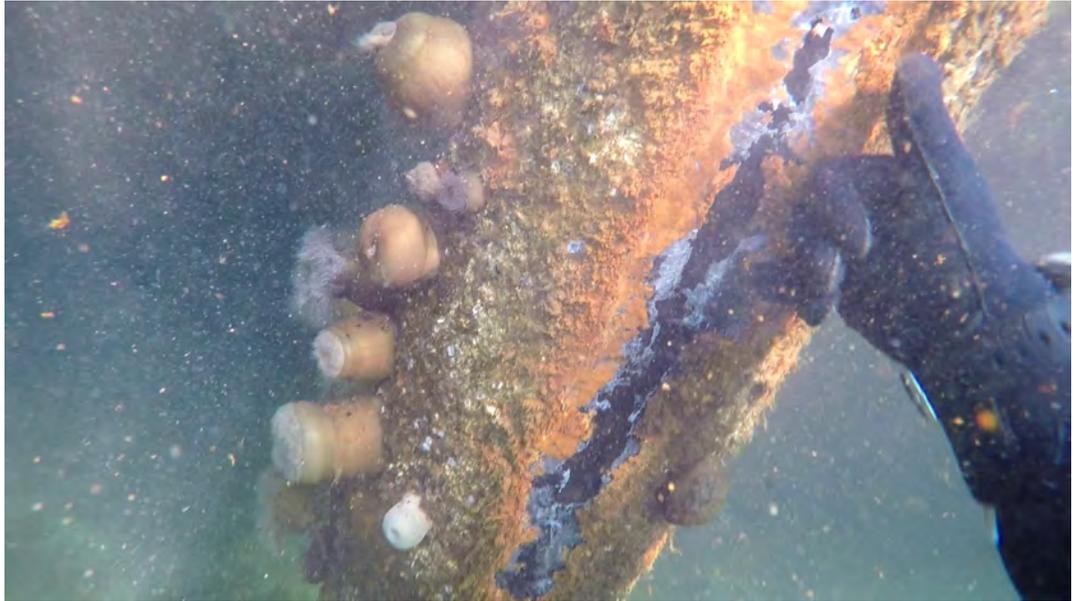
UW-6

8703 Spud Piling & Wells
Photo Type: I - In Depth
Orientation:
Date: 4/27/2017
Repairs:
T-dock Pile O: 18" H x 4" W (up to) hole from mechanical damage.

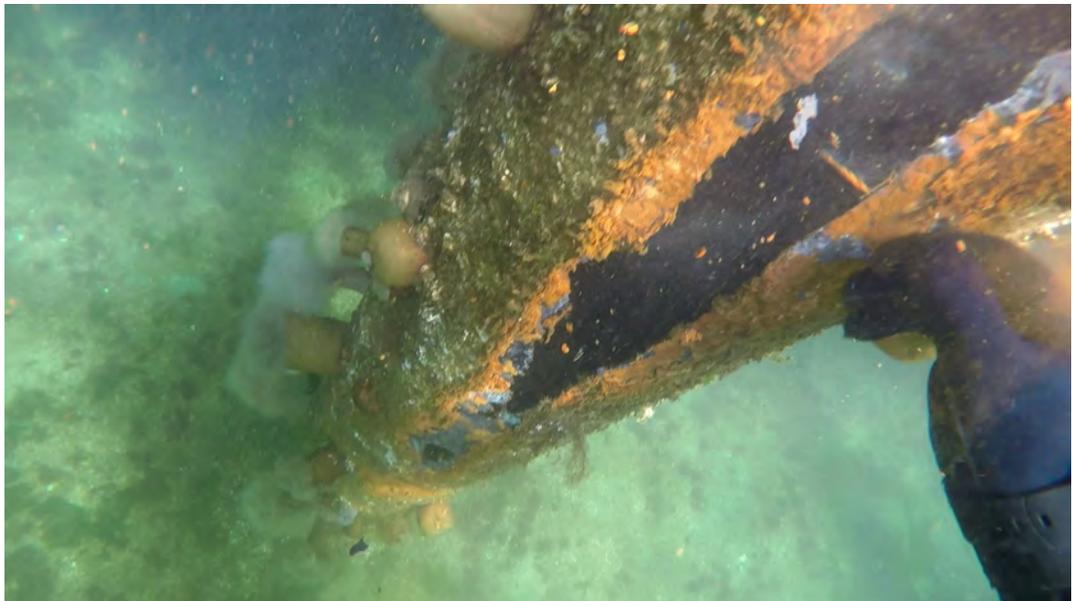
UW-7

8703 Spud Piling & Wells
Photo Type: I - In Depth
Orientation:
Date: 4/27/2017
Repairs:
T-dock Pile P: Large 3-ft. vertical hole from mechanical damage.

K	95		Steel	MDL - ITZ MDL+9 - ITZ	25% area surface rust / 75% area marine growth (typical). 4" wide flat spot (mech abrasion; log boom); no holes.	UW	4/26/2017
	L	75		Steel	MDL - ITZ MDL+6 - ITZ MDL+8	25% area surface rust / 75% area marine growth (typical). 5" wide flat spot (mech abrasion; log boom). 18" H x 2.5" W hole from mech. abrasion (log boom).	UW	4/26/2017
	M	75		Steel	MDL - ITZ MDL+8 - ITZ MDL+9	25% area surface rust / 75% area marine growth (typical). 3" - 4" wide flat spot (mech damage; log boom). 1" diam. hole from mech. abrasion (log boom).	UW	4/26/2017
	N	90		Steel	MDL - ITZ	50% area surface rust / 50% area marine growth (typical).	UW	4/26/2017
	O	75		Steel	MDL - ITZ MDL+5 to +9 MDL+6	25% area surface rust / 75% area marine growth (typical). 4" wide flat spot (mech damage; log boom). 18" H x 4" W hole from mech. abrasion (log boom). See Photo #UW-6	UW	4/26/2017
	P	75		Steel	MDL - ITZ MDL+4 MDL+5	25% area surface rust / 75% area marine growth (typical). 4" H x 2" W hole from mech. abrasion (log boom). 36" H x 5" W large hole from mech. abrasion (log boom). See Photo #UW-7	UW	4/26/2017

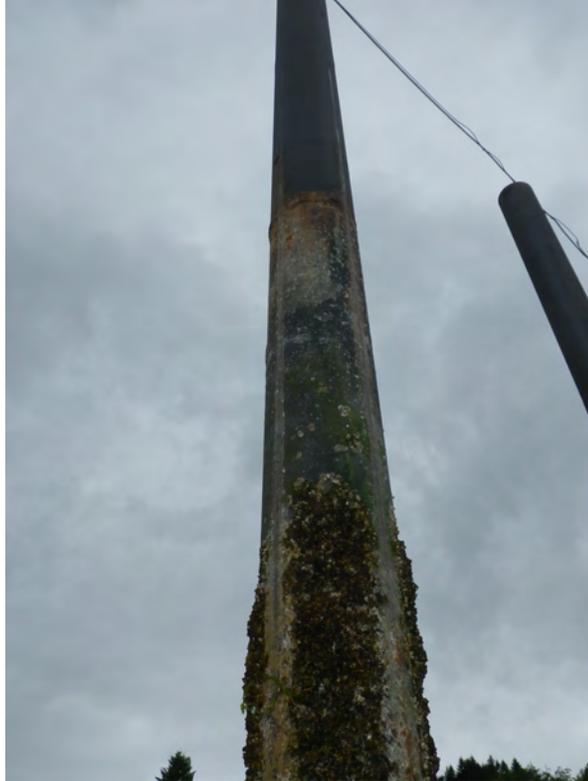
SI-3

8902	<p>INORGANIC ZINC VINYL PAINT: Many of the spud piles have rust blisters and seam rust, see photo #3.</p> <p>Underwater Inspection Findings: Much of the spud pile coating has failed underwater. Pile metal substrate is exposed between 25% and 50% of the pile surface area underwater. See Photos #UW-2 and #UW-8 for typical underwater coating condition.</p>

Typical shot of spud piles. Seam rust on welds are breaking through the paint.

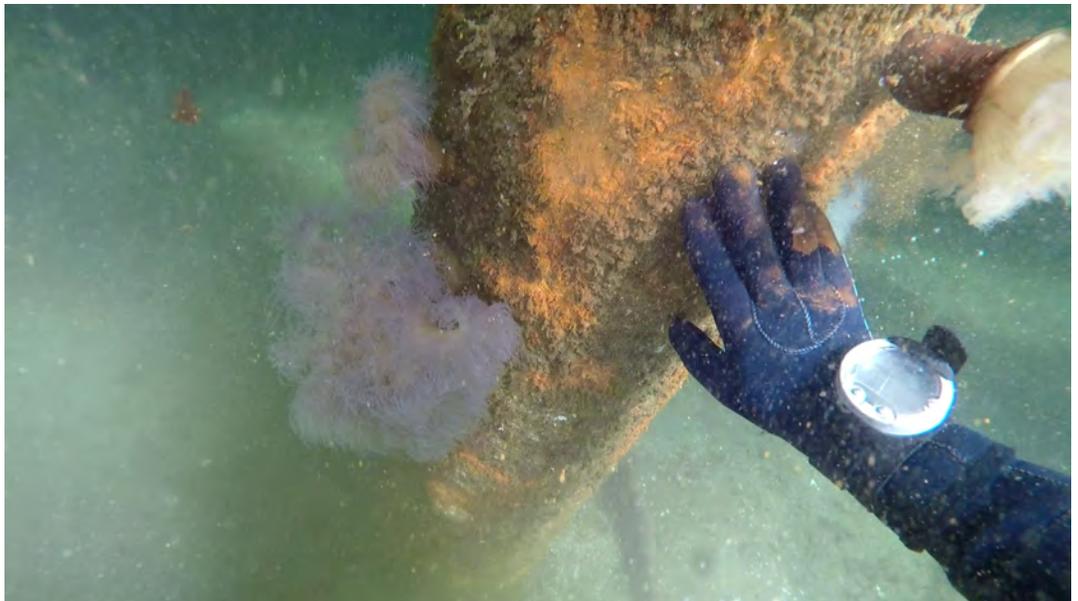
UW-8

Typical pile condition underwater. Coating has failed over 25%-50% of the surface area on the piles below water. Example of ~25% exposed metal shown.
