UNDERWATER INSPECTION REPORT FOR
STEILACOOM BLDG TRESTLE

BRIDGE NO. DOC-1

STRUCTURE ID 00200436

Inspection Date April 26, 2021

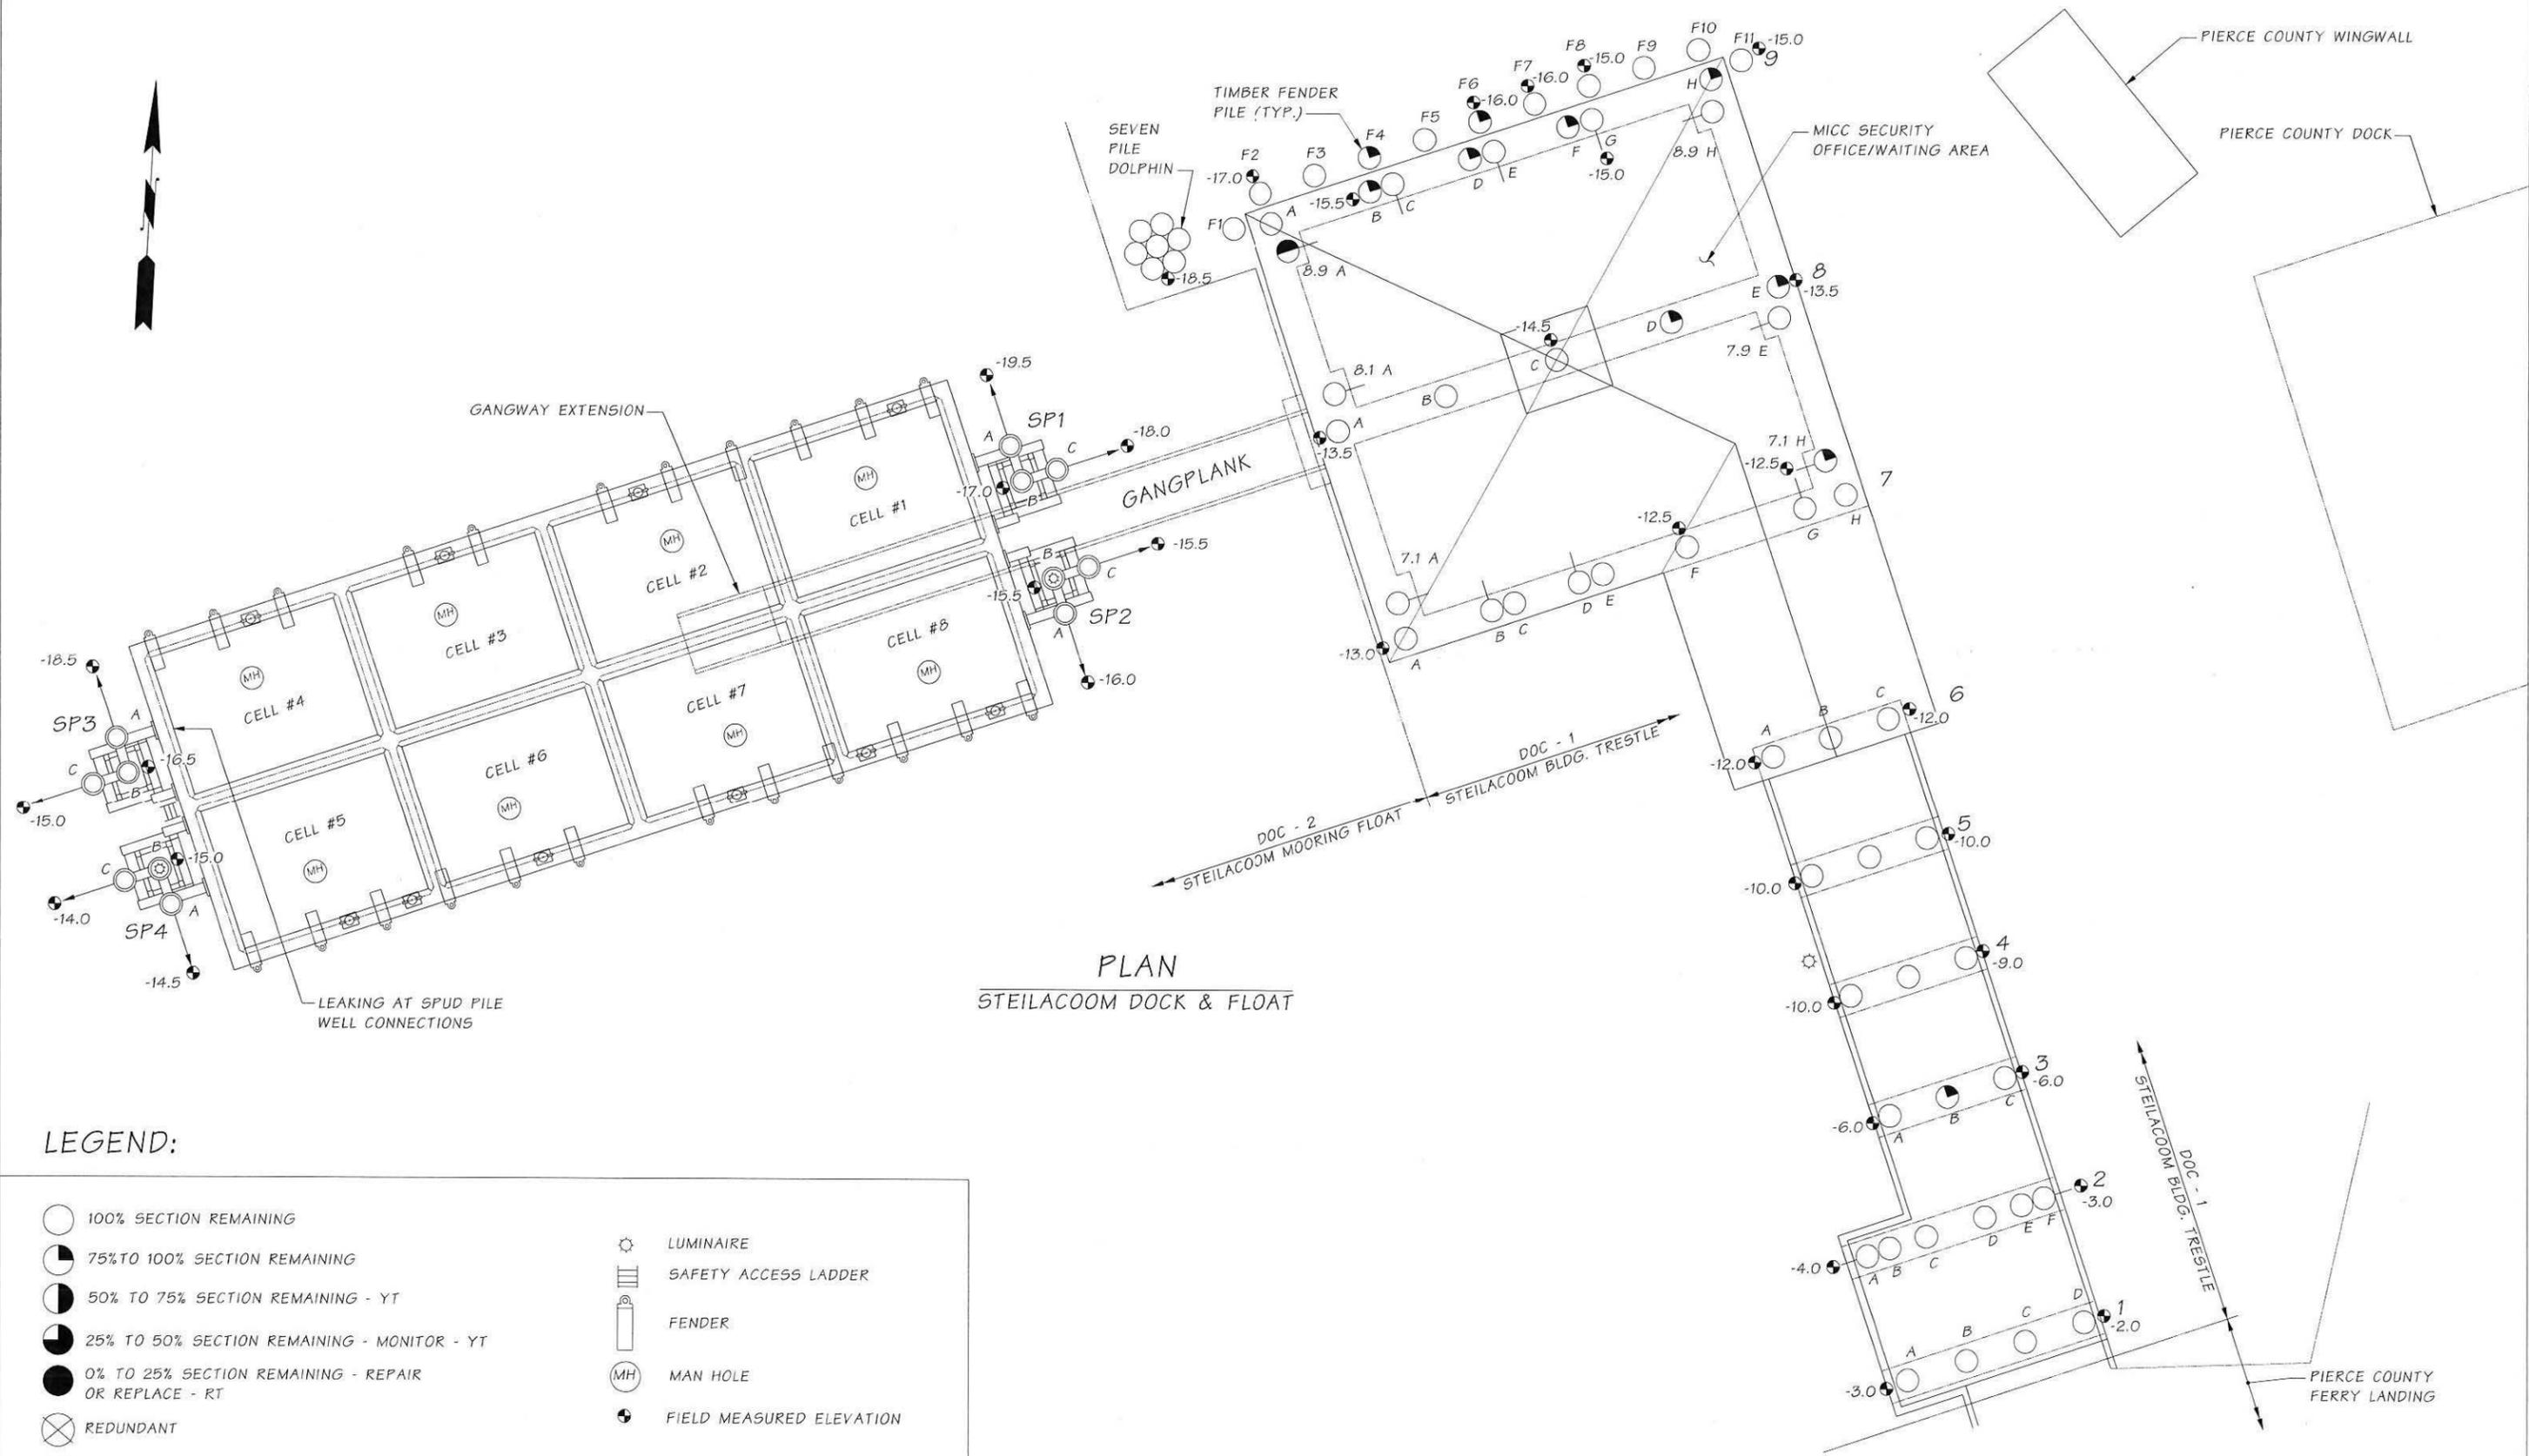
PLAN
STEILACOOM DOCK & FLOAT

Underwater		4/26/2021	Lead: JRWH	Co: LAW				
Routine		4/24/2017	Lead: JSW	Co: KGH				
Pile Location		Condition/Damage				Inspection Type		
Bent	Pile	% Area Remaining	RT or YT	RT Pile Circum. (in)	Elevation	Details/Remarks	Routine/UW	Date
	F3	100					UW	4/26/2021
	F4	75			MDL+4 MDL+7 MDL+11	Two MBEs @ 7:00: 3/4" diam. w/ up to 2" pen. Two MBEs @ 9:00: 3/4" diam. w/ 2" pen. Two MBEs @ 8:00: 3/4" diam. w/ 3" pen.	UW	4/26/2021
	F5	100					UW	4/26/2021
	F6	75			-16 MDL+3 MDL+8 MDL+15	MDL Up to 5 MBE holes from 7:00 to 8:00, up to 3" pen. Two MBEs @ 8:00: 3/4" diam. w/ 4" pen. Two MBEs @ 6:00: 3/4" diam. w/ 3" pen.	UW	4/26/2021
	F7	100			-16 MDL +10	MDL 3/4" diameter MBE at 6:00 with 3" of penetration	UW	4/26/2021
	F8	100			-15 MDL +6	MDL 2 MBC's at 6:00 1-1/2" deep	UW	4/26/2021
	F9	100					UW	4/26/2021
	F10	100			MDL +10 MDL+16	MBE @ 6:00 1" diameter with 2" penetration MBE @ 6:00 3/4" diameter with 3" penetration	UW	4/26/2021

F11	100			-15	MDL	UW	4/26/2021
Dolphin	Dolphin				-18.5	MDL. Seven pile dolphin. Center pile has Limnoria striations (photo UW-7).	UW	4/26/2021
Counts	Timber =	60	7	(dolphin piles)
