**BRIDGE INSPECTION REPORT**

**Br. No.** DOC-2

**Br. Name** STEILACOOM MOORING FLOAT

9 The WSDOT Dive Team performed an underwater inspection of the Steilacoom Mooring Float on April 26, 2021. Twelve steel pipe piles and the concrete floating pontoon exterior were inspected by diving.

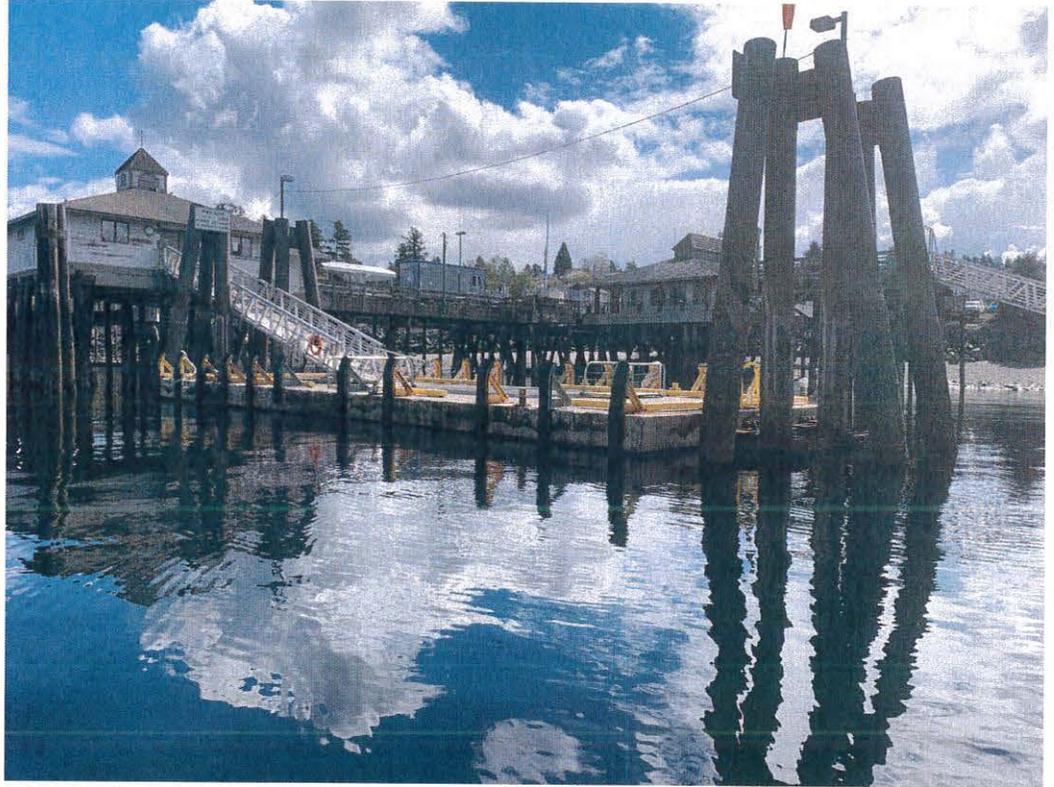
**UW-0**

0 Orientation  
Photo Type: E - Elevation  
Orientation: Shore  
Date: 4/26/2021  
Repairs:  
Elevation of floating pontoon dock.
