Washington State
Department of Transportation
Bridge Preservation Dive Team

UNDERWATER INSPECTION REPORT
FOR THE
MCNEIL IS. STILL HARBOR DOCK
BRIDGE NO. DOC-6
STRUCTURE ID 00200441

Inspection Date April 26, 2017

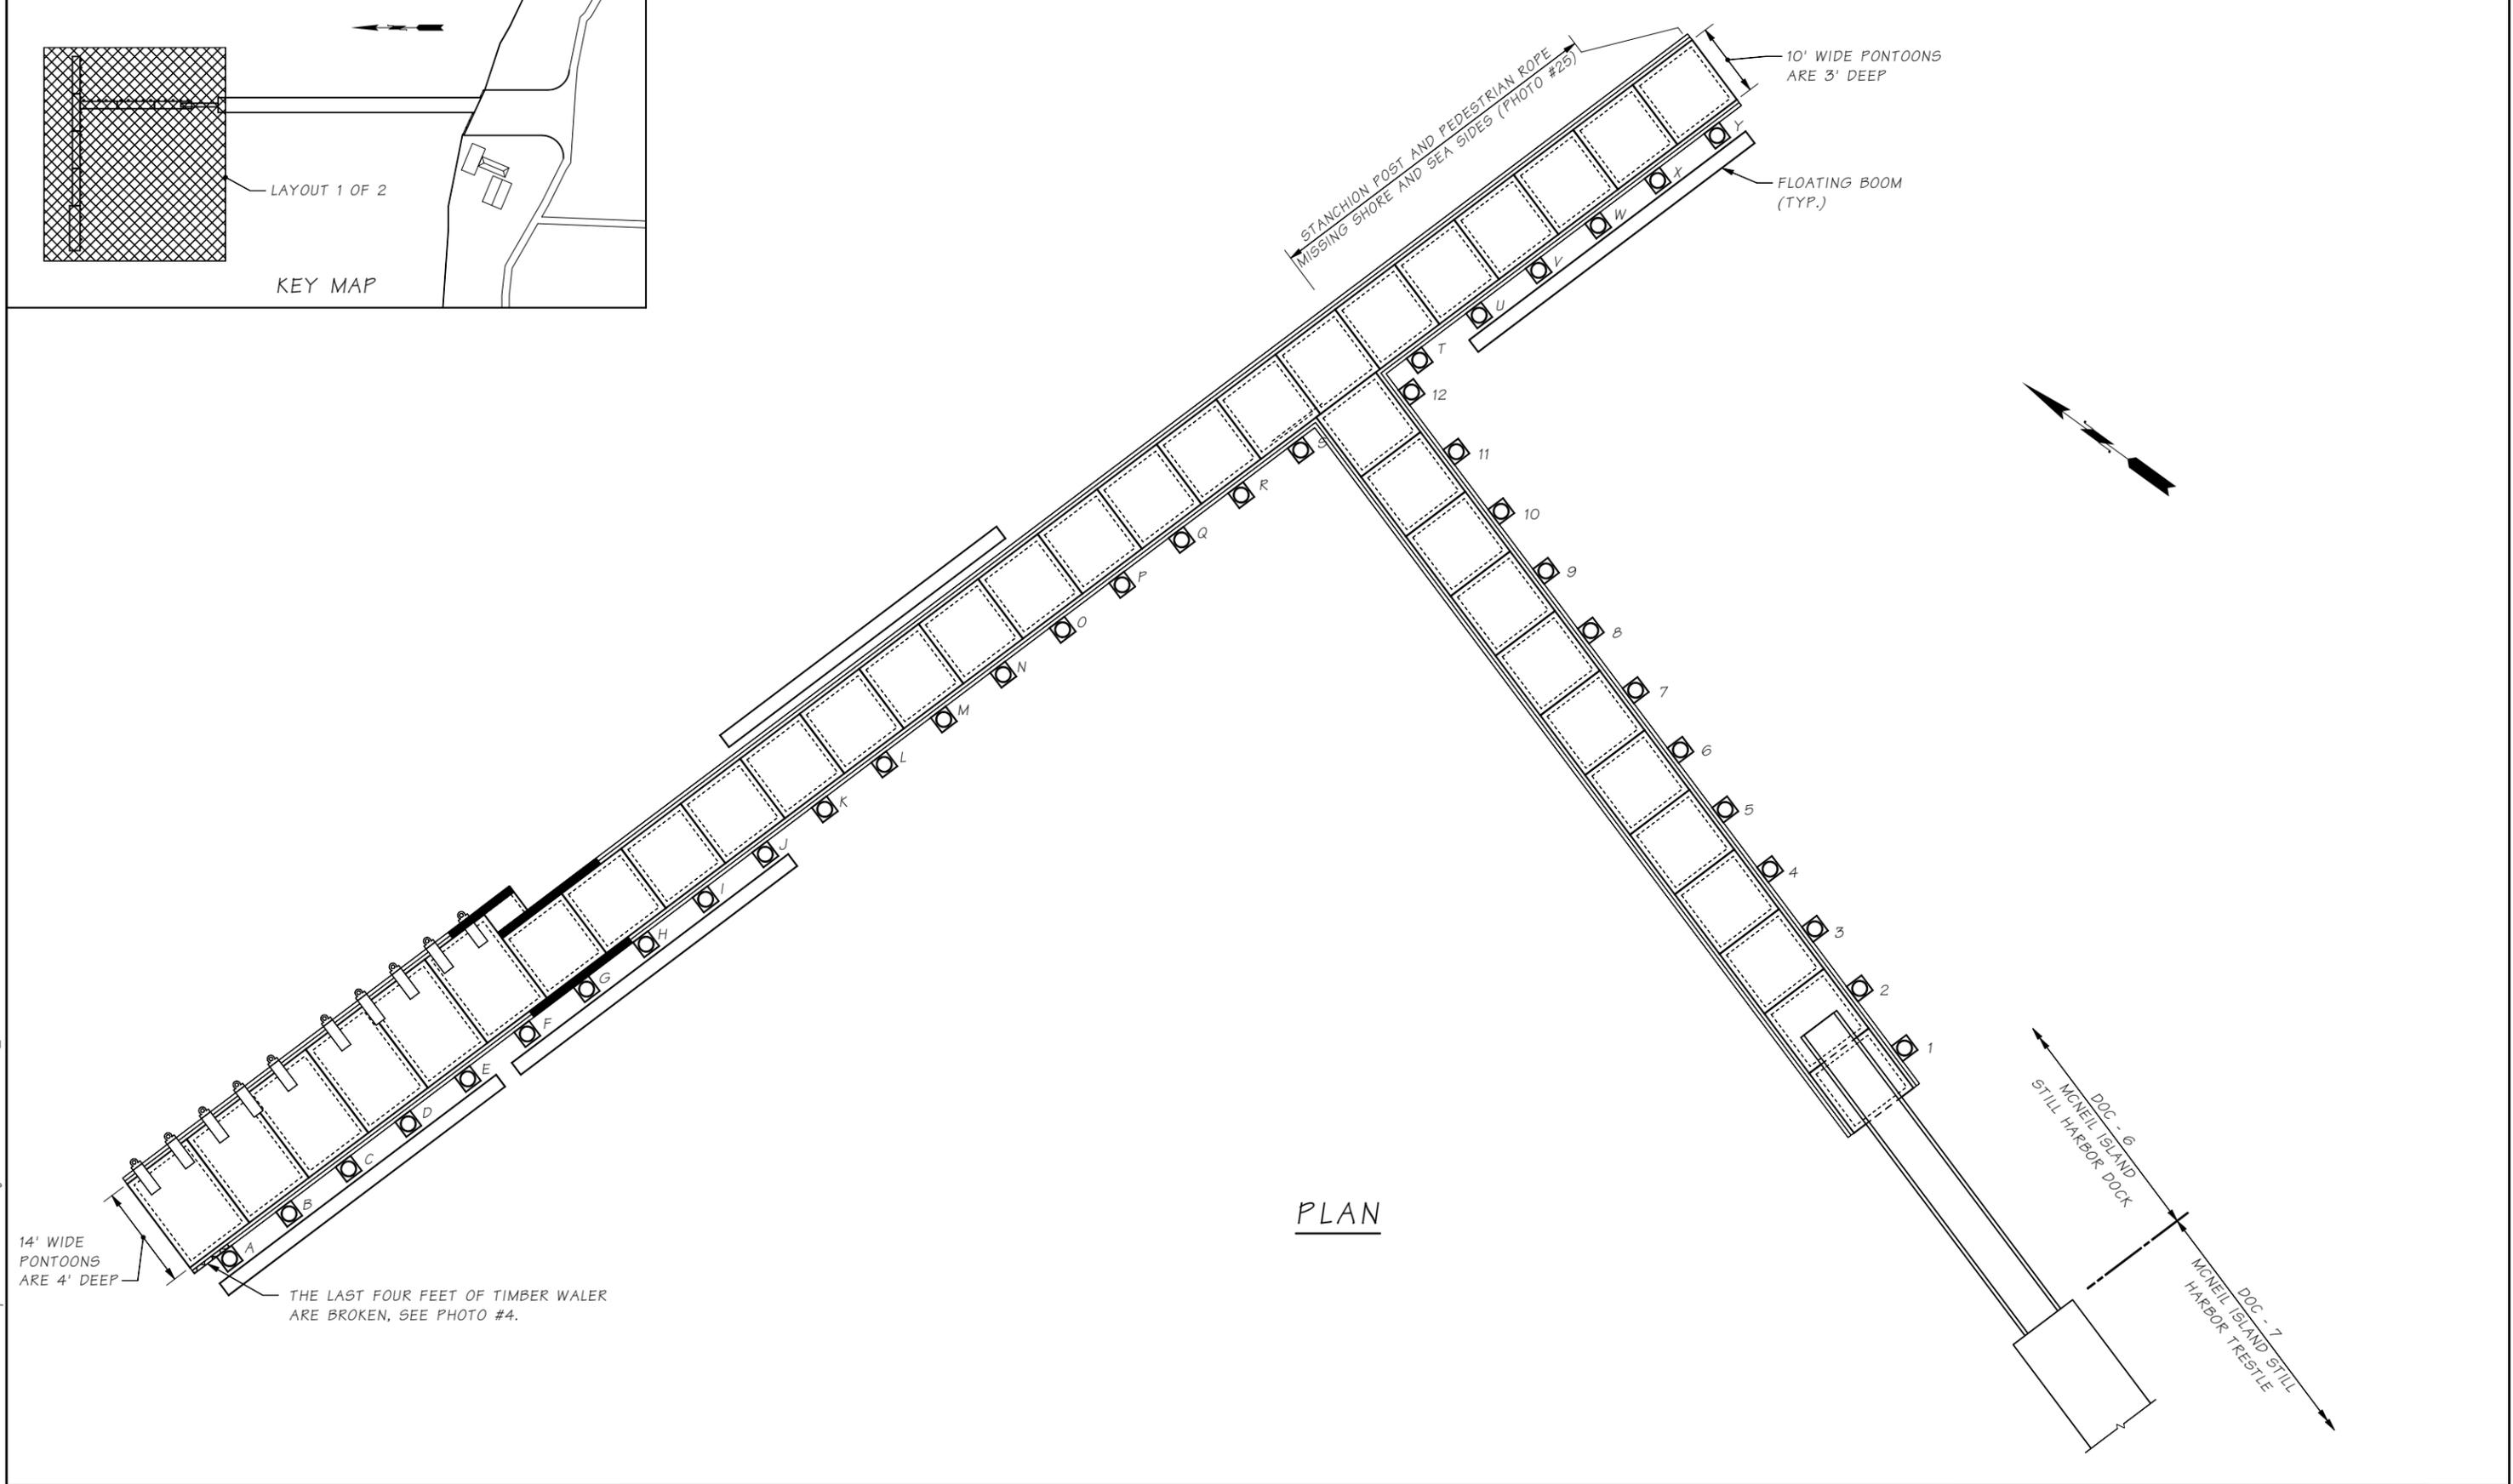
Underwater		4/26/2017	Lead: DON	Co: MBS				
Routine		4/27/2017	Lead: JHL	Co: LAW				
Pile Location			Condition/Damage				Inspection Type	
Bent	Pile	% Area Remaining	RT or YT	RT Pile Circum. (in)	Elevation	Details/Remarks	Routine/UW	Date
	T	90		Steel	MDL - ITZ	50% area surface rust / 50% area marine growth (typical).	UW	4/26/2017
	U	90		Steel	MDL - ITZ	50% area surface rust / 50% area marine growth (typical).	UW	4/26/2017
	V	75		Steel	MDL - ITZ	50% area surface rust / 50% area marine growth (typical).	UW	4/26/2017
					MDL+4	10" H x 3" W hole from mech. abrasion (log boom).		
					MDL+6	18" H x 3" W hole from mech. abrasion (log boom).		
	W	75		Steel	MDL - ITZ	50% area surface rust / 50% area marine growth (typical).	UW	4/26/2017
					MDL+3	8" H x 3" W hole from mech. abrasion (log boom).		
					MDL+4	4" H x 2" W hole from mech. abrasion (log boom).		
					MDL+5	18" H x 4" W hole from mech. abrasion (log boom).

X	90		Steel	MDL - ITZ	50% area surface rust / 50% area marine growth (typical).	UW	4/26/2017
	Y	75		Steel	MDL - ITZ	50% area surface rust / 50% area marine growth (typical).	UW	4/26/2017
					MDL+3	6" H x 3" W hole from mech. abrasion (log boom).		
					MDL+5	9" H x 3" W hole from mech. abrasion (log boom).		
					MDL+6	6" H x 3" W hole from mech. abrasion (log boom).		
	counts	steel	37
